PROJECT MEMORANDUM PG&E – TRI-VALLEY 2002 CAPACITY INCREASE PROJECT

To: Jensen Uchida, CPUC
From: Vida Strong, Aspen Project Manager
Date: March 15, 2006
Subject: Weekly Report #101: March 5, 2006 – March 11, 2006
CPUC Environmental Monitor (EM): Anne Sweet Coronado

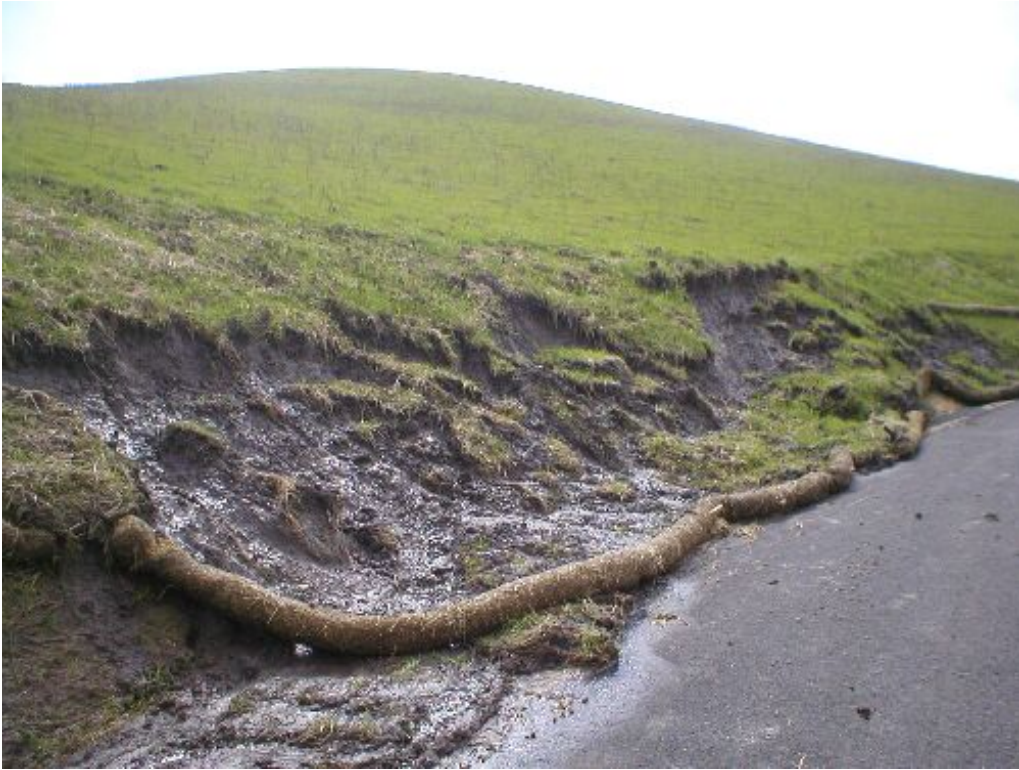
Along the underground alignment installation which extends up a steep slope extending from Manning Road off of North Livermore Avenue, the back filled trench line (backfilling occurred last fall) appears stable, showing good vegetative growth. The CPUC EM had noted previously that along Road 6 slumping of cut slope areas above the road had occurred. Due to the recent storms much greater slumping of the area has occurred (see Figure 1). North Valley removed the loose soil from the roadway and the slope. Opus and North Valley have been and will continue to take steps to ensure that downslope sedimentation does not occur. Per the PG&E 'Erosion and Sediment Control Concern' letter dated February 24, 2006, "Once the project area is sufficiently dry to conduct work, this area will be repacked, re-contoured, and reseeded."

Figure 1 – Additional slumping in the road cut above Road 6, March 6, 2006.

PG&E is working on the engineering designs for permanent solutions to the v-ditches and culvert inlets along Moller Road and Road 6, in addition to the soil slumping on the cut slope above Road 6. Work in these areas is delayed due to the wet conditions. In the interim, North Valley Construction has been maintaining these areas through the use of temporary erosion control devices to ensure that sediment does not enter the adjacent drainages.

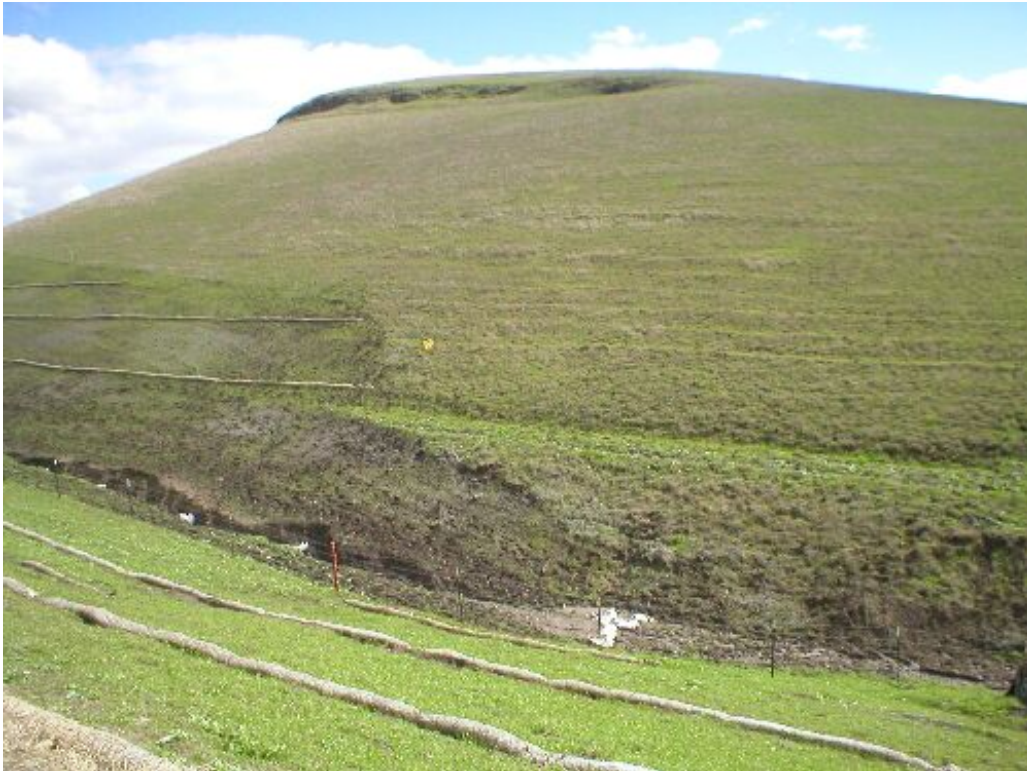
Along Road 7 a drainage path which runs across the underground alignment has become incised (see Figure 2). Sandbags had been installed downstream of the area and sediment has accumulated. A culvert outlet area along Road 7 continues to show signs of ponding (see Figure 3).

Figure 2 – Incised drainage along the underground alignment, March 6, 2006.

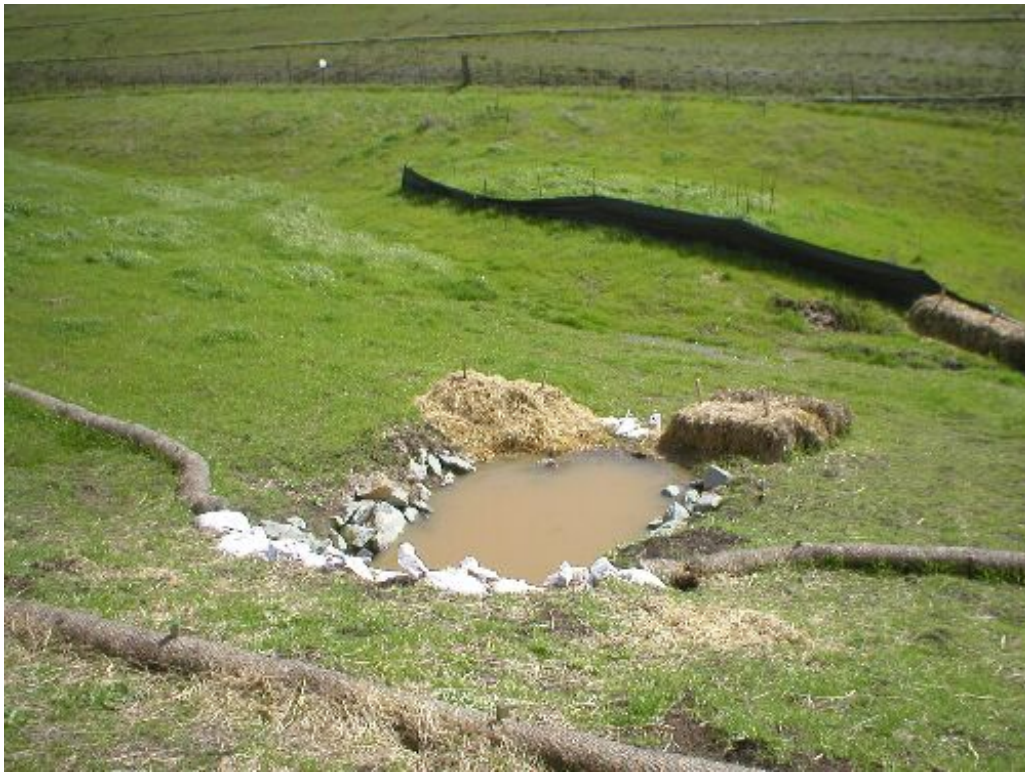
Figure 3 – Culvert outlet along Road 7, March 6, 2006.

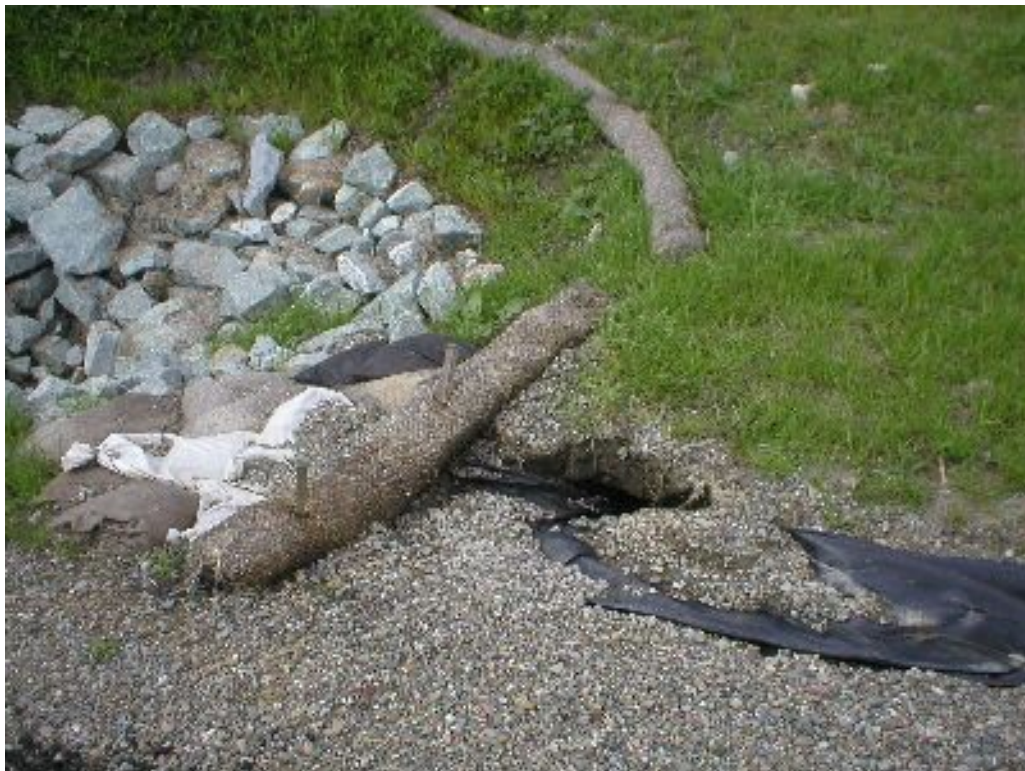
Along Moller Road and the mitigation site access road, a few areas along the new roadbed, including some culvert inlet areas, continue to show signs of ponding. Previously the ponded area adjacent to the west ramp to the substation was significantly drained. Crews hand dug a small trench from the pond to the nearest culvert outlet. The recent rains have contributed to new ponding in this area. Crews again worked to drain the water. The recent storms have also caused some undercutting at a culvert inlet along Moller Road (see Figure 4).

Figure 4 – Undercutting of a culvert inlet along Moller Road, March 6, 2006.
