PROJECT MEMORANDUM PG&E – TRI-VALLEY 2002 CAPACITY INCREASE PROJECT

To: Jensen Uchida, CPUC
From: Vida Strong, Aspen Project Manager
Date: March 23, 2006
Subject: Weekly Report #102: March 12, 2006 – March 18, 2006
CPUC Environmental Monitor (EM): Anne Sweet Coronado

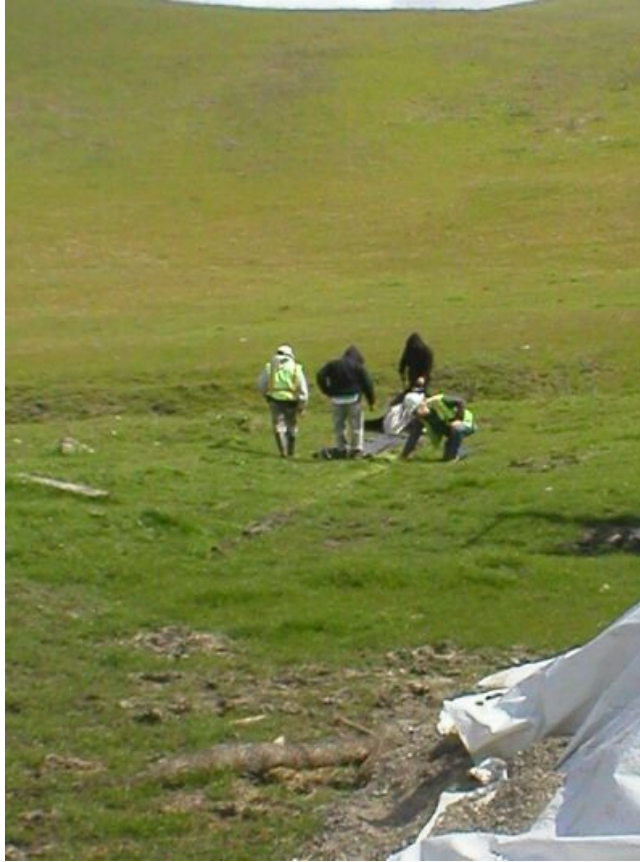
Figure 1 – North Valley crews escorted by a biologist removing damaged sediment fence, March 15, 2006.

Along Moller Road, two areas of slumping down slope of the road bed remain covered in plastic. Opus and North Valley have been and will continue to take steps to ensure that down slope sedimentation into resource areas does not occur. During the subject week, crews removed segments of sediment fence which were damaged. The North Valley crew was accompanied by a biologist to ensure that no animals were injured or trapped in the fencing during removal activities (see Figure 1). Some sediment fence installations are no longer necessary because of vegetative cover growth. Sediment fence was re-installed in areas still needing protection.

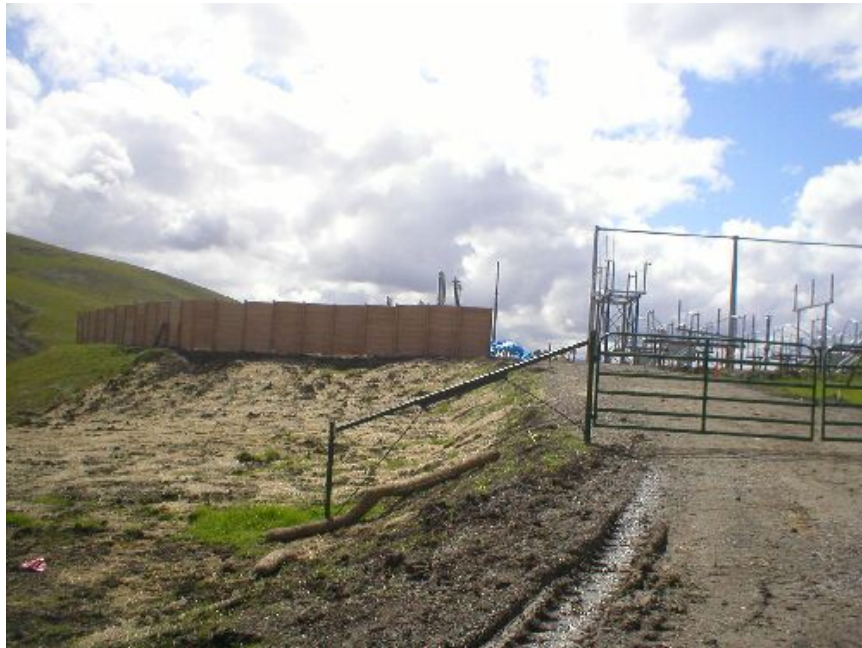
Figure 2 – Concrete wall installed around the North Dublin Substation, March 15, 2006.

Black and Veatch continued construction at North Dublin Substation during the subject week. Fence crews continued to install the concrete wall around the Substation (see Figure 2). On January 25th, crews filled the transformer with mineral oil. The Spill Prevention Control Countermeasure (SPCC) pond and drainage network has not been completed. An earthen berm with a plastic cover was placed around the transformer in case an oil spill occurs prior to completion of the pond. The secondary containment will continue to be maintained until the constructed SPCC pond is functional. On Tuesday, March 7th, an adult female California red-legged frog was sighted in the SPCC pond. The frog was relocated to Tassajara Creek by an approved biologist and agency notifications were made. Per the USFWS inquiries and recommendations, exclusion fencing was placed around the pond to prohibit entrance of additional amphibians. During the tour, the CPUC EM confirmed that the sediment fencing had been installed (see Figure 3). On March 15, a killdeer bird nest with four eggs was identified northeast of the Substation in a gravel area adjacent to the back access road. CDFG was contacted and a buffer of 80-feet around the nest was established.

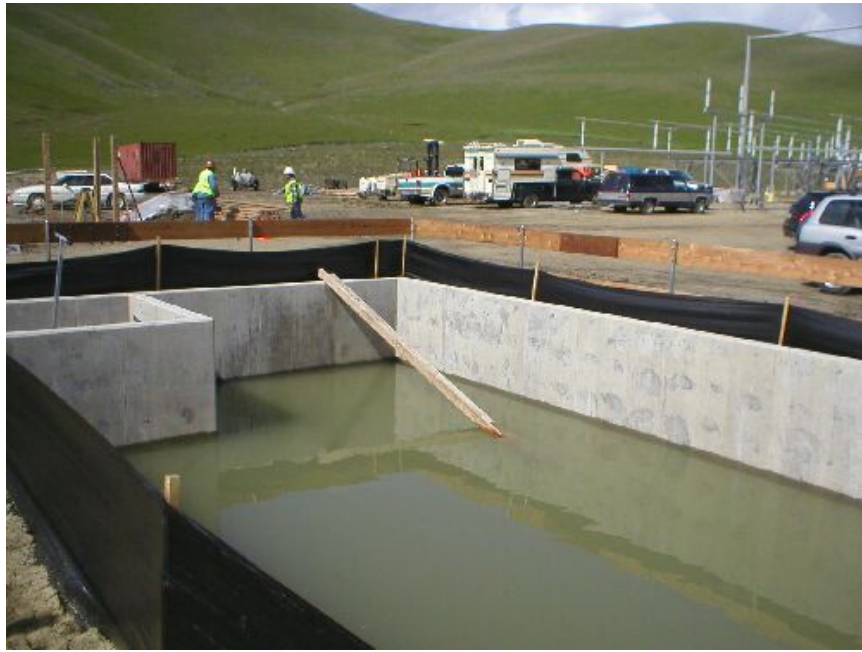
Figure 3 – SPCC pond with sediment fence installed around the perimeter, March 15, 2006.
