PROJECT MEMORANDUM PG&E – TRI-VALLEY 2002 CAPACITY INCREASE PROJECT

To: Jensen Uchida, CPUC
From: Vida Strong, Aspen Project Manager
Date: April 20, 2006
Subject: Weekly Report #106: April 9, 2006 – April 15, 2006
CPUC Environmental Monitor (EM): Anne Sweet Coronado

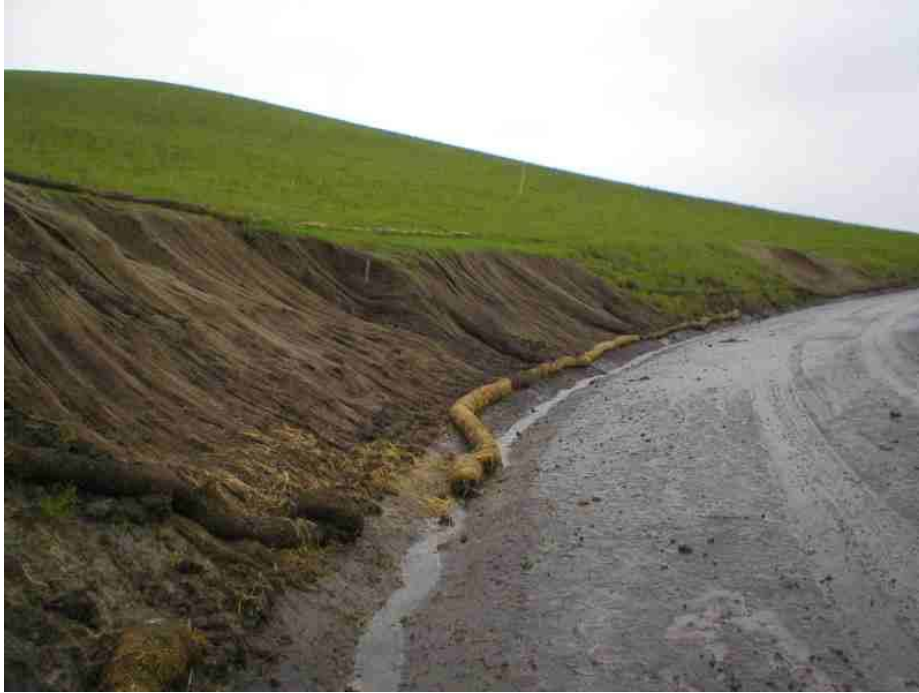
Figure 1 – NVC crews removed slumped soils and re-installed jute netting and wattles over the Road 6 slump area, April 12, 2006.

The CPUC EM had noted previously that slumping of cut slope areas above the road had occurred along Road 6. Due to the recent storms much greater slumping of the area has occurred. During the subject week, the CPUC EM inspected the most recent repairs to this area after the significant slumping the previous week. NVC crews removed the loose soils and installed a fiber mat and wattles on April 16th (see Figure 1). In addition, they removed soil from v-ditches. Per Opus, two burrowing owls were repeatedly spotted at a burrow located approximately 35 feet west of Road 6 at Station 20+50. An owl was sighted during the CPUC EM tour on April 12th.

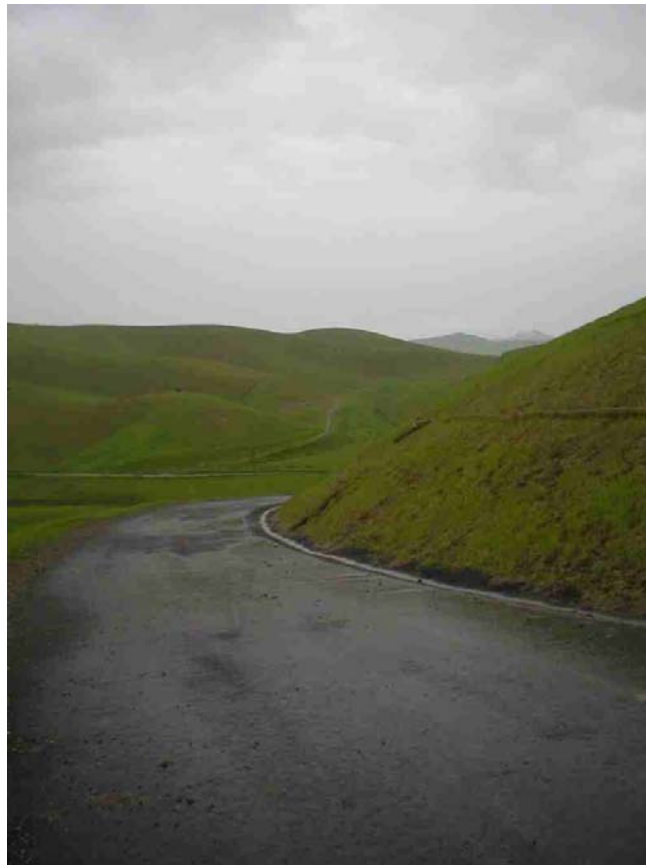
Figure 2 – Far view of Road 7, April 12, 2006.
Note the good vegetative cover.

Along the drainage adjacent to Road 7, NVC crews installed additional sand bag check dams. The general area appears to have good vegetative growth (see Figure 2).

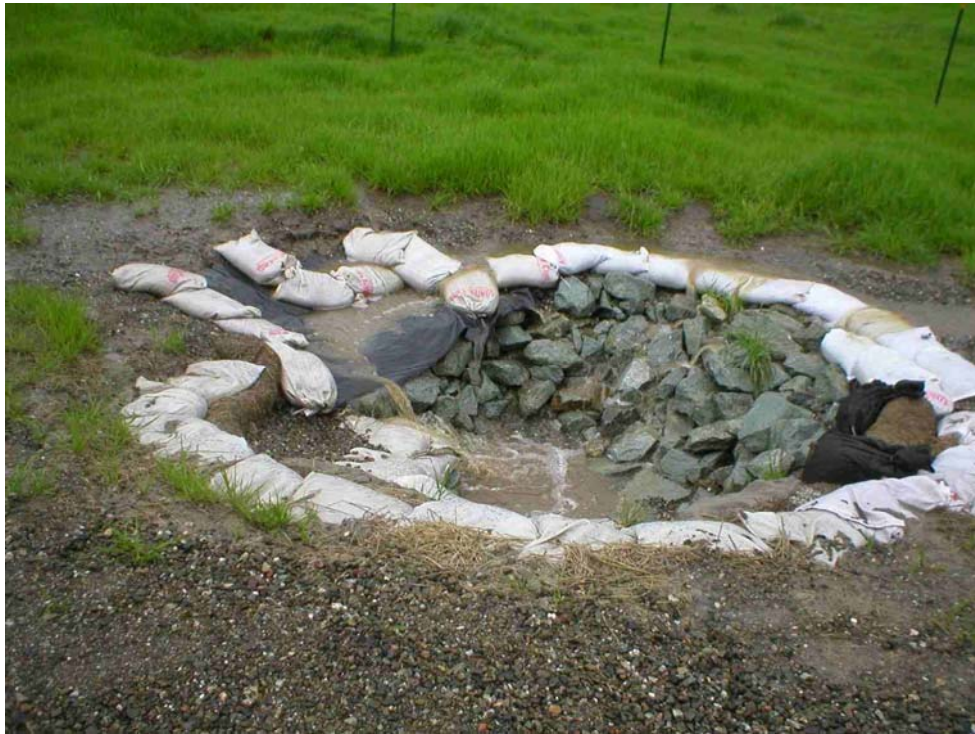
Figure 3 – Storm water flow into a culvert along Moller Road, April 10, 2006.

Along Moller Road and the mitigation site access road, a few areas along the new roadbed, including some culvert inlet areas, continue to show signs of ponding. Although sediment has built up in some areas along the road, it is continually being removed by NVC and the area maintained. Installed erosion controls around the culverts were functioning well (see Figure 3). The two areas of slumping downslope of the road bed had remained covered in plastic. However, during the subject week the plastic was removed and straw wattles were installed to enable vegetative growth over the previously covered areas. Previously, the CPUC EM noted that the area upslope from the Tassajara Creek bank stabilization area showed poor grass growth and that the installed jute netting was ripped and had pulled away from the slope, possibly preventing further vegetative growth. During the prior week the CPUC EM noted that soil had slumped down the slope. NVC had fenced the area to prevent pasturing cows from degrading areas of reinstalled jute netting. The fencing also served to reinforce the installed sediment fencing which runs along the riprap above the creek. NVC also installed sheets of visquene along the portions of the bank area exhibiting the least stability and most erosion. Opus and NVC have been taking steps to ensure that downslope sedimentation into resource areas does not occur.
