PROJECT MEMORANDUM
PG&E – TRI-VALLEY 2002 CAPACITY INCREASE PROJECT

To: Jensen Uchida, CPUC
From: Vida Strong, Aspen Project Manager
Date: June 22, 2006
Subject: Weekly Report #112: June 11, 2006 – June 17, 2006
CPUC Environmental Monitor (EM): Anne Sweet Coronado

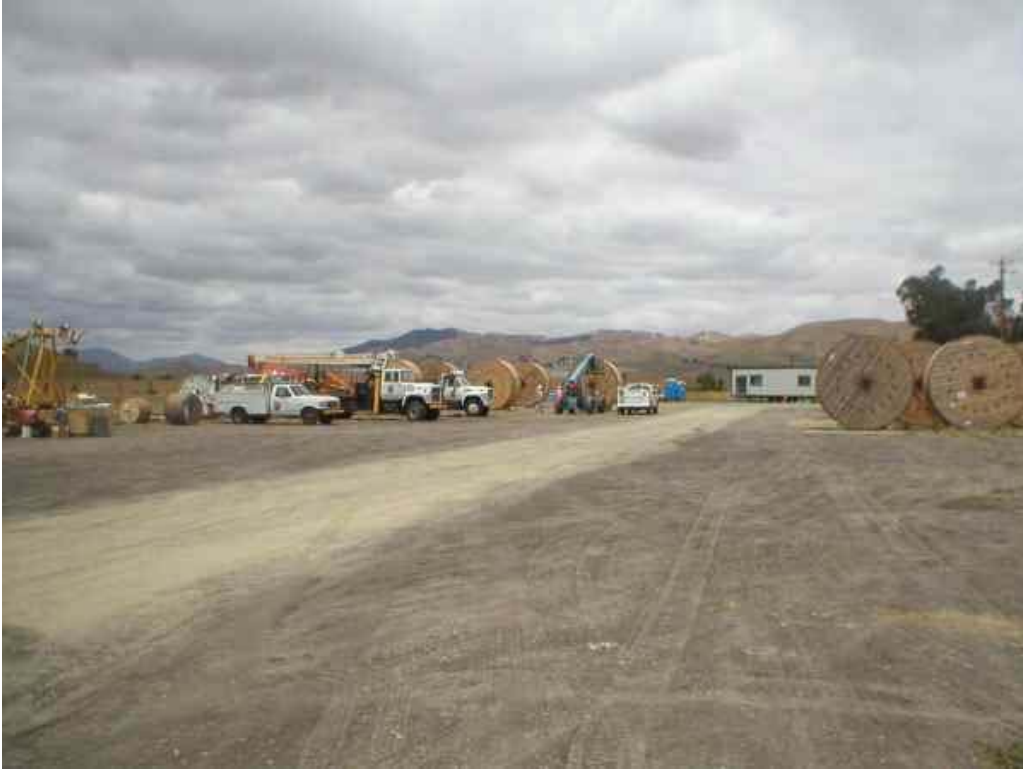
At the Ranger yard located next to the Cayetano Substation along North Livermore Boulevard, transmission line spools have been delivered and placed on steel plates. In addition the line installation equipment has also been delivered (see Figure 1). On Friday, June 9th at 11:30 a.m., a previously unidentified nest was disturbed during movement of 4-inch diameter conduit which had been stored at the yard. Two nestlings and eggs were taken to the Lindsay Wildlife Museum for care, feeding, and rehabilitation. The Lindsey staff was still unable to identify the birds during the subject week, but may be able to when the bird's feathers begin to come in. Lindsey staff reported that the two birds are in good condition.

Figure 1 – Wilson yard. Note the transmission cable reels and pulling equipment.
June 13, 2006.

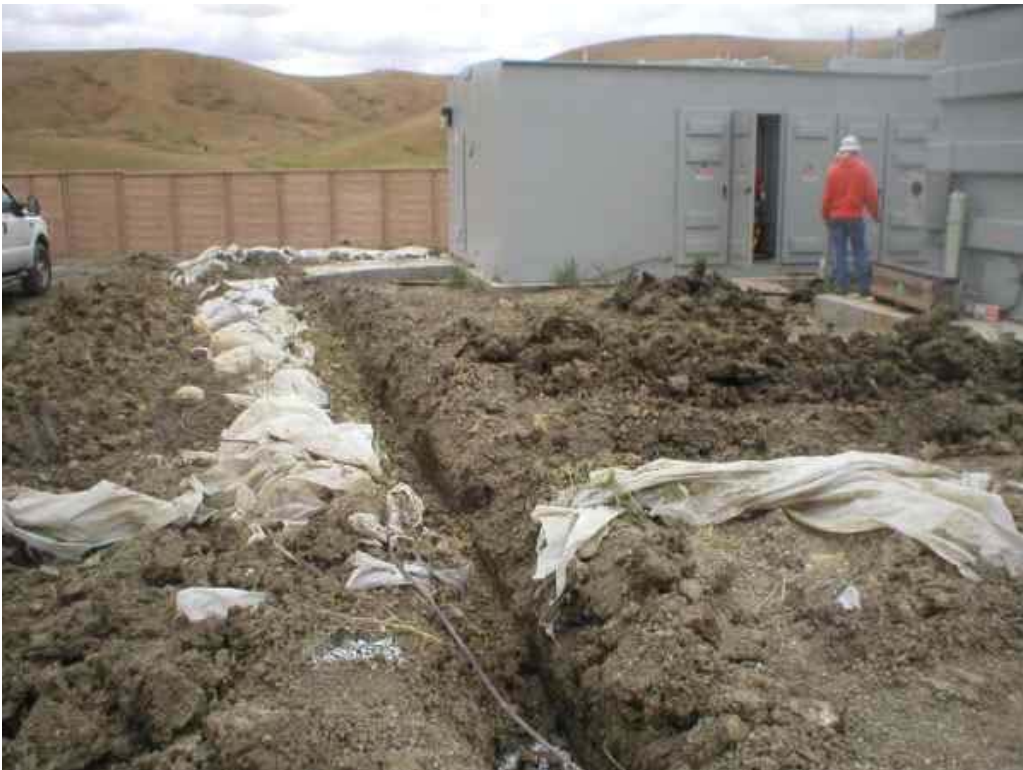
Black and Veatch crews had demobilized from the North Dublin Substation on April 14th due to the persistent rains and saturated soils. Work at the Substation started up again during the subject week. Crews trenched in the substation pad around the transformer (see Figure 2), installed grounding grid, and grounded the overhead line. On January 25th, crews filled the transformer with mineral oil. The Spill Prevention Control Countermeasure (SPCC) pond and drainage network has not been completed. An earthen berm with a plastic cover was placed around the transformer in case an oil spill occurs prior to completion of the pond. The secondary containment will continue to be maintained until the constructed SPCC pond is functional. Atlas wire crews conducted overhead wire testing and switch gear testing.

Figure 2 – Trench for the grounding grid at the North Dublin Substation.
June 13, 2006.

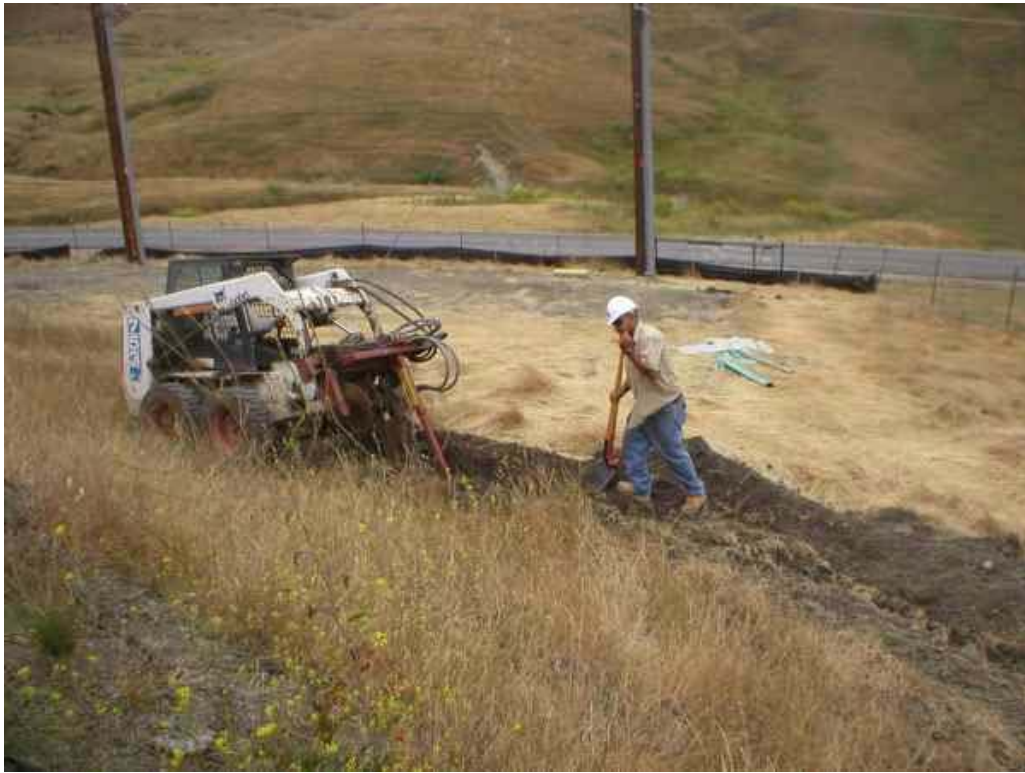
During the subject week, Vitale and Sons trenched outside and around the substation wall to install the irrigation line (see Figure 3).

Figure 3 – Vitale and Sons trenching around the North Dublin Substation for installation of the irrigation line. June 13, 2006
