PROJECT MEMORANDUM PG&E – TRI-VALLEY 2002 CAPACITY INCREASE PROJECT

To: Jensen Uchida, CPUC
From: Vida Strong, Aspen Project Manager
Date: July 14, 2005
Subject: Weekly Report #67: July 10, 2005 – July 16, 2005
CPUC Environmental Monitor (EM): Anne Sweet

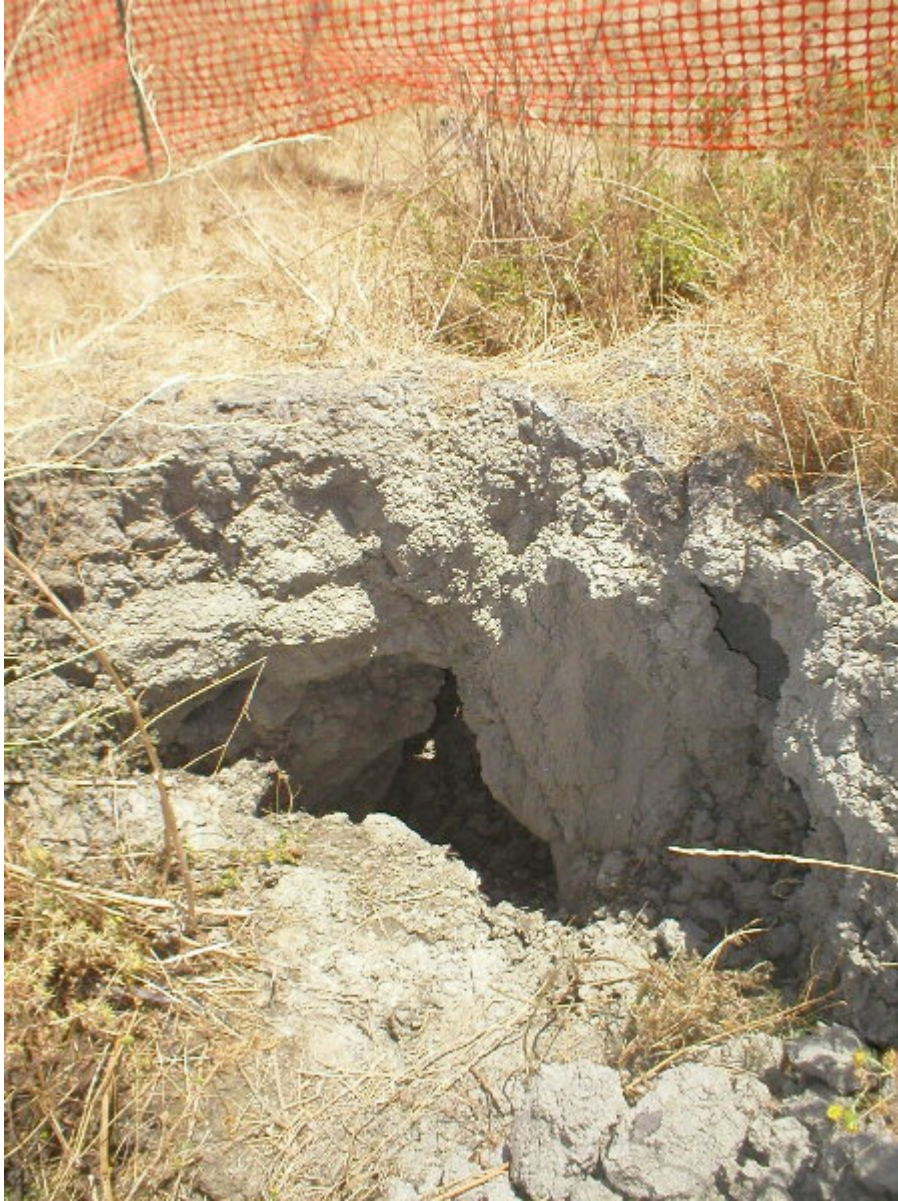
Per Opus on Friday July 8th, a California tiger salamander (CTS) was sighted at the northern portion of the Moller access road near the planned 0.33-acre wetland mitigation site (see Figure 1). The CTS was found hiding in a crack in the soil in an area under the bridge in a sink hole at the edge of the road. Exclusion fence was erected around this location to protect the CTS and construction crews were redirected away from the area. The CDFG and USFWS were notified. Continued consultation regarding protection of the CTS has occurred. A 500-exclusion zone has been set up around the CTS burrow area.

Figure 1 –CTS burrow, near the mitigation site, Phase 3, July 15, 2005.

On July 14, the Opus Project Manager called the CPUC EM with notification that one of the operators was not aware of the 500 foot-exclusion zone and a 400-foot by 20-foot area was scraped within the zone coming within 100 feet of the CTS borrow. The site Foreman when he realized what was occurring immediately stopped the operator. Opus notified Mary Hammer of the USFWS in an e-mail. PG&E EI, Bill Fisher, surveyed the area after the incident and did not find any dead or injured sensitive species. To compensate for the impacted burrows, PG&E proposed to survey the road construction area for 20 other areas (approximately 20 square feet each) with multiple burrows and flag these burrows for avoidance. The incident was documented as a non-compliance in the weekly report prepared by Opus.

PG&E EI, Sara Higgins, informed the CPUC EM that crews had sprayed the burrow area with water the night of the 14th in hopes that the CTS would come out of the burrow; however, early morning surveys conducted on July 15 were unfruitful. The PG&E EIs have been approved by USFWS to relocate the CTS. PG&E plans to repeat the exercise on July 18. If the CTS does not come up, USFWS has requested the burrow area be hand excavated prior to construction restarting in the area.

On July 14, an operator was not aware of the 500 foot CTS exclusion zone and a 400-foot by 20-foot area was scraped within the zone coming within 100 feet of the CTS borrow. The site Foreman, when he realized what was occurring, immediately stopped the operator. Opus notified Mary Hammer of the USFWS in an e-mail. PG&E EI/Biologist, Bill Fisher, surveyed the area after the incident and did not find any dead or injured sensitive species.

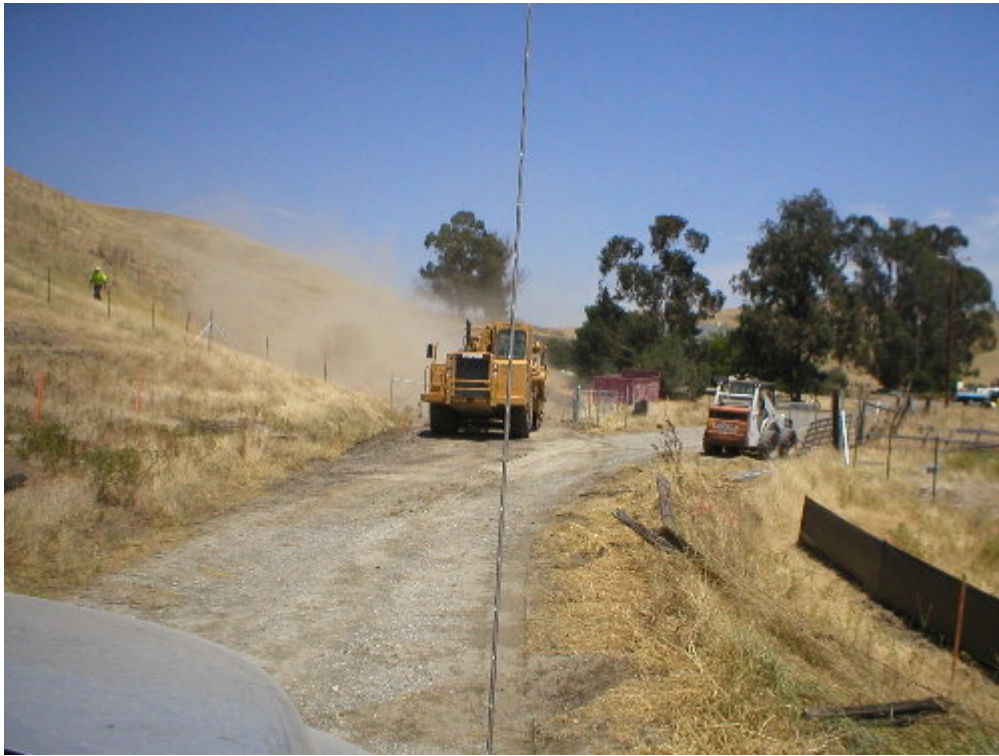
While driving along the Moller Ranch Road, the CPUC EM noticed that a grader was producing copious amount of dust (see Figure 2). The PG&E EI said that the crews have been good about watering the area and that she'll look into this dust production.

Figure 2 – Dust produced by grading operations, Phase Three, July 15, 2005.

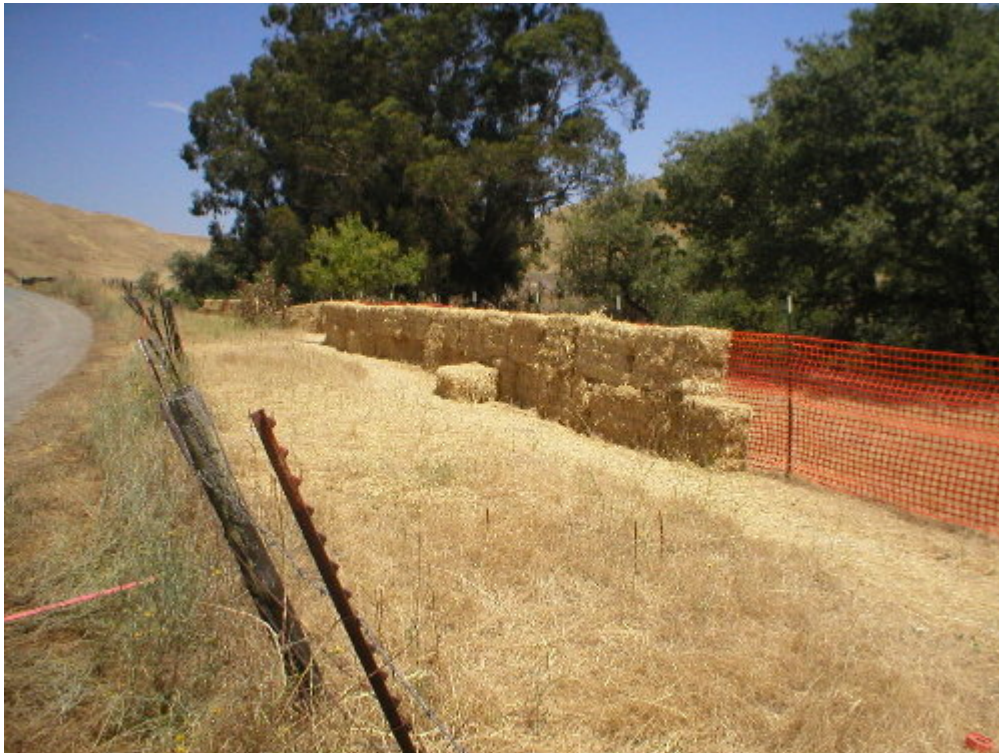
Previously, the PG&E EI and biologist identified a barn owl nest containing a nesting pair and fledgling along the right-of-way. Subsequent correspondence with the CDFG has occurred. A 250-foot exclusion zone has been set up. Limited vehicle traffic will be allowed to progress through the area; and as agreed, a hay bale wall has been built to shield the nest (see Figure 3). The PG&E EIs must monitor the nest closely to see if the birds appear harmed or harassed.

Figure 3 – Barn owl exclusion wall constructed along the Moller Ranch Road, Phase Three, July 15th.
