## **PROJECT MEMORANDUM PG&E – TRI-VALLEY 2002 CAPACITY INCREASE PROJECT**

**To:** Jensen Uchida, CPUC  
**From:** Vida Strong, Aspen Project Manager  
**Date:** September 28, 2005  
**Subject:** Weekly Report #77: September 18, 2005 – September 24, 2005  
**CPUC Environmental Monitors (EMs):** Anne Sweet and Jenny Slaughter

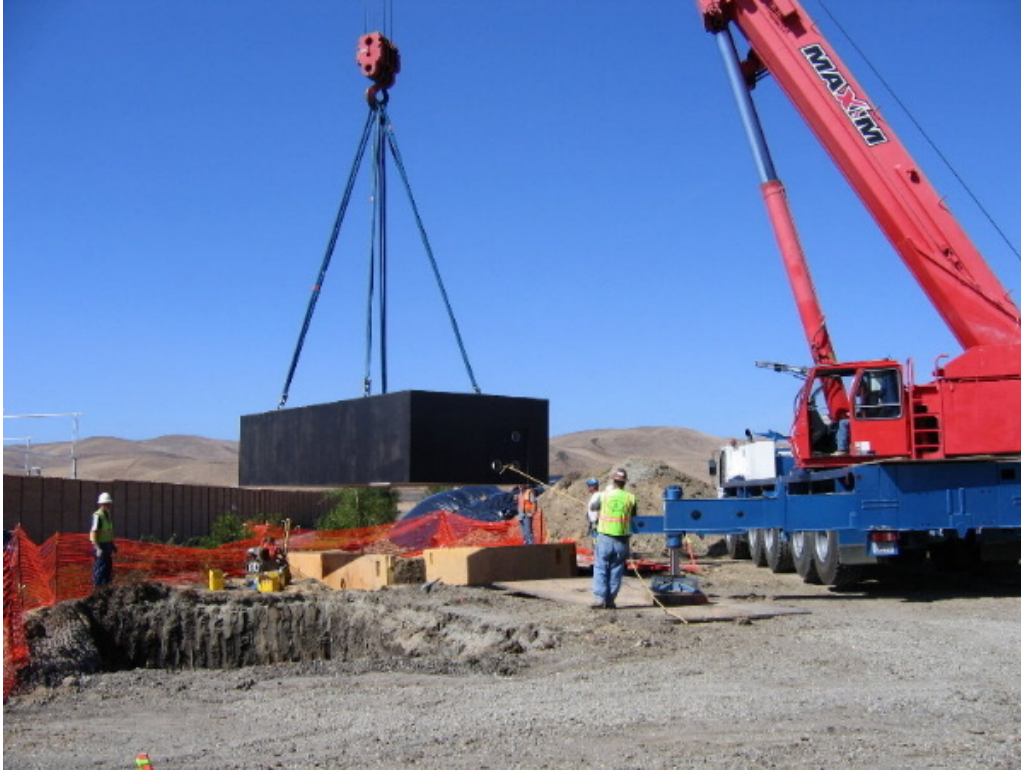
**Figure 1** – Vault installation near the North Livermore Substation, September 23, 2005.

Vault excavation and installation continued on the underground portion north of the Cayetano Substation on North Livermore Avenue (see Figure 1). Extending up and over the hill off of Manning Road, crews are finishing up the excavation, installing conduit, and backfilling the second trench of the double circuit line. Crews initially used a disk to break up the soil and then were able to strip the top soil and stockpile it along the side of the right-of-way. Excavation is being conducted using a Cleveland trenching machine. Two trenches are being installed 15 feet apart as part of the double circuit portion of the project. Crews have completed trenching past Road 5 toward the Transitions Station and used a slurry pumping system to backfill the trench up the steep hillside. Crews continually separate the topsoil as the trench line proceeds. Trenching through Cayetano Creek, which parallels Road 5, has been completed and is currently being backfilled. California red-legged frogs (CRLF) were identified approximately 400 feet from this location and an approved biologist was at the location monitoring for frogs prior to and during construction.

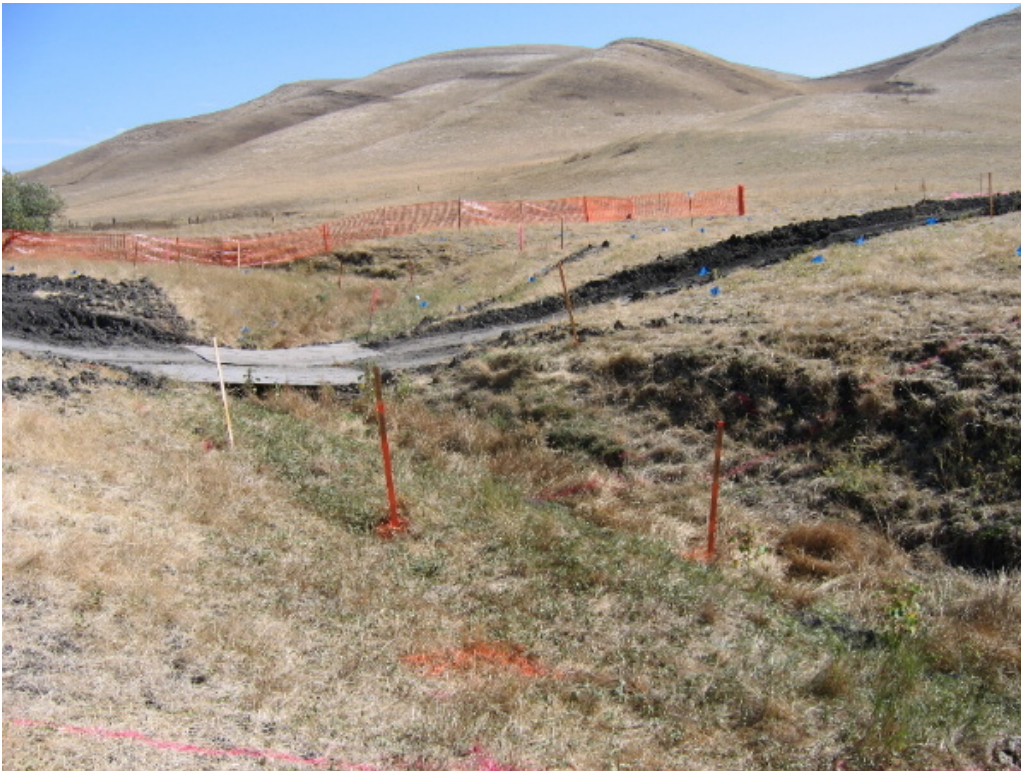
**Figure 2** – Cayetano Creek crossing of Access Road 6 before permanent culvert installation, September 22, 2005.

On September 20<sup>th</sup>, the Streambed Alteration Agreement Amendment was issued allowing PG&E to install the permanent culverts along access Road 6 and remove the Congdon's tarplant in that construction area. Culvert installation at Road 6 took place over the weekend of September 24<sup>th</sup> and 25<sup>th</sup>. Crews installed rip-rap, gravel, and two 60-inch culverts in a section of the drainage (see Figures 2 and 3). A biological monitor was present during construction. The Congdon's tarplant in the area was collected before the area was disturbed and the seed material will be preserved, as proposed, at Rancho Santa Ana

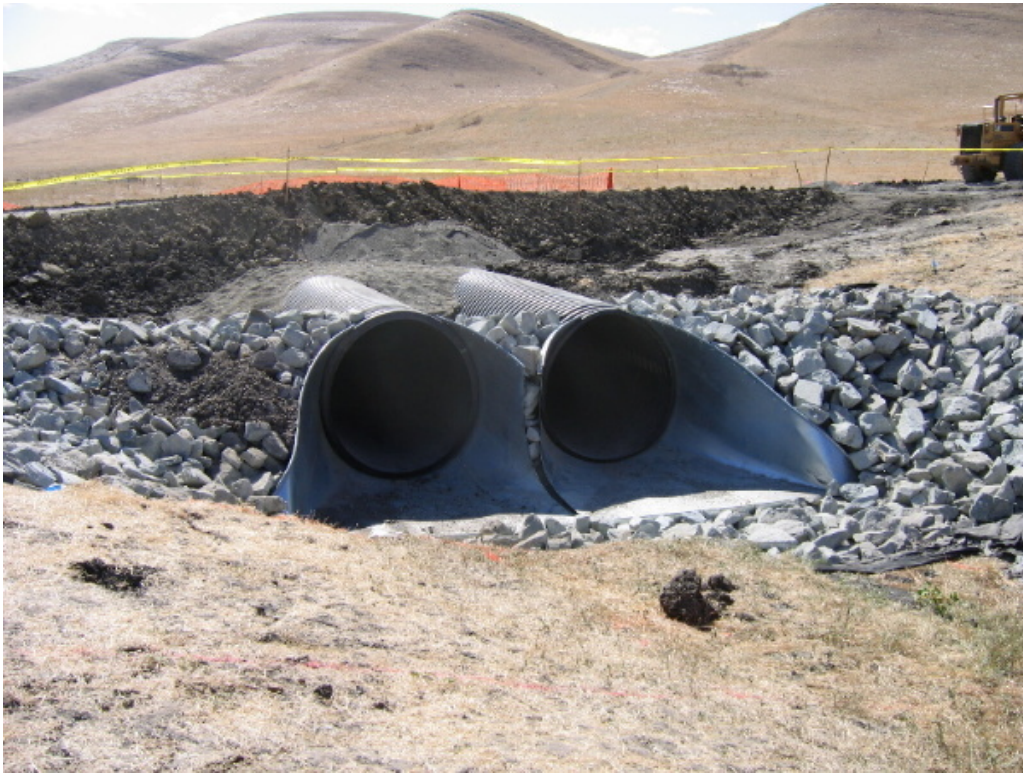
**Figure 3** – Culvert installation at the crossing in Figure 2 was installed on September 24<sup>th</sup> and 25<sup>th</sup>.

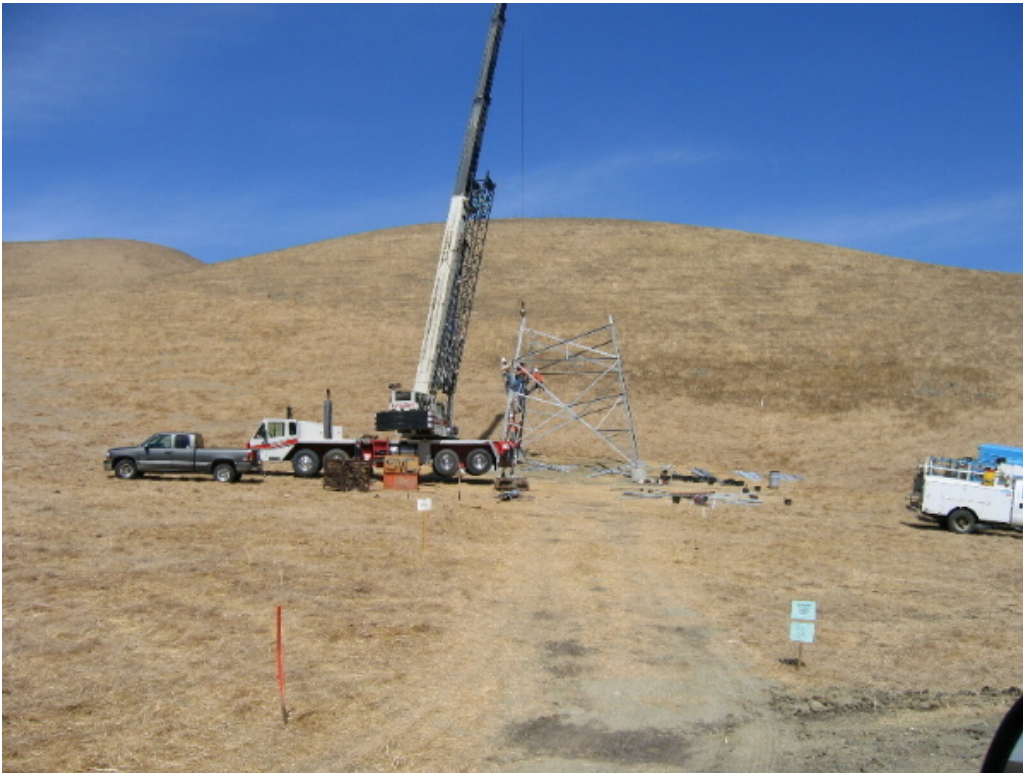
**Figure 4** – Tower 1 construction near Moller Road, September 21, 2005.

PG&E crews continued to work on completing Tower 6 and started work on Towers 1 and 2 during the subject week (see Figure 4). Tower assembly is occurring in the lay down yard located off Doolan Canyon Road and onsite at tower locations. Materials are being transported to and from the work sites via helicopter or truck. A biological monitor was monitoring the tower crews during the week.
