PROJECT MEMORANDUM PG&E – TRI-VALLEY 2002 CAPACITY INCREASE PROJECT

To: Jensen Uchida, CPUC
From: Vida Strong, Aspen Project Manager
Date: October 14, 2005
Subject: Weekly Report #79: October 1, 2005 – October 8, 2005
CPUC Environmental Monitor (EM): Anne Sweet

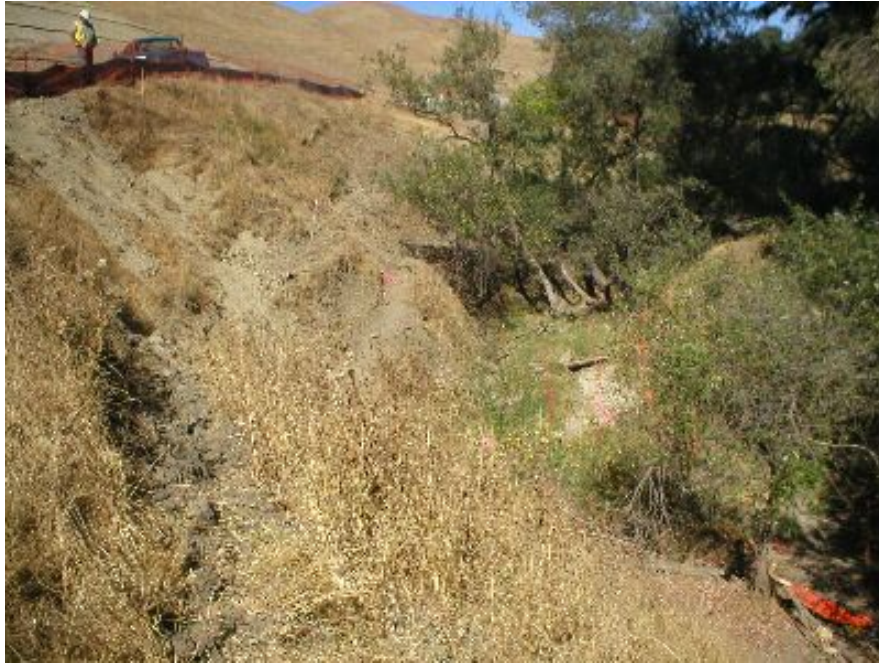
The project mitigation measures require that the CPUC EM field validate the flagging of the right-of-way and resource exclusion boundaries prior to the start of construction. All project areas have been signed off including the bank stabilization work adjacent to Moller Road, which was approved on October 4. The CPUC EM conditioned the approval to have ready and on-site all of the necessary materials for an upstream coffer dam and water diversion pipe as outlined in the CDFG Streambed Alteration Agreement (see Figure 1).

Figure 1 – Bank stabilization area within Tassajara Creek, October 4, 2005.

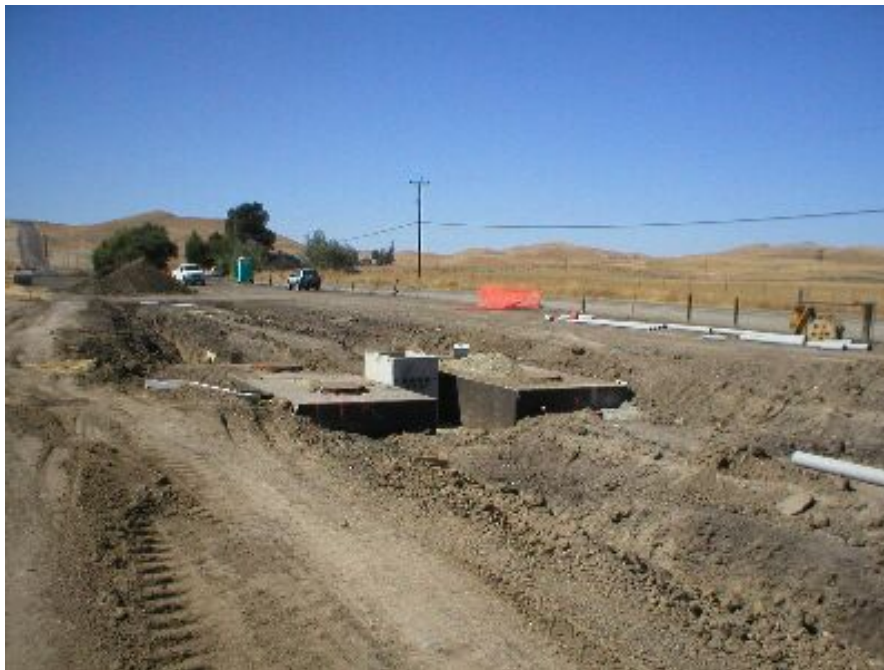
Vault installation and tie-ins continued on the underground sections (see Figure 2). During the site tour, the CPUC EM noted that erosion controls protecting the two sensitive drainage areas along Manning Road, which intersect the trench line, were in need of repair. The PG&E EI was informed and repairs were made. Extending up and over the hill off of Manning Road and continuing to the Transition Station, crews are finishing up backfill and compaction of the double circuit trench line. Crews initially used a disk to break up the soil and then were able to strip the topsoil and stockpile it along the side of the right-of-way. Top soils are being backfilled over the completed installation. Crews have started restoration activities including reseeding. Crews also continue conduit proofing. Trenching through Cayetano Creek, which parallels Road 5, has been completed and backfill was completed during the subject week. California red-legged frogs (CRLF) were identified in the project right-of-way and surrounding areas of the creek. An approved biologist was at the location monitoring for frogs preceding and during construction. The PG&E EI issued an internal non-compliance to Ranger Construction during the subject week for going outside of the approved work areas. The CPUC EM was promptly notified.

Figure 2 – Vault installation north of the Cayetano Substation, October 5, 2005.

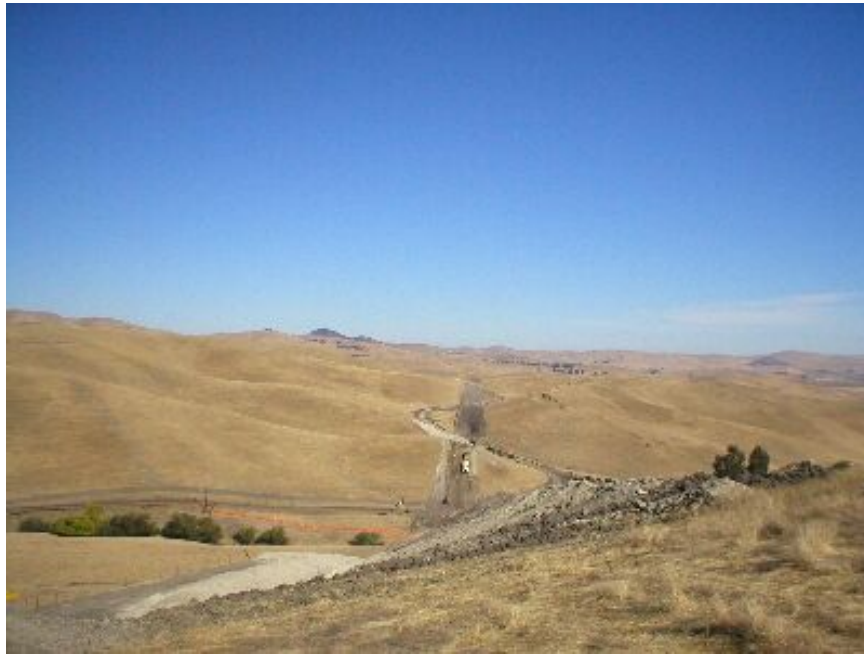
Granite Construction continued disking and grading along Access Roads 6 and 7 during the subject week (see Figure 3). The area appeared to be watered frequently to cut down on construction related dust. Granite worked to install culverts along Road 7. At the Transition Station, Ranger Construction excavated for vault installation (see Figure 4).

Figure 3 – Road 7 and underground alignment,
October 5, 2005.

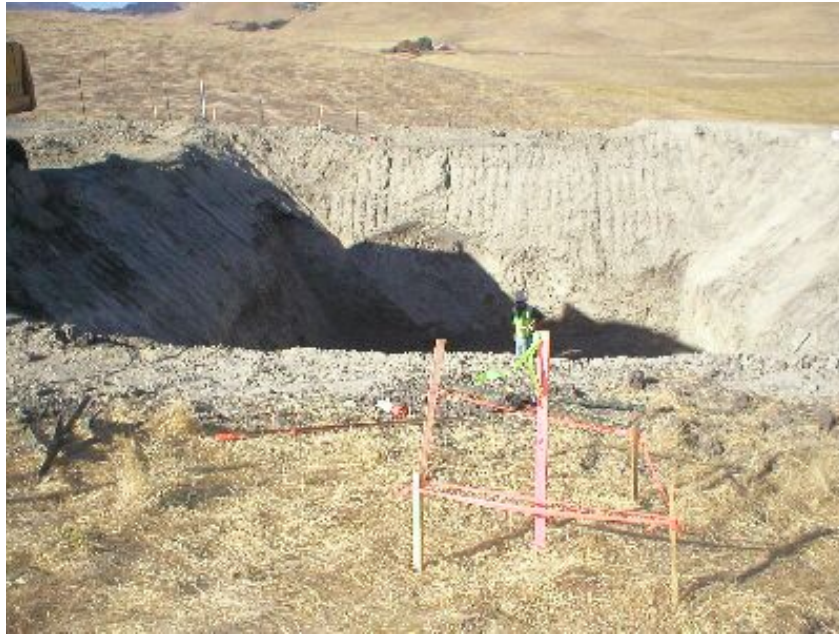
Figure 4 – Vault excavation at the transition station,
October 5, 2005.
