PROJECT MEMORANDUM PG&E – TRI-VALLEY 2002 CAPACITY INCREASE PROJECT

To: Jensen Uchida, CPUC
From: Vida Strong, Aspen Project Manager
Date: October 27, 2005
Subject: Weekly Report #81: October 16, 2005 – October 22, 2005
CPUC Environmental Monitor (EM): Anne Sweet

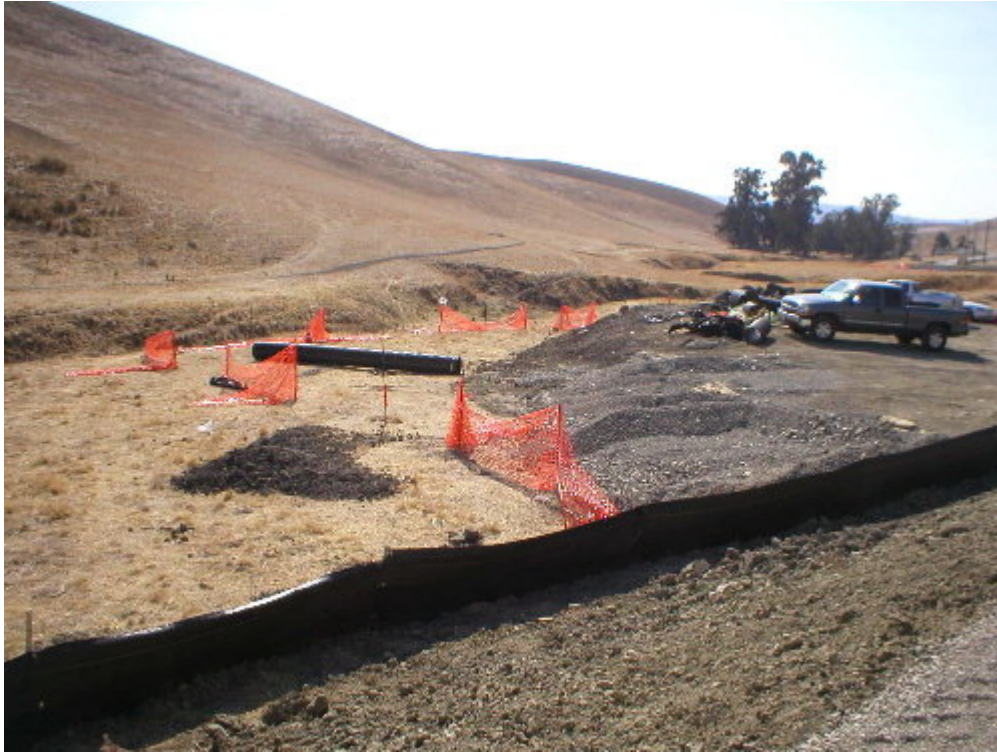
- At the staging areas next to the Substation along Moller Ranch Road, erosion controls need to be installed around spoils piles (see Figure 1).
- The presence of cattle in the project area has led to additional difficulties in maintaining the silt fences and fiber rolls. These erosion prevention and sediment control devices needed repair in several areas (see Figure 2).

Figure 1 – Staging areas next to the Substation along Moller Ranch Road. Erosion controls need to be installed around spoils piles.

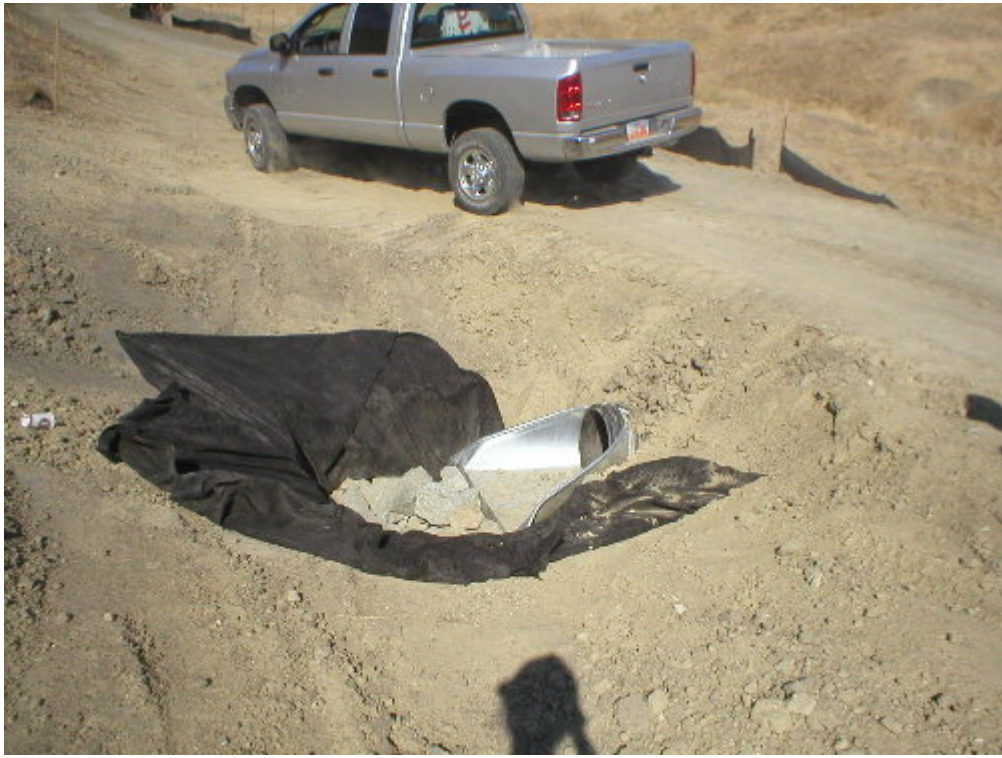
- The CPUC EM also noted general site erosion concerns, especially at the culvert areas (see Figure 3).

Figure 3 – Culvert undergoing installation along Moller Ranch Road.
