## **PROJECT MEMORANDUM PG&E – TRI-VALLEY 2002 CAPACITY INCREASE PROJECT**

**To:** Jensen Uchida, CPUC  
**From:** Vida Strong, Aspen Project Manager  
**Date:** December 8, 2005  
**Subject:** Weekly Report #87: November 27, 2005 – December 3, 2005  
**CPUC Environmental Monitor (EM):** Jenny Slaughter

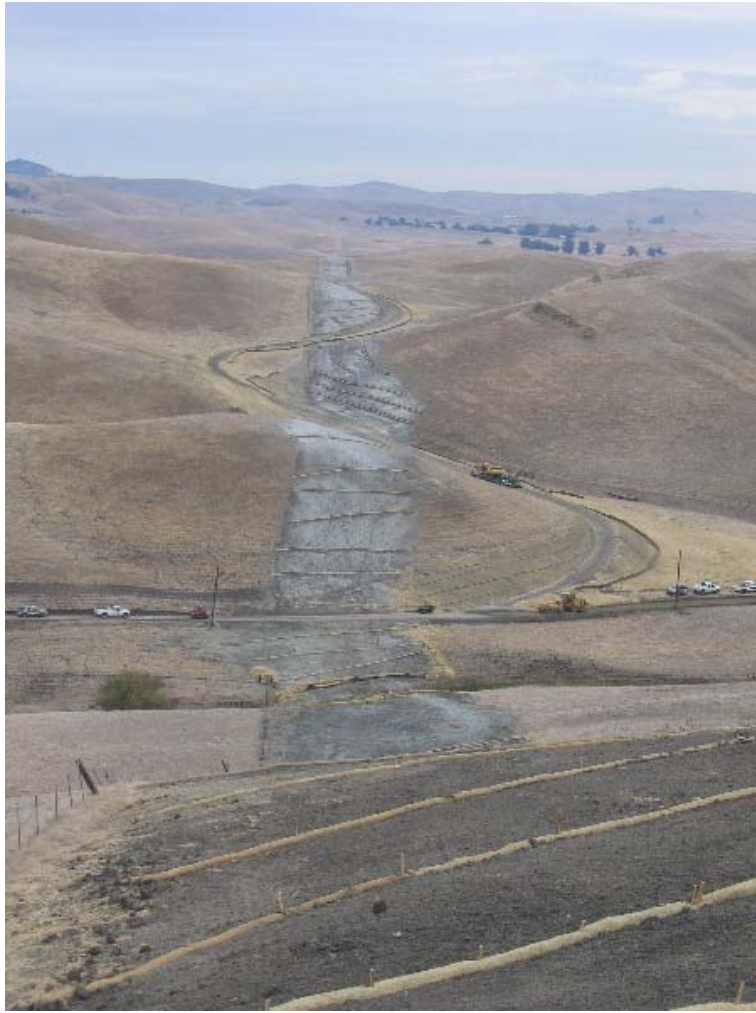
**Figure 1** – Trench line extending from the Transition Station and Road 7, November 30.

Underground construction included continued work at the Transition Station where crews installed ground grid within trenches which were then backfilled. Erosion control installation and maintenance continued. Sand bag check dams were placed along the roadside v-ditches along Roads 6 and 7 (see Figure 1). The CPUC EM noted that along Road 7, a build up of sediment had occurred around erosion controls near the vault installation and maintenance was needed. The CPUC EM also noted that culverts installed on Road 6 looked as though they were collecting materials and showed potential to be clogged. A Project Memorandum was issued on November 29 to document this and other related issues project wide. Under this Memorandum, information was requested from PG&E regarding the effectiveness of the installation, how they plan to clear the materials, and how further build up will be prevented. During the subject week, Opus had also expressed concerns to PG&E regarding inlet drain erosion, repair of silt fence, the need for additional sand bags, the need to key in wattles, and for additional straw and seed. These concerns were reiterated and eventually addressed by the end of the subject week.

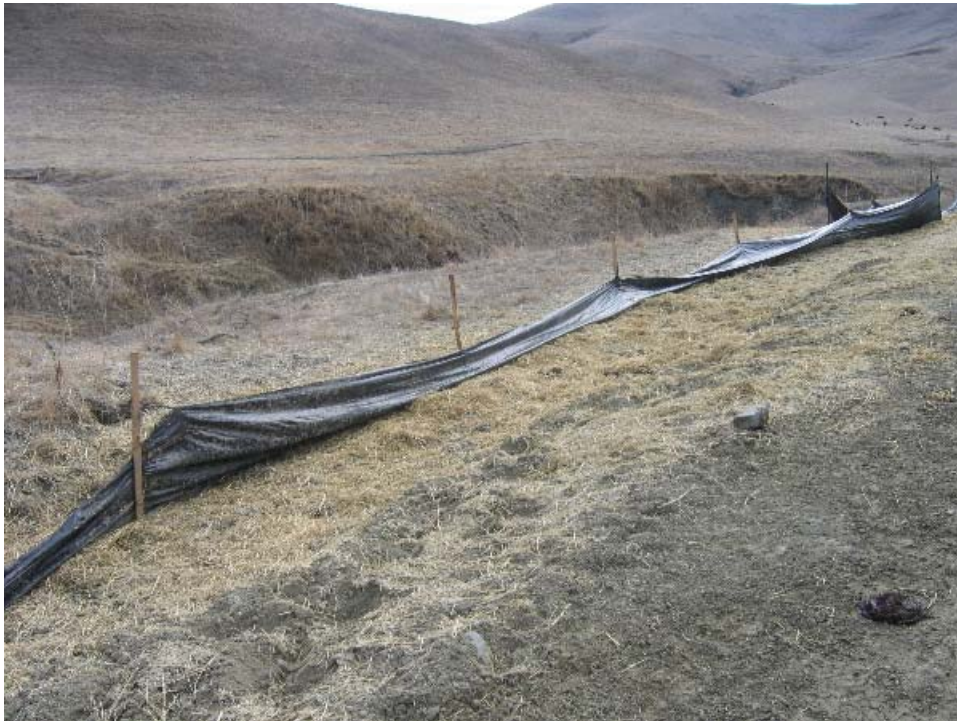
**Figure 2** – Sediment fencing in need of repair along the MSA Road, November 28, 2005.

On November 28, the CPUC EM inspected the Mitigation Site Access Road and noted that the installed erosion controls were in serious need of maintenance and repair. The previously installed sediment fencing needed to be repaired; a hay bale had fallen apart and straw debris had partially blocked a culvert; and straw wattles needed to be replaced and installed (see Figure 2 and 3). Rain was occurring and was forecasted to continue for the next four days. The CPUC EM notified the PG&E EI about the problem. In response, the PG&E EI said that she had been noting the need for maintenance of the area erosion controls throughout the last month in her daily reports. Upon returning to the location on November 29, the CPUC EM documented that no repairs had been made. Opus and PG&E were notified that the problem was persisting. This issue was included in the Project Memorandum issued November 29. Opus provided that there had been a breakdown in communication regarding the maintenance needs of the location. PG&E placed two contractors at the location to make repairs and stated that maintenance operations would continue. Along the MSA Road, Granite fixed the sediment fence, reinstalled straw wattles, broadcasted hay, and hydro-seeded. In addition, two laydown areas had broadcasted hay and had been hydro-seeded. Along Moller Road, a concrete v-ditch was installed from Station 31+00 to 33+00.

Project Memo or NCR	Date Issued	Description	Follow-Up Activities
<b>PHASE THREE</b>			
Project Memorandum	11/29/05	<p>Upon inspection of the Mitigation Site Access Road the CPUC EM noted that the installed erosion controls were in serious need of maintenance and repair. Rain was occurring and was forecasted to continue for the next four days. The CPUC EM notified the site EI about the problem. Upon returning to the location on the next day the CPUC EM documented that no repairs had been made.</p> <p>In a different area along Road 7, a build up of sediment has occurred around erosion controls near the Vault installation, and maintenance is needed.</p> <p>In addition to the above issues, culverts installed on Road 6 looked as though they were collecting materials and showed potential to be clogged. Under this Memo, information is requested from PG&amp;E regarding the effectiveness of the installation, how they plan to clear the materials, and how further build up will be prevented .</p>	Repairs to the MSA Road erosion controls had been made following issuing the memo.

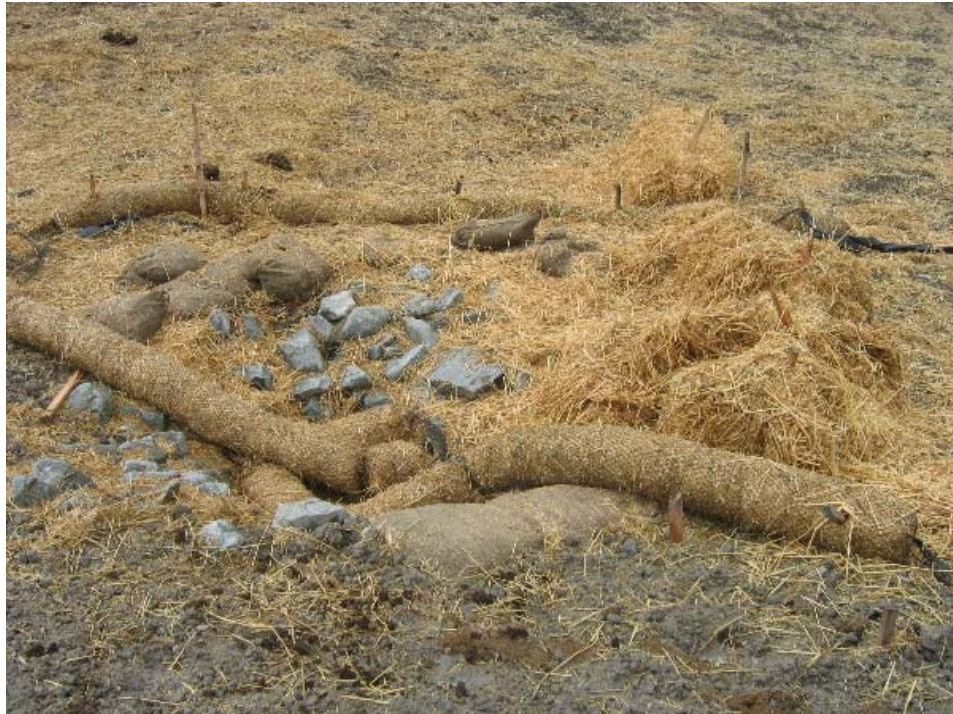
**Figure 3** – Clogged culvert in need of repair along the MSA Road, November 28, 2005.

On November 28, upon inspection of the Mitigation Site Access Road, the CPUC EM noted that the installed erosion controls were in serious need of maintenance and repair. The CPUC EM also noted that culverts installed on Road 6 looked as though they were collecting materials and showed potential to be clogged. Along Road 7, a build up of sediment has occurred around erosion controls near the vault installation and maintenance is needed. During the subject week Opus had expressed concerns to PG&E regarding inlet drain erosion, repair of silt fence, the need for additional sand bags, the need to key in wattles and for additional straw and seed. A Project Memorandum was issued on November 29 to document erosion control issues project wide. Under the November 29 Memorandum, information was requested from PG&E regarding the effectiveness of the installation, how they plan to clear the materials, and how further build up will be prevented. These concerns were reiterated and eventually addressed by the end of the subject week.
