PROJECT MEMORANDUM PG&E – TRI-VALLEY 2002 CAPACITY INCREASE PROJECT

To: Jensen Uchida, CPUC
From: Vida Strong, Aspen Project Manager
Date: December 21, 2005
Subject: Weekly Report #89: December 11, 2005 – December 17, 2005
CPUC Environmental Monitor (EM): Anne Sweet

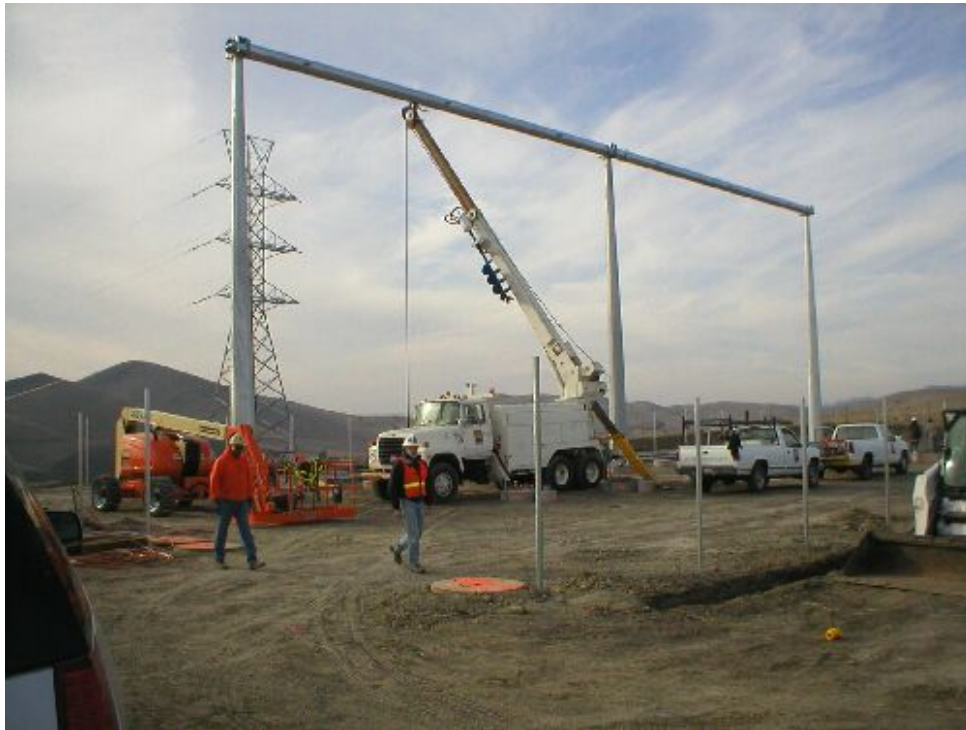
At the Transition Station crews completed installation of the ground grid within trenches which were then backfilled. Erosion control installation and maintenance continued. Crews erected the frame structure during the subject week (see Figure 1). Granite Construction has already completed paving Road 6 and Moller Road. Granite continued to work on a punch-list of outstanding repair and maintenance items. On December 15, Granite was on-site to conduct maintenance work on a culvert on Road 6 (see Figure 2).

Figure 1 – Crews have installed the frame structure at the Transition Station, December 15, 2005.

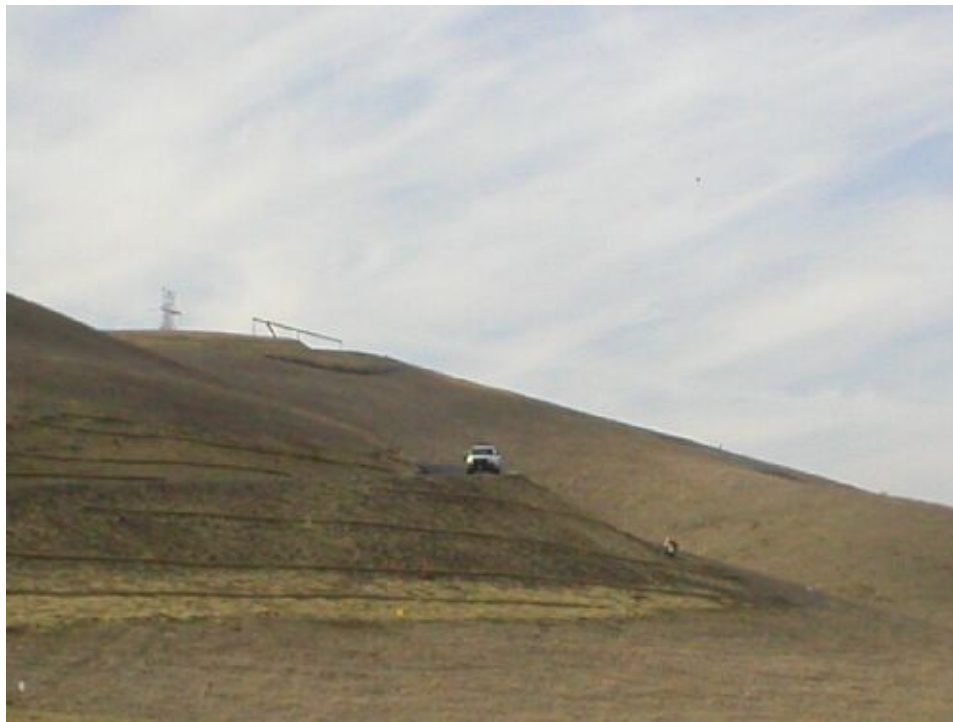
Figure 2 – Granite was on-site conducting erosion control maintenance along Road 6 at a culvert, December 15, 2005.

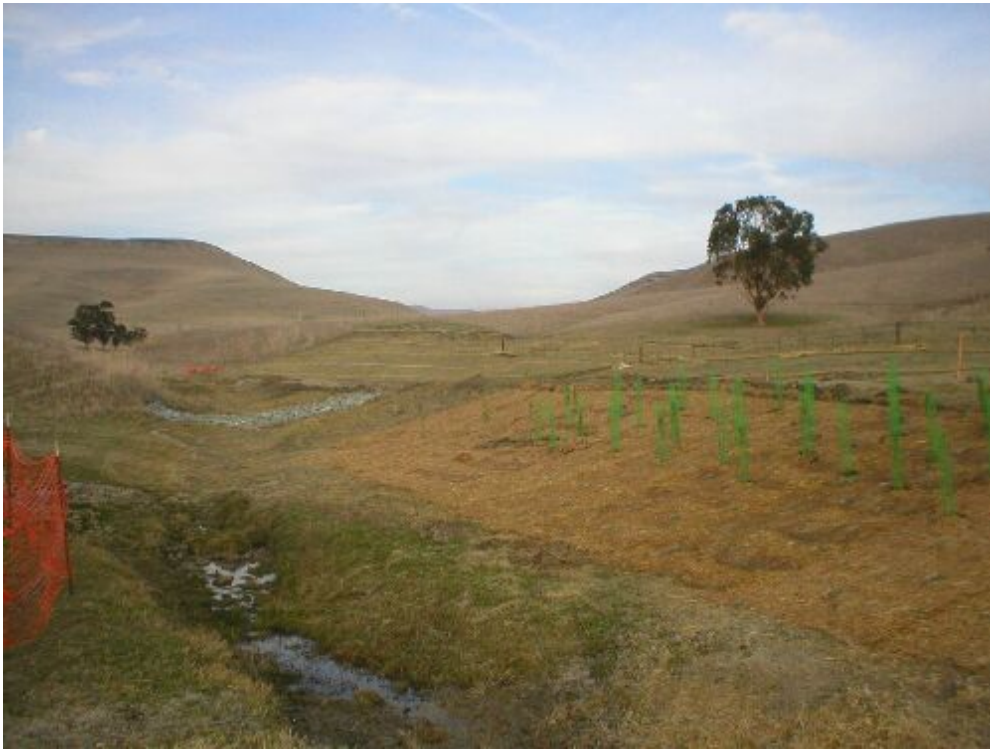
During a tour of the Mitigation Site on December 14, The CPUC EM discovered that monofilament erosion control matting had been installed along/adjacent to the Tassajara Creek tributary which runs through the Mitigation Site (see Figure 3 and 4). The USFWS BO disallows use of such matting. This type of matting has already been mistakenly installed and subsequently removed elsewhere in the project and noted as a compliance problem. The CPUC EM expressed concerns regarding the matting installation to the PG&E/Opus

An NCR was issued by Aspen/CPUC on December 15. On December 14, The CPUC EM discovered that monofilament erosion control matting had been installed along/adjacent to the Tassajara Creek tributary which runs through the Mitigation Site. The USFWS BO disallows use of such matting. This type of matting has already been mistakenly installed and subsequently removed elsewhere in the project and noted as a compliance problem. The PG&E/Opus EI took out the installation in the presence of the CPUC EM. PG&E was contacted and the CPUC EM was informed that PG&E was aware of the issue and that the matting had been installed the day prior on Tuesday December 13. PG&E had informed the contractor that the matting had to be removed and plans were set to remove the matting on Thursday December 15.

Figure 3 – Monofilament matting installation adjacent to the drainage within the mitigation site, December 14, 2005.

EI and he decided to take it out himself in the presence of the CPUC EM (see Figure 5). PG&E was contacted and the CPUC EM was informed that PG&E was aware of the issue and that the matting had been installed the day prior on Tuesday, December 13, under oversight by Jones and Stokes. PG&E had informed the contractor that the matting had to be removed and plans were set to remove the matting on Thursday, December 15. A Non-Compliance Report (NCR) was issued by Aspen/CPUC on December 15. Information was requested from PG&E as to why the CPUC was not informed of the flawed installation. In addition, information was requested to explain why the matting removal was planned for two days after the discovery and not immediately. PG&E responded on December 16, that at the time of the discovery on December 13 it was one half hour before sunset and there was not enough time to conduct the removal and exit the site given the existing work hour regulations. The crew which installed the matting was previously scheduled to return on December 15, so the removal was planned for that time.

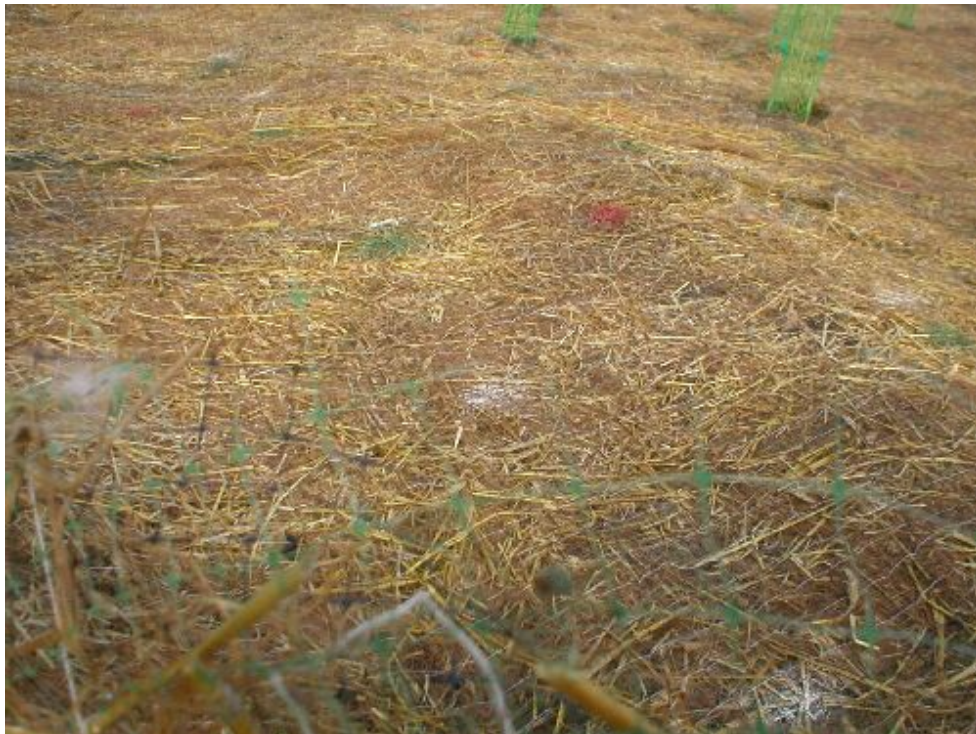
Figure 4 – Close up view of the monofilament matting the Mitigation Area, December 14, 2005. Note the green grid top layer. Hay is sandwiched in between two such layers.

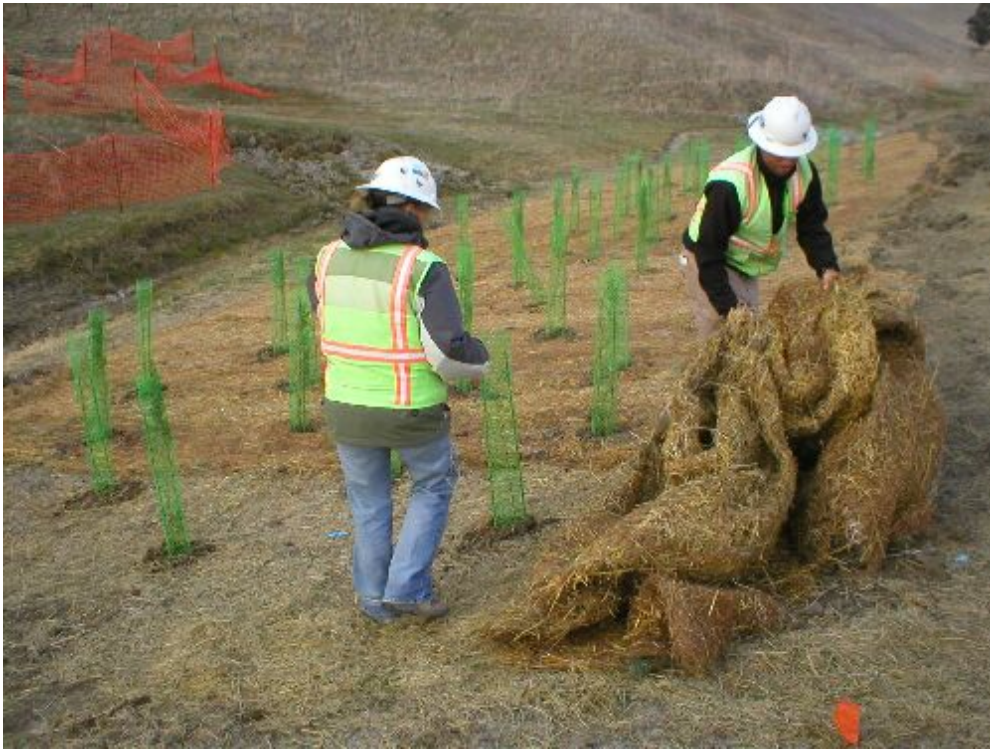
Figure 5 – PG&E EI/Opus removing the monofilament matting installation, December 14, 2005.
