PROJECT MEMORANDUM PG&E – TRI-VALLEY 2002 CAPACITY INCREASE PROJECT

To: Jensen Uchida, CPUC
From: Vida Strong, Aspen Project Manager
Date: February 3, 2006
Subject: Weekly Report #95: January 22, 2006 – January 28, 2006
CPUC Environmental Monitor (EM): Anne Sweet

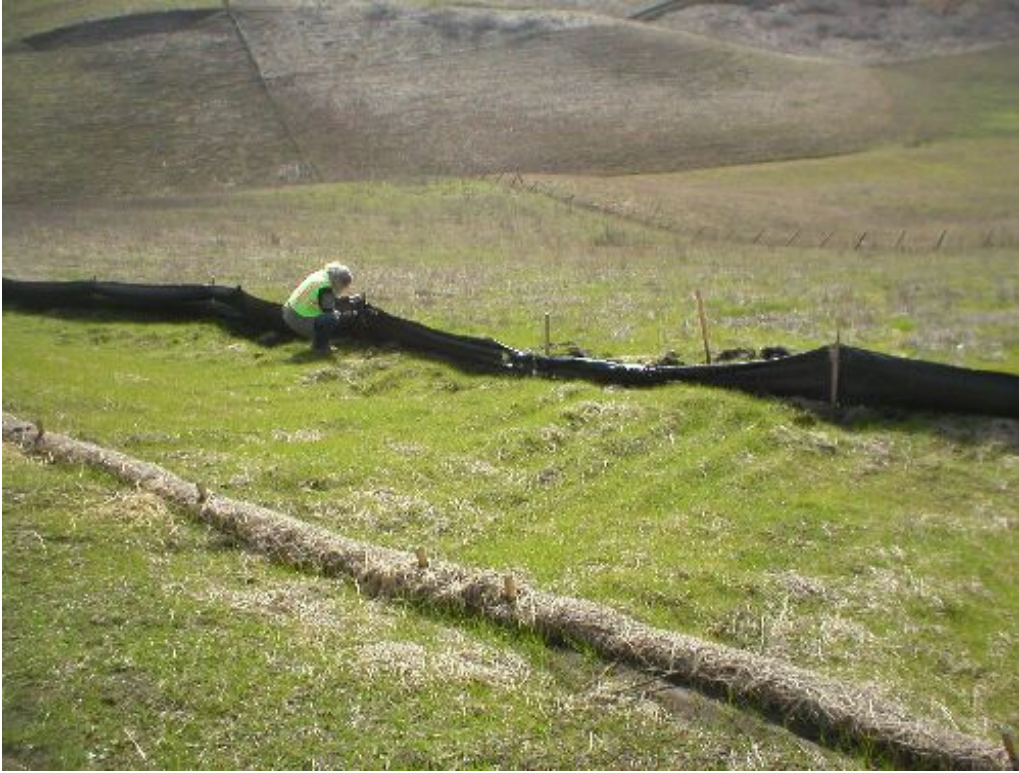
At the Transition Station, new construction is finished for the time being; however, during the subject week Wilson removed the steel columns which had been exhibiting unexpected oscillations. Per information from the PG&E inspector, Wilson Construction will most likely return March 15th. Erosion controls continue to be maintained around the station (see Figure 1).

Figure 1 – Sediment fence repair down slope from the Transition Station, January 27, 2006.

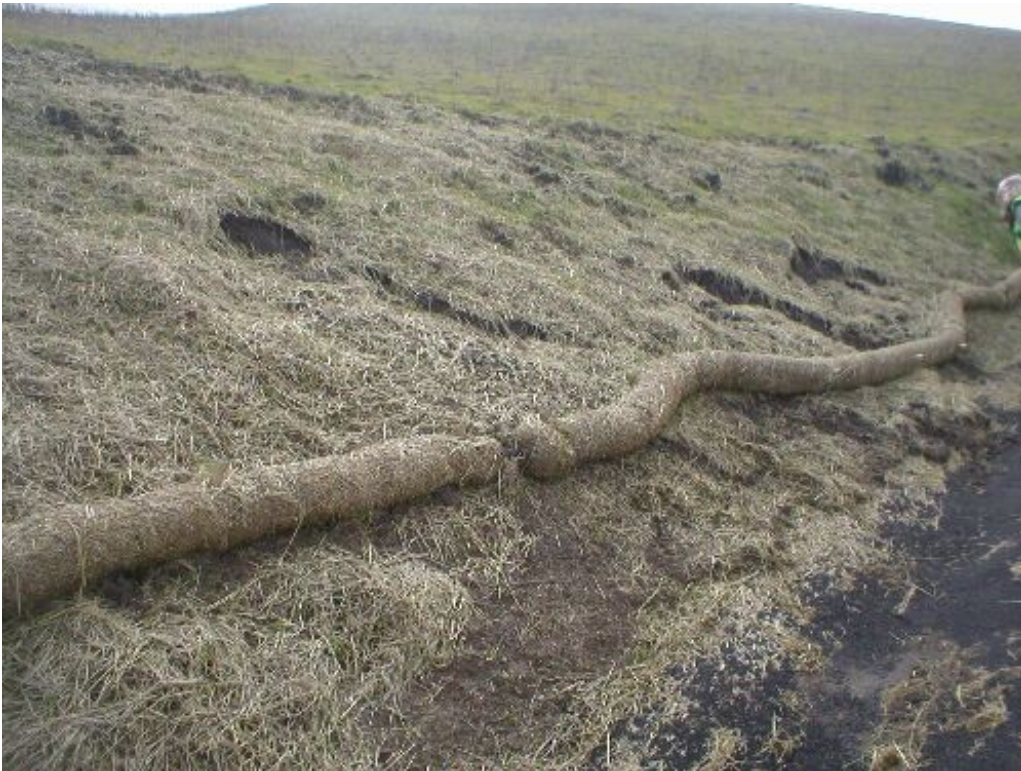
The CPUC EM had noted previously that the earthen v-ditches along Road 6 showed signs of erosion and sediment had build up in the sandbag checks. Subsequently, the sediment has been cleaned out from the area and additional sandbags have been installed. However, during the latest tour the CPUC EM noticed slumping of the graded areas above Road 6 (see Figure 2).

Figure 2 – Slumping along the graded area above Road 6, January 27, 2006.

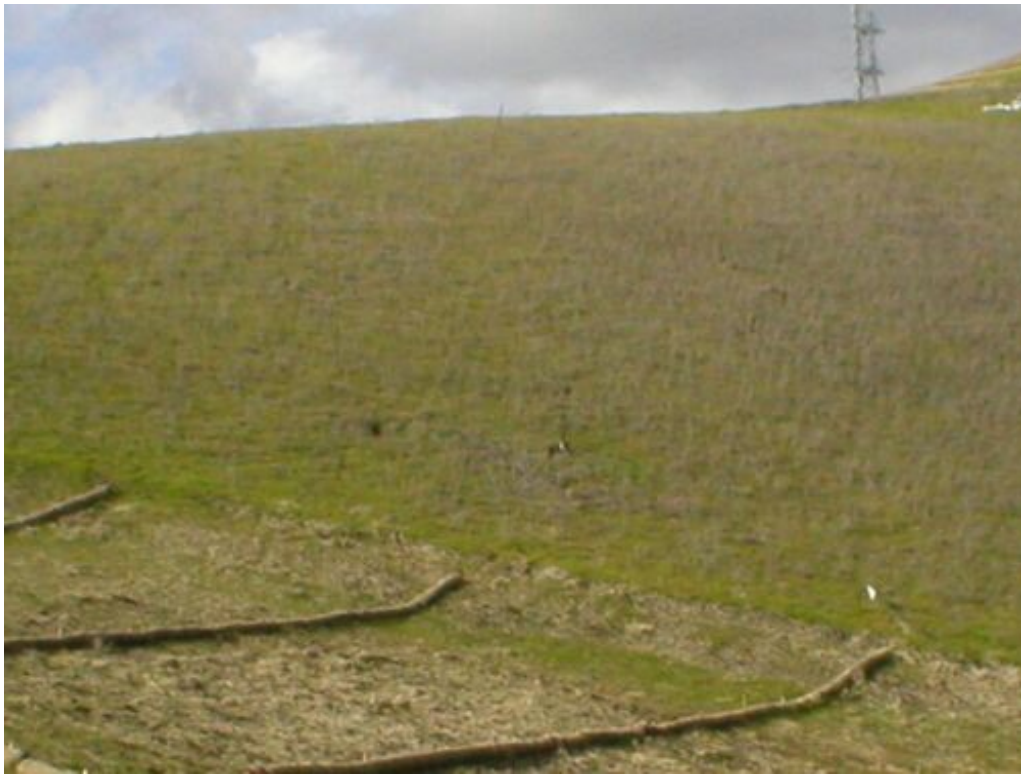
On Friday, January 13th, a burrowing owl was observed approximately 80 feet northeast of Road 6 at approximate Station 29+00. The owl was sighted repeatedly at the same location and again during the site tour on January 27th (see Figure 3). No work other than erosion control maintenance is planned to occur in the area until cable installation begins this spring. Previously along Road 7, some landslides had occurred which uprooted the staked-in wattles. The area has been repaired and erosion controls have been reinstalled; however, on-going maintenance is necessary. Although some grass growth has occurred across the seeded project areas, growth in many areas is very sparse and reseeding might be necessary (see Figure 4).

Figure 3 – Burrowing owl (see mid photo light speck), January 27, 2006.

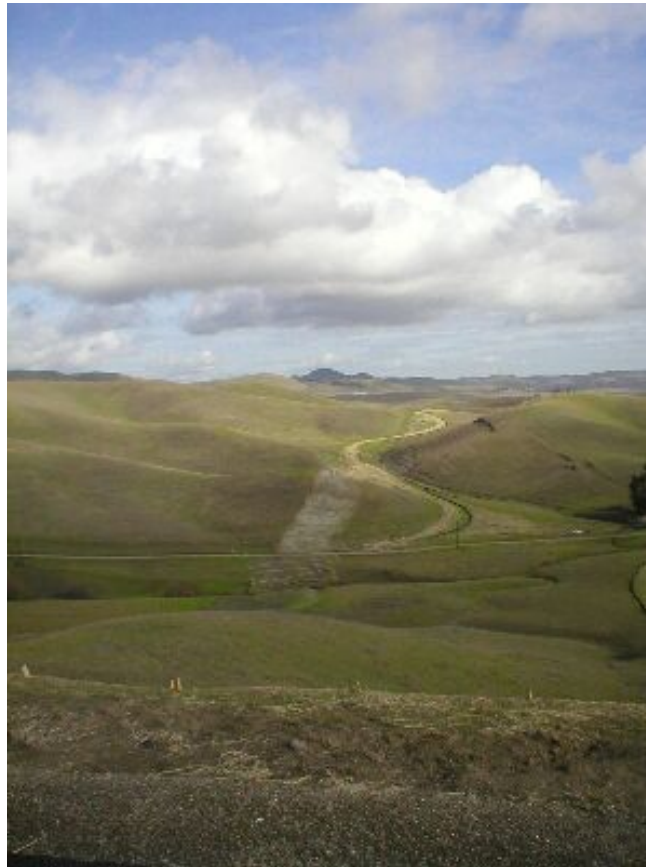
Figure 4 – Road 7 - Note the areas of construction without grass cover, January 27, 2006.

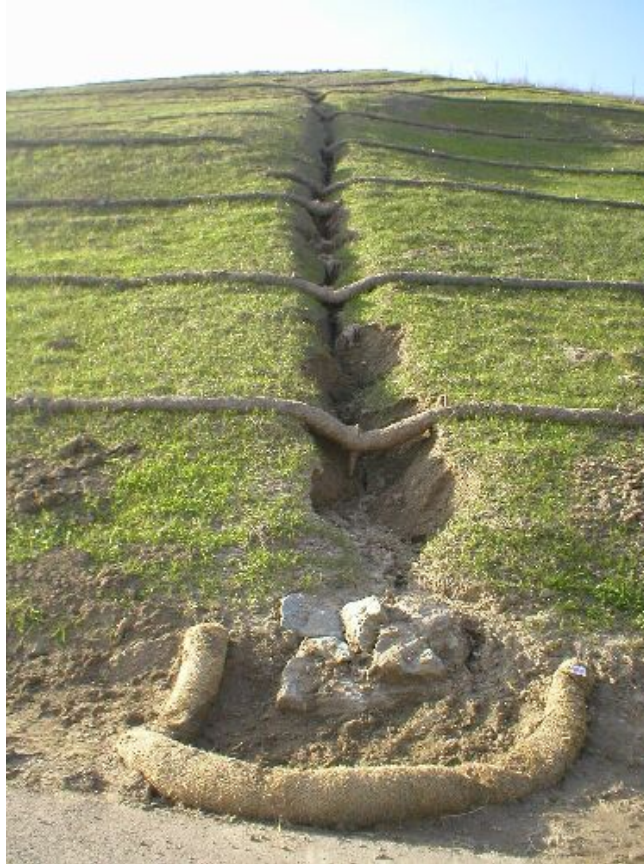
Along Moller Road and the mitigation site access road, several areas along the new roadbed including some culvert inlet areas continue to show signs of ponding and erosion. Significant erosion has occurred in v-ditches along the side of Moller Road. The earthen v-ditch areas remain at risk for further erosion (see Figure 5). The substation pad shows signs of erosion, some of which has breached the sediment fence.

Figure 5 – Continued erosion issue along Moller Road, January 25, 2006.

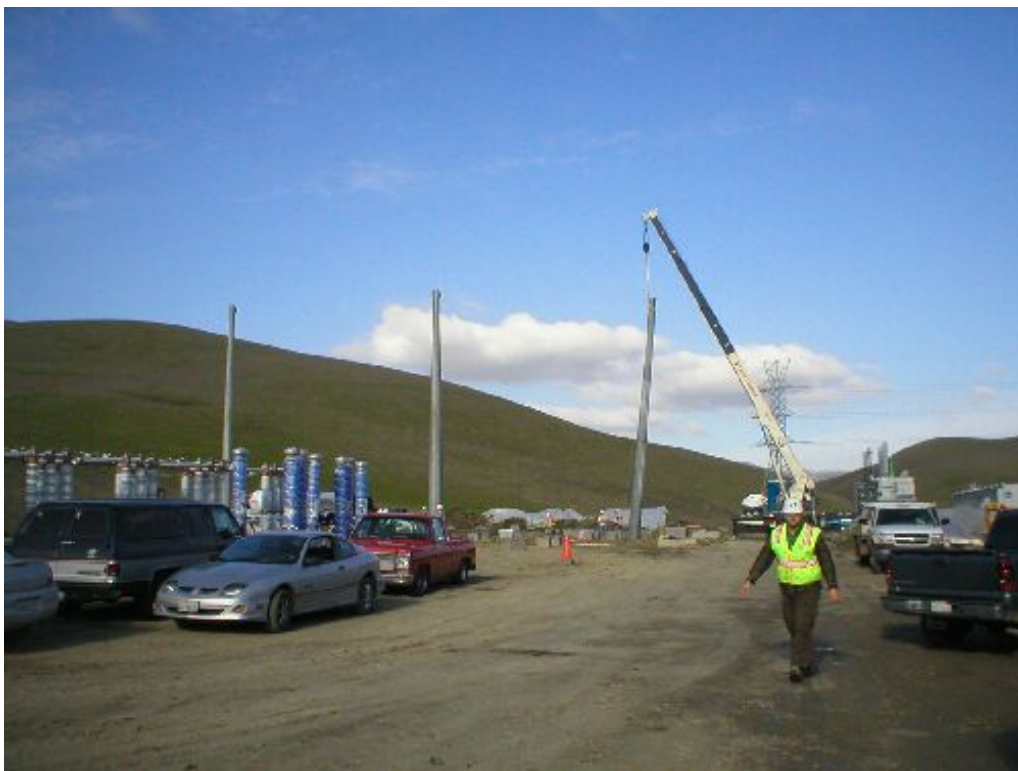
Black and Veatch erected the tower frames at the North Dublin Substation during the subject week (see Figure 6). On Wednesday, January 25th, crews flushed, tested and filled the transformer with mineral oil (see Figure 7). Work extended past daylight hours. Opus notified USFWS on January 19th that the work might extend beyond daylight hours. "Post-sunset" mitigation measures were implemented. The Spill prevention Control Countermeasure (SPCC) pond and drainage network has not been completed. An earthen berm with a plastic cover was placed around the transformer in case an oil spill occurs prior to completion of the SPCC pond.

Figure 6 – Tower assembly at the North Dublin Substation, January 25, 2006.

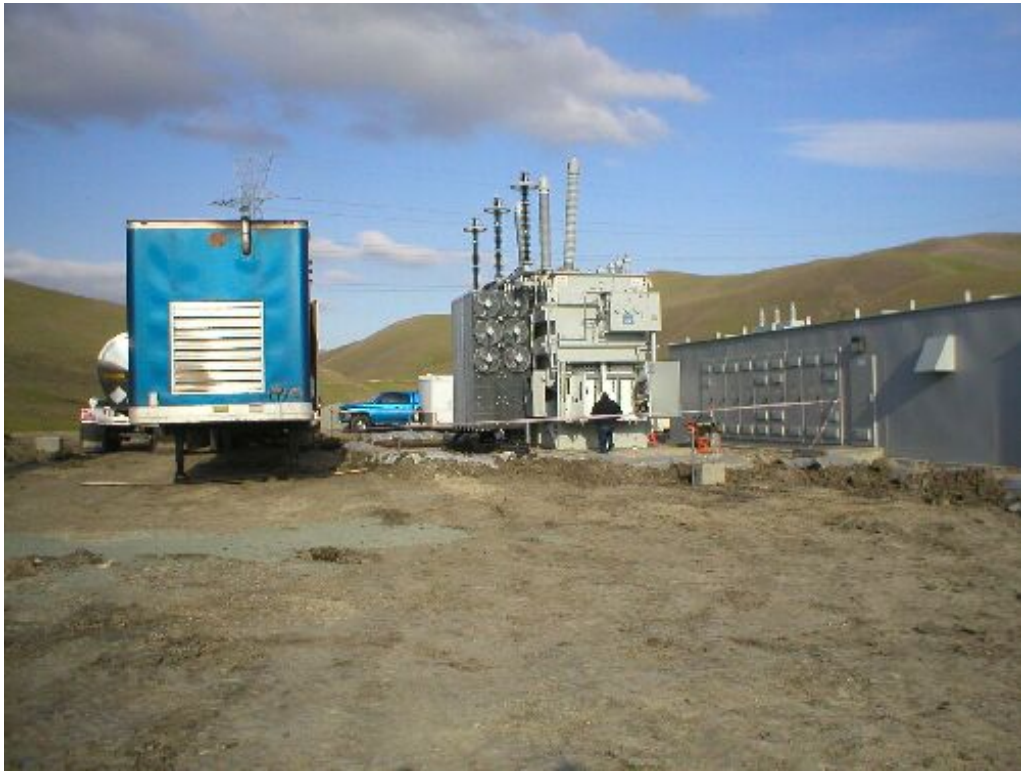
Figure 7 – Transformer being prepared for mineral oil fill at the North Dublin Substation, January 25, 2006.
