**PROJECT MEMORANDUM**  
**PG&E – TRI-VALLEY 2002 CAPACITY INCREASE PROJECT**

**To:** Jensen Uchida, CPUC  
**From:** Vida Strong, Aspen Project Manager  
**Date:** May 25, 2006  
**Subject:** Weekly Report #108: May 14, 2006 – May 20, 2006  
**CPUC Environmental Monitor (EM):** Anne Sweet Coronado

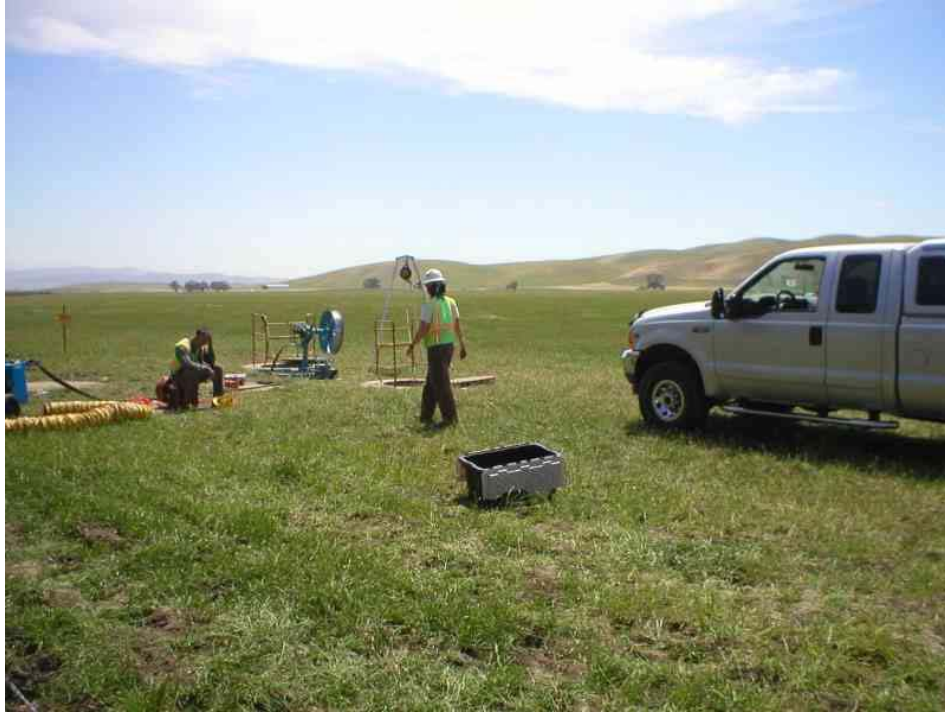
Ranger Construction has returned to the site and the new crew members are being environmentally trained prior to beginning work. The Ranger crew cleaned vaults located along the underground alignment and pulled mandrels through the installed conduit between Vaults 1 through 5 (see Figure 1).

**Figure 1** – Ranger crews proofing the conduit by pulling a mandrill at the Vault 2 location, May 15, 2006.

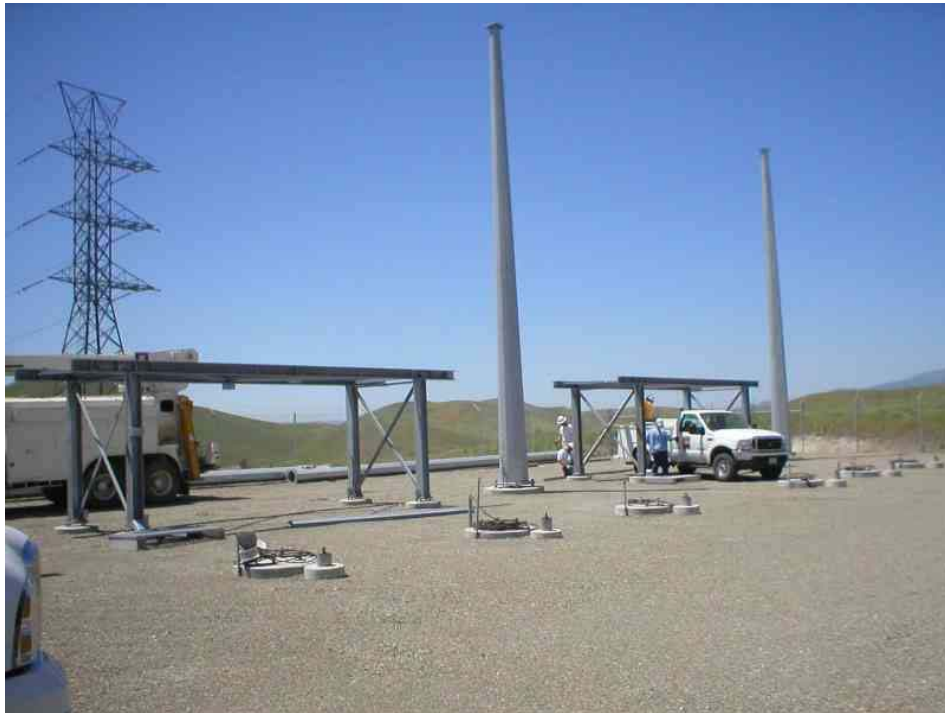
At the Transition Station, Wilson Construction re-erected the beam structure on Monday, May 15<sup>th</sup> (see Figure 2). Per Opus, a “high-frequency line” was installed with the structure in an effort to prevent the beam movement previously caused by wind and resonance.

**Figure 2** – Wilson crew re-erecting the Transition Station structure, May 15, 2006.

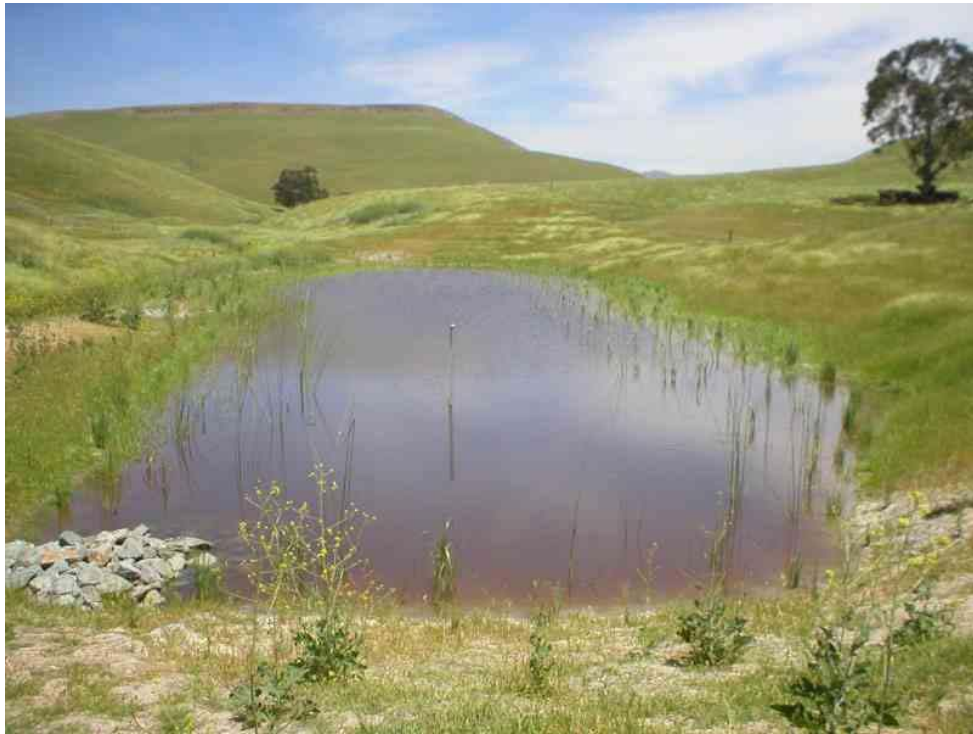
The engineered pond at the mitigation site still contains water (see Figure 3). If the water remains later in the season, it will be drained in order to discourage bull frog populations. A close inspection of the pond was conducted and numerous tadpoles were noted; however, without a specialist on-site, it was difficult to assess whether they were red legged frog tadpoles (see Figure 4). Per Opus, a new red tail hawk nest has been identified in a tree near the site.

**Figure 3** – Mitigation pond, May 15, 2006.

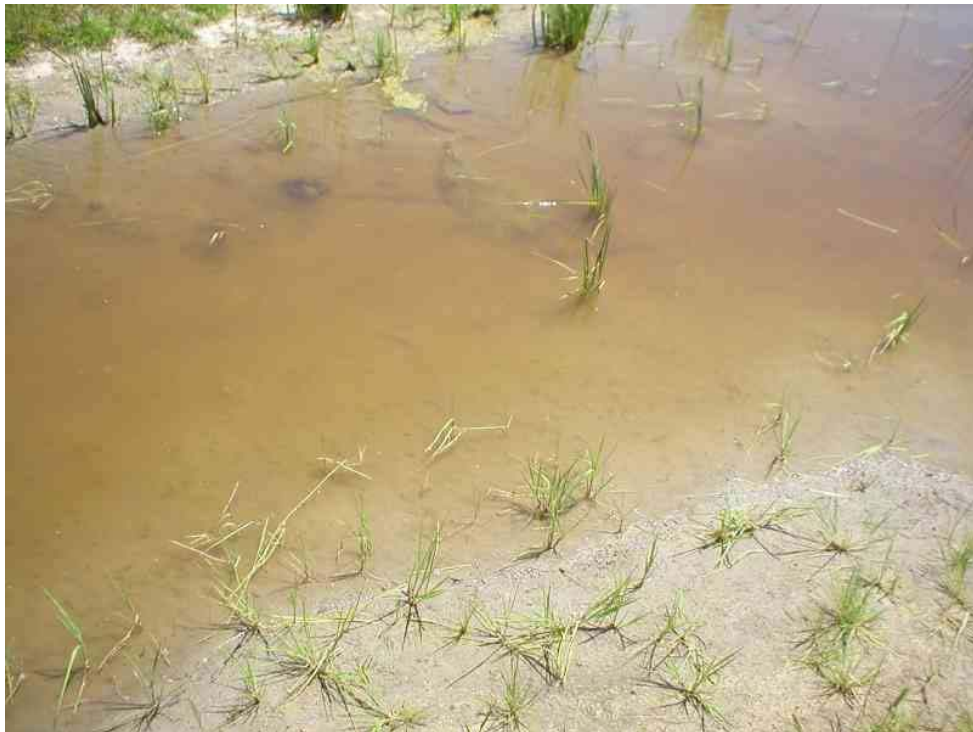
**Figure 4** – Mitigation pond, May 15, 2006.  
Note the spots in the water which are tadpoles.

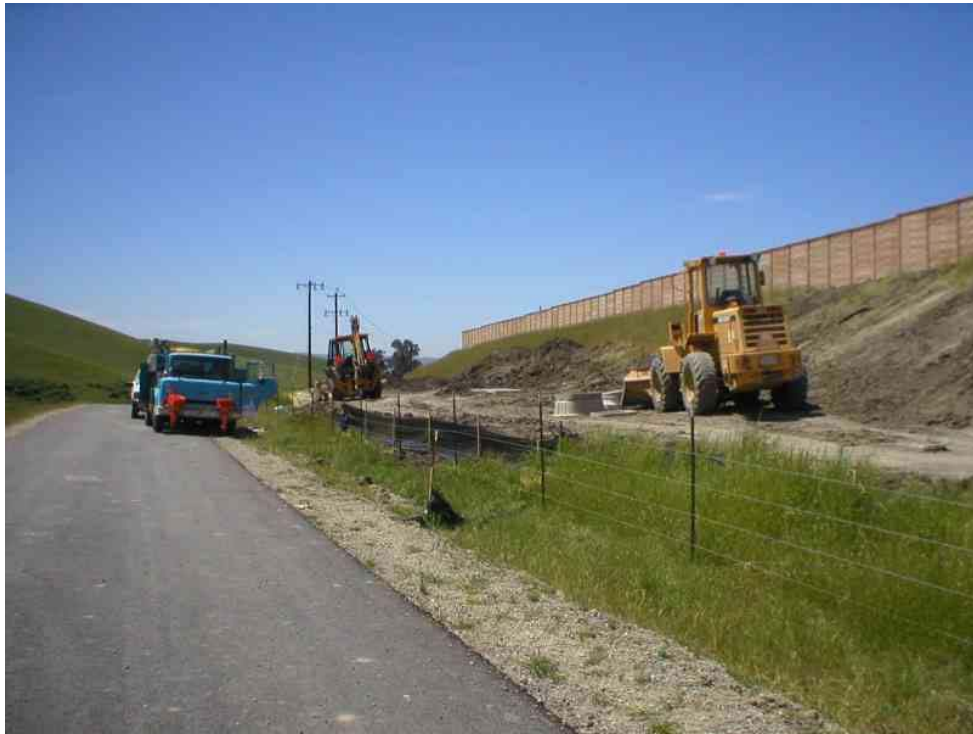
A PG&E crew has been conducting "gas-stubbing" activities which connect the North Dublin Substation to the distribution line. The work involves trenching and installing underground conduit outside of the substation wall adjacent to Moller Road. Crews also installed communication vaults in the same vicinity (see Figure 5). A loggerhead shrike nest was identified adjacent to the North Dublin Substation approximately 180 feet from where the work is occurring. Opus notified CDFG of the nest on May 12<sup>th</sup>. The CPUC EM notified Opus on May 13<sup>th</sup> and May 15<sup>th</sup> that the project mitigation measures require a 250-foot buffer. Since work within the buffer had not yet been approved by CDFG, work at this location was suspended. On May 17<sup>th</sup>, Opus contacted CDFG to request permission to complete the vault work within the 250-foot buffer as well as permission to use a two-track access road to Tower #2 which passes within 30 feet of the nest (see Figure 6). On May 17<sup>th</sup>, CDFG responded that activities may not take place within 75 feet of the nest, thus use of the access road was prohibited.

**Figure 5** – “Gas-stubbing” and communication vault work adjacent to the North Dublin Substation, May 15, 2006

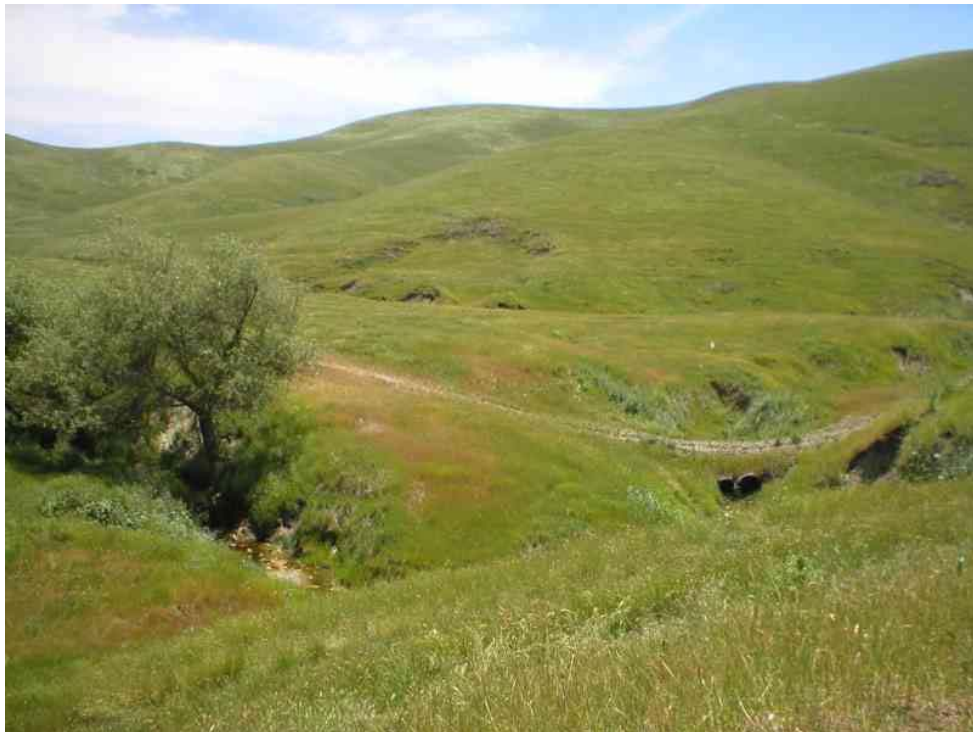
A loggerhead shrike nest was identified adjacent to the North Dublin Substation approximately 180 feet from where work is occurring. The CPUC EM notified Opus on May 13<sup>th</sup> that project mitigation measures require a 250-foot buffer. On May 15<sup>th</sup> the CPUC EM issued a verbal warning for PG&E to provide CDFG approval to continue with work within the buffer or to otherwise bring the project into compliance with the mitigation measure. PG&E responded by moving work outside the buffer zone and CDFG reduced the 250-foot buffer to 75 feet on May 17<sup>th</sup>.

**Figure 6** – Tree containing the loggerhead shrike nest, May 15, 2006. Note the two-track access road which runs approximately 30 feet from the nest.

On May 12<sup>th</sup>, Opus notified Marcia Grefsrud, CDFG of the loggerhead shrike nest that was identified adjacent to the North Dublin Substation approximately 180 feet from where work is occurring. The project mitigation measures require a 250-foot buffer. Following a second notification by the CPUC EM on May 15<sup>th</sup>, PG&E moved construction activities out of the buffer zone. On May 17<sup>th</sup>, Opus contacted CDFG to request permission to complete the vault work within the 250-foot buffer as well as permission to use a two-track access road to Tower #2 which passes within 30 feet of the nest (see Figure 6). On May 17<sup>th</sup>, Marcia Grefsrud with CDFG responded that activities may not take place within 75 feet of the nest, thus use of the access road was prohibited.
