PROJECT MEMORANDUM
PG&E – TRI-VALLEY 2002 CAPACITY INCREASE PROJECT

To: Jensen Uchida, CPUC
From: Vida Strong, Aspen Project Manager
Date: July 5, 2006
Subject: Weekly Report #114: June 25, 2006 – July 1, 2006
CPUC Environmental Monitor (EM): Anne Sweet Coronado

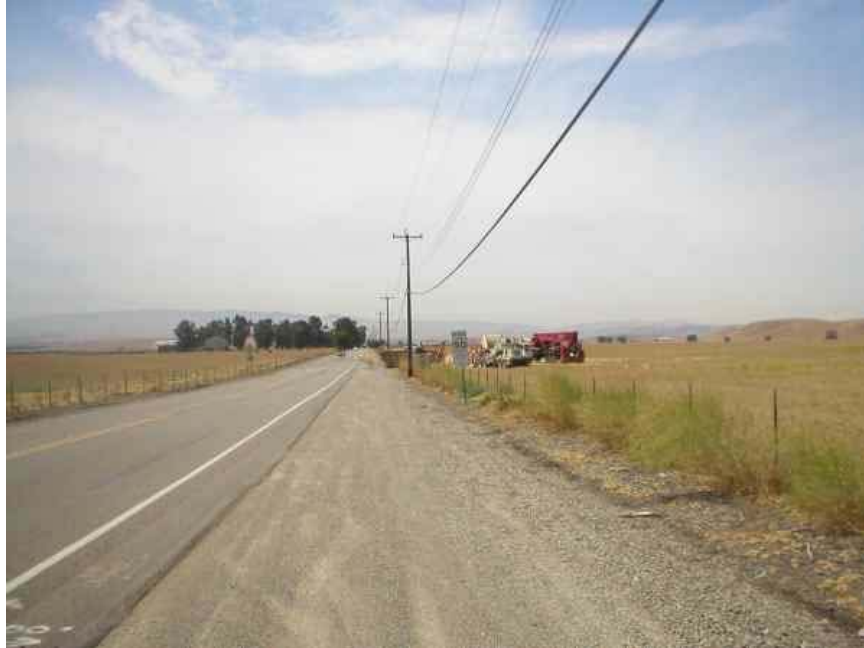
boom were moved from the street, but remained at the Vault 3 location as well as the fallen transmission reel into the subject week (see Figure 1). Underground line pulling work was suspended. A safety meeting was held on Monday, June 26, and line pulling work started up again. Sheedy Crane brought a much larger crane to the vault location (see Figure 2). In addition, they requested more work space than what exists under the project easements and right of way agreements. Opus submitted a Temporary Extra Work Space (TEWS) request on Monday June 26, which requested a 50-ft by 300-ft area adjacent to Vaults 2 and 3 along North Livermore Boulevard. No sensitive resources occur in the areas. Mowing of the areas for fire suppression will be allowed; however, no grading or earth disturbance will be permitted. The CPUC EM approved the request after the areas were reviewed in the field on June 26th. On June 26th Opus also submitted a Variance Request #20 asking for additional permanent space at the Vaults 2, 3, 4 and 5 areas for safety reasons. Vaults 4 and 5 both lie within 800 feet of potential CRLF and CTS breeding habitat. Vault 5 lies adjacent to a drainage area considered potential habitat. The request was reviewed in the field on June 26 and approved by the CPUC on June 29. Mowing of the area for fire suppression will be allowed; however, no grading or earth disturbance will be permitted. A 30 buffer outside of the drainage area will be adhered to from May 1 to October 31 and a 200-foot buffer will be adhered to November 1 through April 30. A monitor will accompany the construction at Vault 4 and Vault 5, and will survey all areas prior to mowing and movement of equipment.

Figure 1 – Overturned cable reel and crane remain at the Vault 3 accident location.
June 26, 2006.

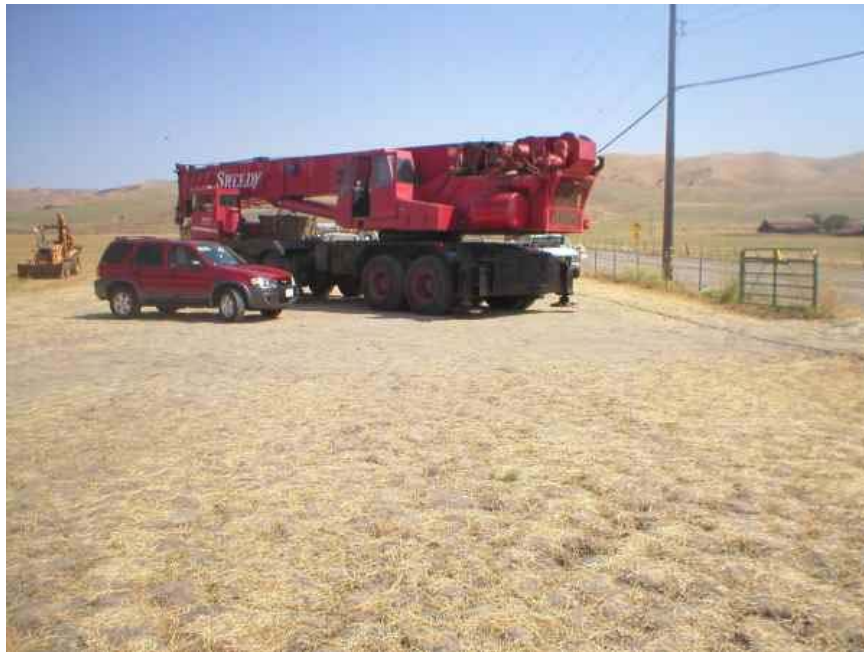
Figure 2 – New crane brought to the Vault 3 location.
June 26, 2006.

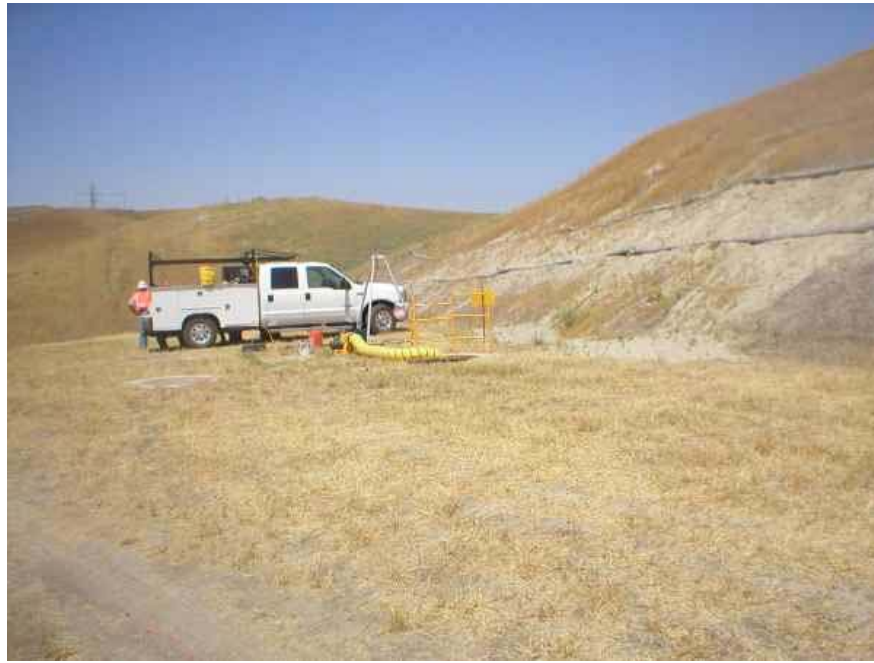
Jensen PreCast crews continued racking at Vaults 7 and 8 (see Figure 3).

Figure 3 – Jensen PreCast crews conducting racking at Vault 7.
June 26, 2006.

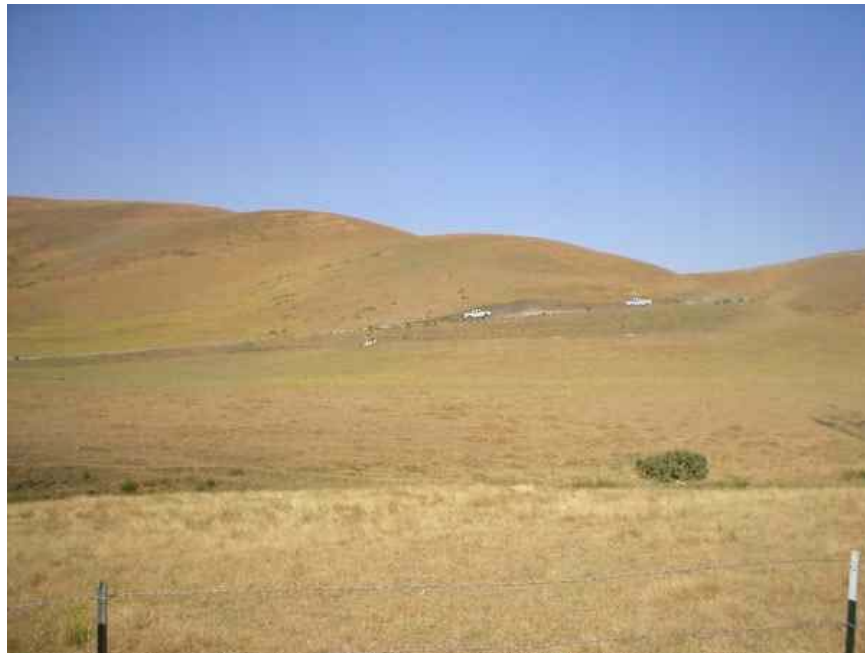
Along Road 6, two burrowing owls have been repeatedly spotted in nearby burrows. Opus notified Marcia Grefsrud, CDFG, via e-mail on May 9th. Opus requested permission to use Road 6 for movement of materials and equipment to the Transition Station and the associated vault area (equipment will include a crane as well as a flat bed truck hauling spools of transmission line, etc.). Per the Opus e-mail “the burrowing owl has been favoring a burrow less than 10 feet from Road 6.” However, no work will occur within 1000 feet of the burrow and a biological monitor will accompany all crews in this area. On May 10th, Marcia Grefsrud agreed to the proposal to use Road 6; however, she stated that “...if there is any sign of nest disturbance, PG&E may have to stop using the Roads.” Opus reported that the owls were observed again during the subject week. Opus continues escorting crews past the burrow (see Figure 4).

Figure 4 – Opus Biologist escorting Jensen PreCast crews past the identified burrowing owl nest located along Road 6.
June 26, 2006.

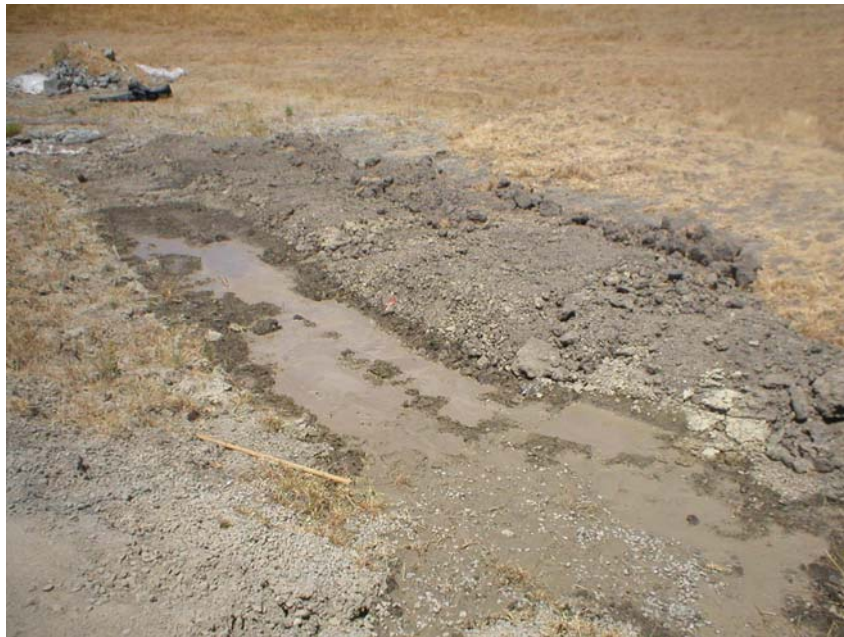
Along Moller Road, the CPUC EM had previously noted that the area upslope from the Tassajara Creek bank stabilization area showed poor grass growth and that the installed jute netting was ripped and had pulled away from the slope, possibly preventing further vegetative growth. The CPUC EM also noted that soil had slumped down the slope. NVC had fenced the area to prevent pasturing cows from degrading areas of reinstalled jute netting. Now that the soils have dried, restoration may commence; however, a schedule for the work has not been submitted. Granite and CH2MHill reviewed this site during previous weeks. During the subject week, Granite started filling in a depressed area along Moller Road outside of the North Dublin Substation which had ponded and held water during the past rainy season (see Figure 5).

Figure 5 – Dirt placed in a depression which had shown significant ponding along Moller Road. June 30, 2006.

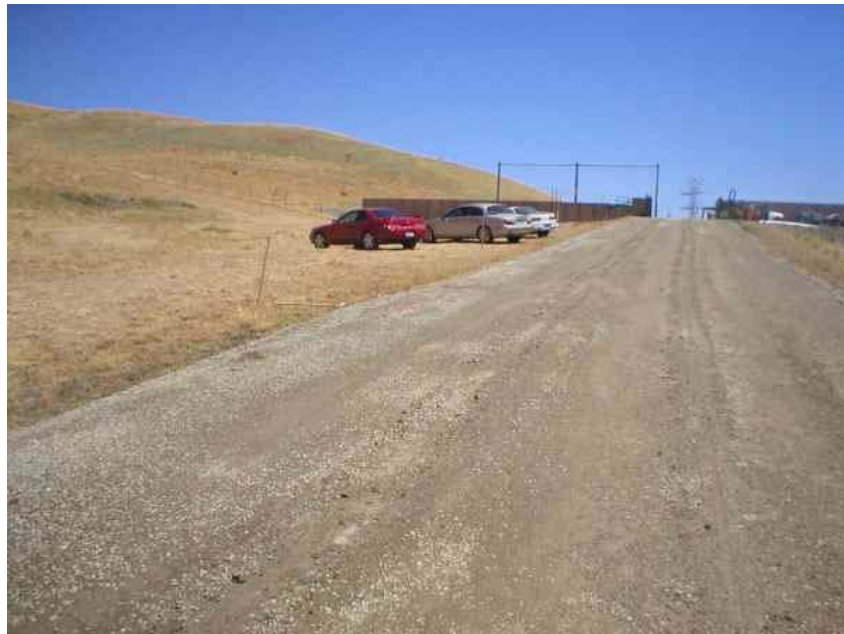
Black and Veatch have been overseeing work at the North Dublin Substation. Granite Construction continued grading and paving preparations at the substation site. On June 30, the CPUC EM observed that crews were parked off the road leading to the Substation (see Figure 6). The location is a restored and revegetated area which lies within a swale which leads to culverts out letting to Tassajara Creek. The Black and Veatch Foreman was informed that the area is not approved for parking. The vehicles were immediately moved. Previously, on January 25th, crews filled the transformer with mineral oil. The Spill Prevention Control Countermeasure (SPCC) pond and drainage network has not been completed. An earthen berm with a plastic cover was placed around the transformer in case an oil spill occurs prior to completion of the pond. The secondary containment will continue to be maintained until the constructed SPCC pond is functional. Granite worked on trenching for plumbing hookups to the SPCC pond during the subject week. Atlas wire crews conducted overhead wire testing and switch gear testing.

On June 30, the CPUC EM observed that crews were parked off the road leading to the Substation. The location is a restored and re-vegetated area which lies within a swale which leads to culverts out letting to Tassajara Creek. The Black and Veatch Foreman was informed that the area is not approved for parking. The vehicles were immediately moved.

Figure 6 – Crews parked on restored areas outside of the North Dublin Substation. June 30, 2006.
