PROJECT MEMORANDUM
PG&E – TRI-VALLEY 2002 CAPACITY INCREASE PROJECT

To: Jensen Uchida, CPUC
From: Vida Strong, Aspen Project Manager
Date: August 10, 2006
Subject: Weekly Report #119: July 30, 2006 – August 5, 2006
CPUC Environmental Monitor (EM): Anne Sweet Coronado

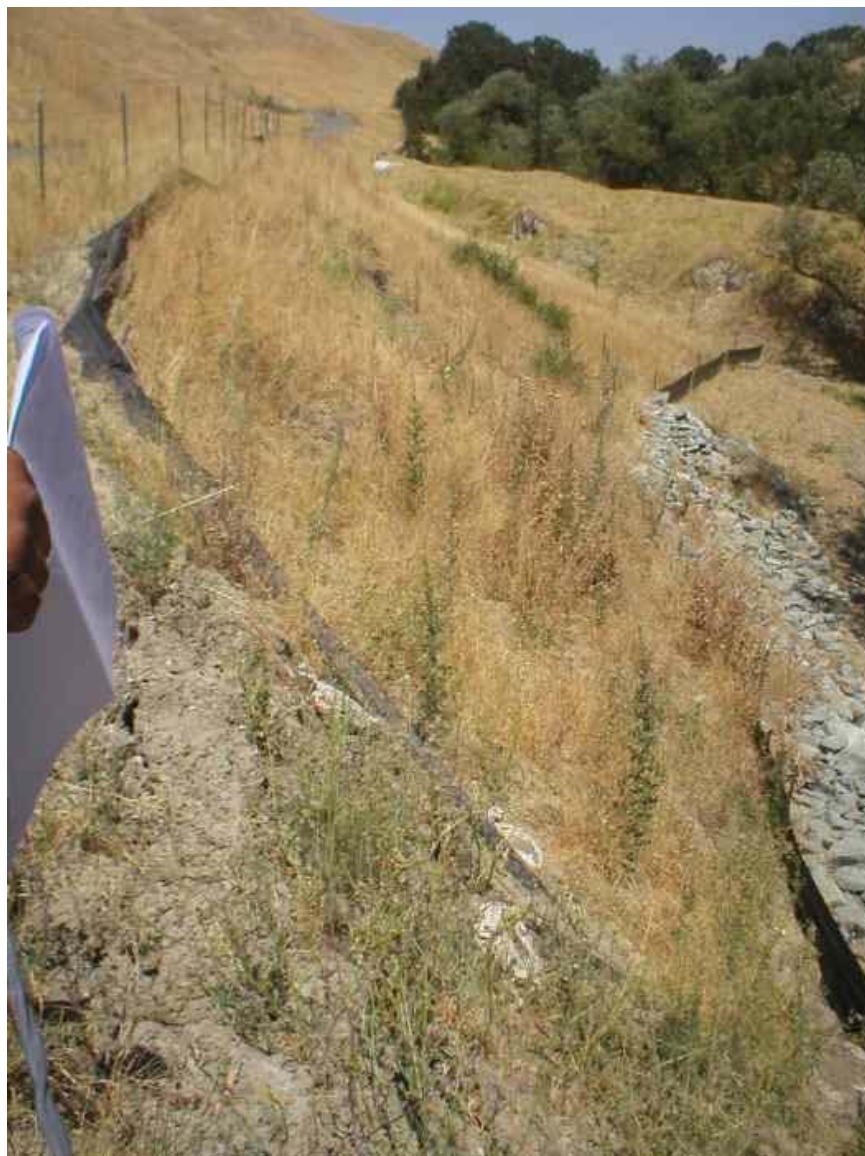
Along Moller Road, the CPUC EM had previously noted that the area upslope from the Tassajara Creek bank stabilization area showed poor grass growth and that the installed jute netting was ripped and had pulled away from the slope, possibly preventing further vegetative growth. The CPUC EM also noted that soil had slumped down the slope. NVC had fenced the area to prevent pasturing cows from degrading areas of reinstalled jute netting. As provided by PG&E above, the work is scheduled through August which agrees with the permit requirements in which the Tassajara Creek work is restricted to a May 1st to October 31st window. The area was reviewed in the field during the August 4th meeting (see Figure 1).

Figure 1 – Tassajara Creek bank stabilization area slated for restoration. August 3, 2006.

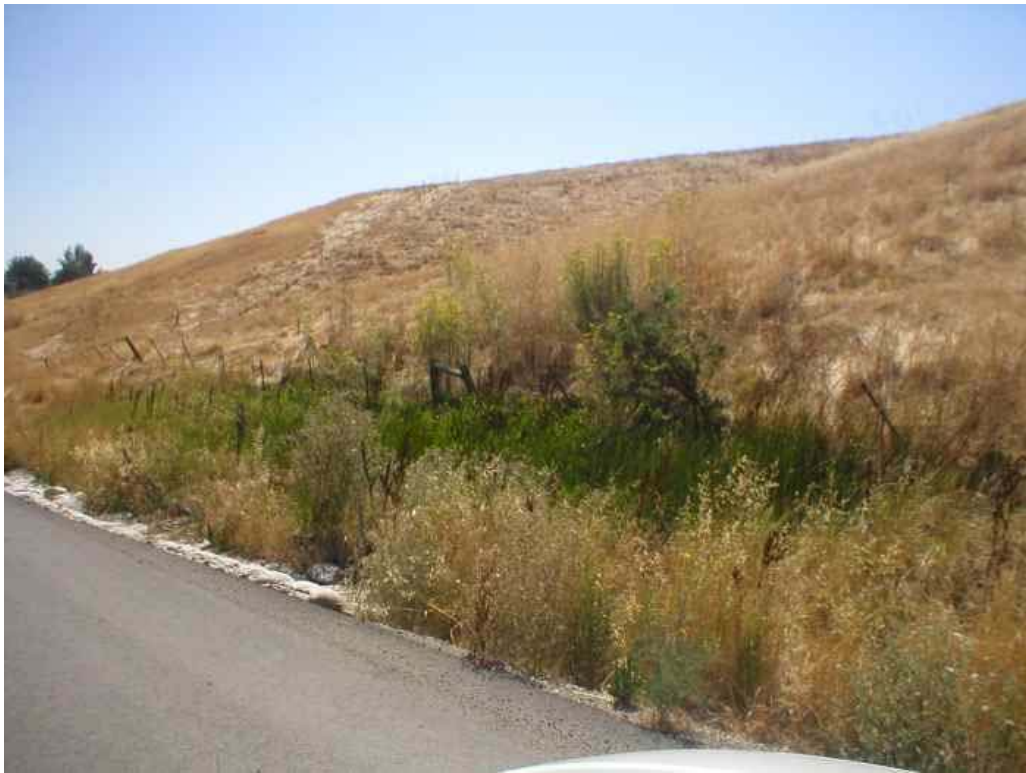
During the grading of Moller Road which had occurred last year, the CPUC EM had been concerned by the installation of French-drains under the road near an existing wetland area, fearful that the areas would be impacted. However upon inspection during the subject week that wetland area appears intact (see Figure 2).

Figure 2 – Small wetland area adjacent to Moller Road, August 3, 2006.

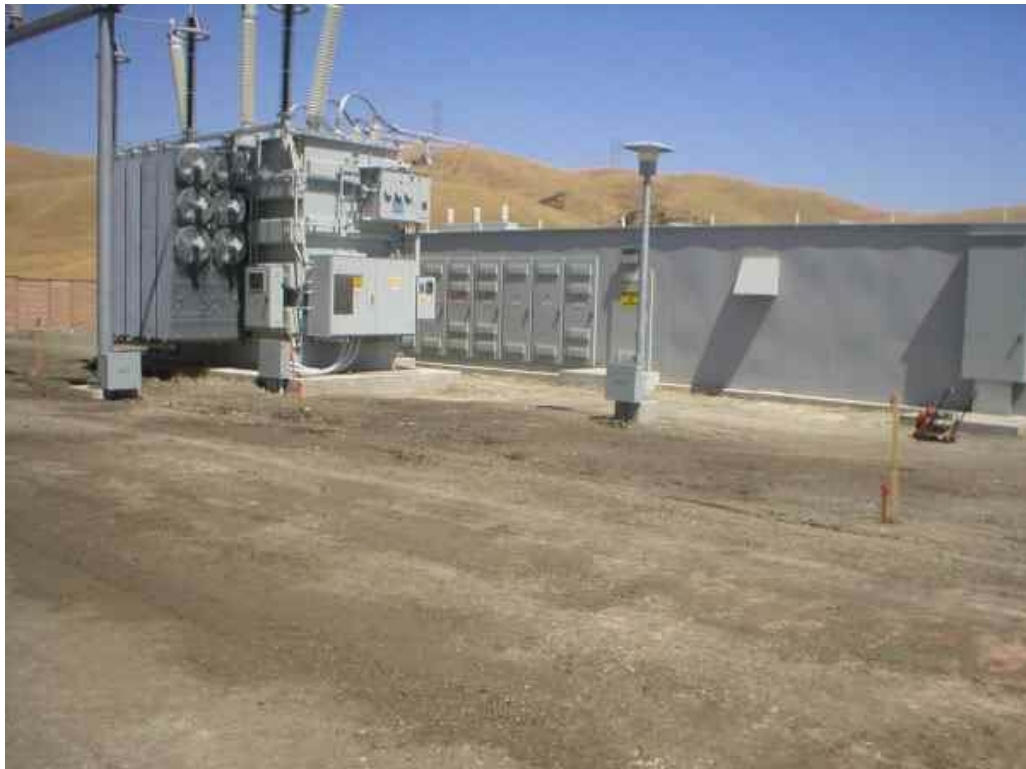
Black & Veatch has been overseeing work at the North Dublin Substation. Granite Construction has returned to conduct earthwork on the site. PG&E crews conducted electrical work in the switchgear buildings. Crews had filled the transformer with mineral oil on January 25th. A v-ditch drainage network was cut in to connect with the Spill Prevention Control Countermeasure (SPCC) pond during the subject week. The plastic covered earthen berm, which had been placed around the transformer in case an oil spill occurred prior to completion of the pond, was dismantled (see Figure 3). Granite also graded around the substation pad.

Figure 3 – Transformer at the North Dublin Substation, August 3, 2006.
Note that the secondary containment berm around the transformer has been dismantled.
