**PROJECT MEMORANDUM**  
**PG&E – TRI-VALLEY 2002 CAPACITY INCREASE PROJECT**

**To:** Jensen Uchida, CPUC  
**From:** Vida Strong, Aspen Project Manager  
**Date:** August 31, 2006  
**Subject:** Weekly Report #122: August 20, 2006 – August 26, 2006  
**CPUC Environmental Monitor (EM):** Anne Sweet Coronado

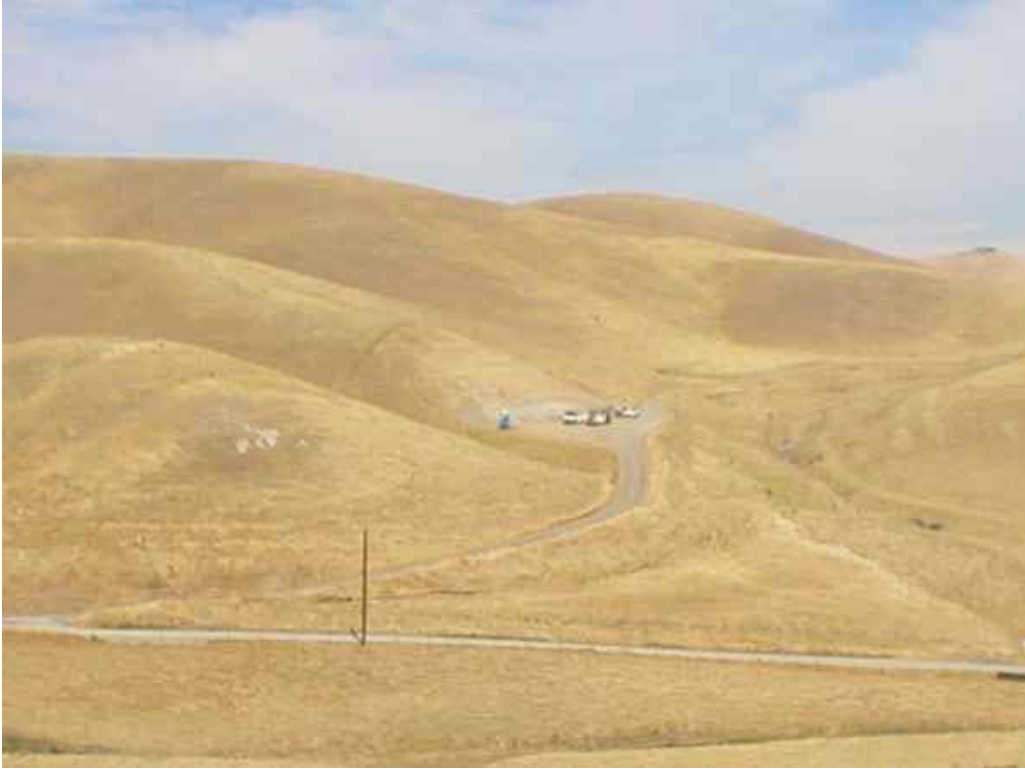
All underground cable pulling work is now complete across the project. Cable splicing continued at vaults by Nexans crews (see Figure 1). Wilson Construction crews conducted vault cleaning and interduct preparation and bonding. Wilson crews also pulled fiber optic cable.

Grass seeding had occurred last year along Road 7 after installation of the underground line. However, currently some areas appear to need additional seeding prior to the next rainy season (see Figure 1).

**Figure 1** – Cable splicing at Vault 7, located along Road 7, August 23, 2006. Note the sparsely vegetated patches where re-vegetation appears to be needed.

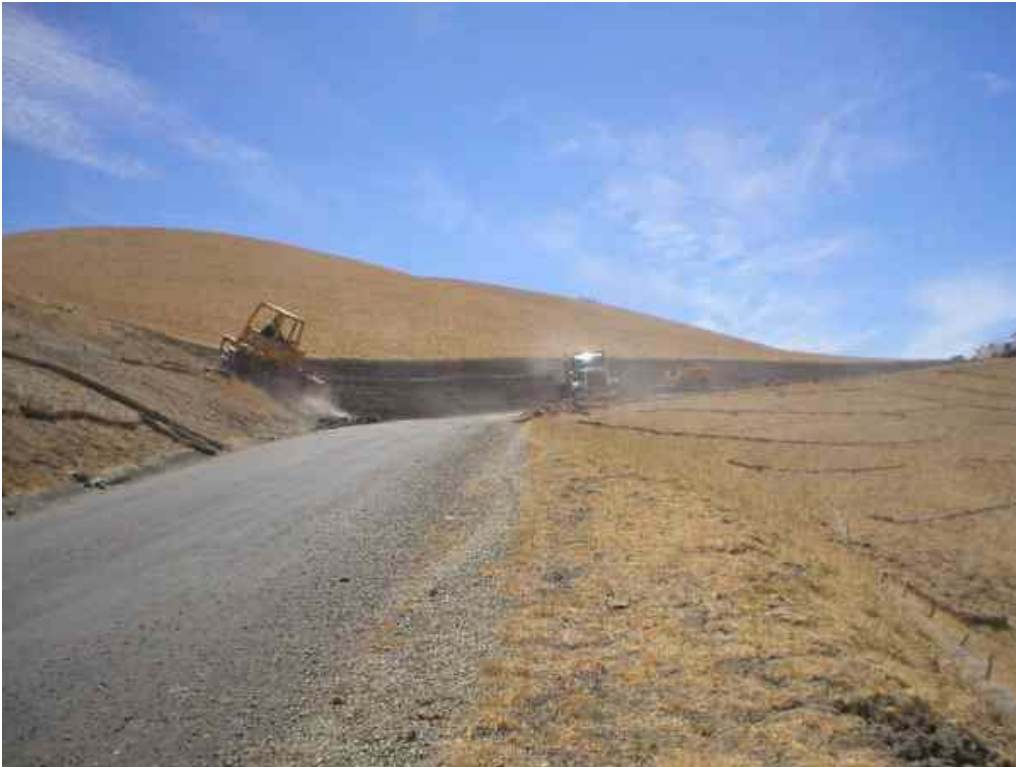
The CPUC EM had noted previously that slumping of cut slope areas above Road 6 had occurred. NVC crews began restoration of the area during the subject week (see Figure 2). They removed the slumped soils, and started re-grading and compacting the areas. In another area along Road 6, project related erosion

**Figure 2** – Restoration work on the previously slumped section upslope of Road 6, August 23, 2006.

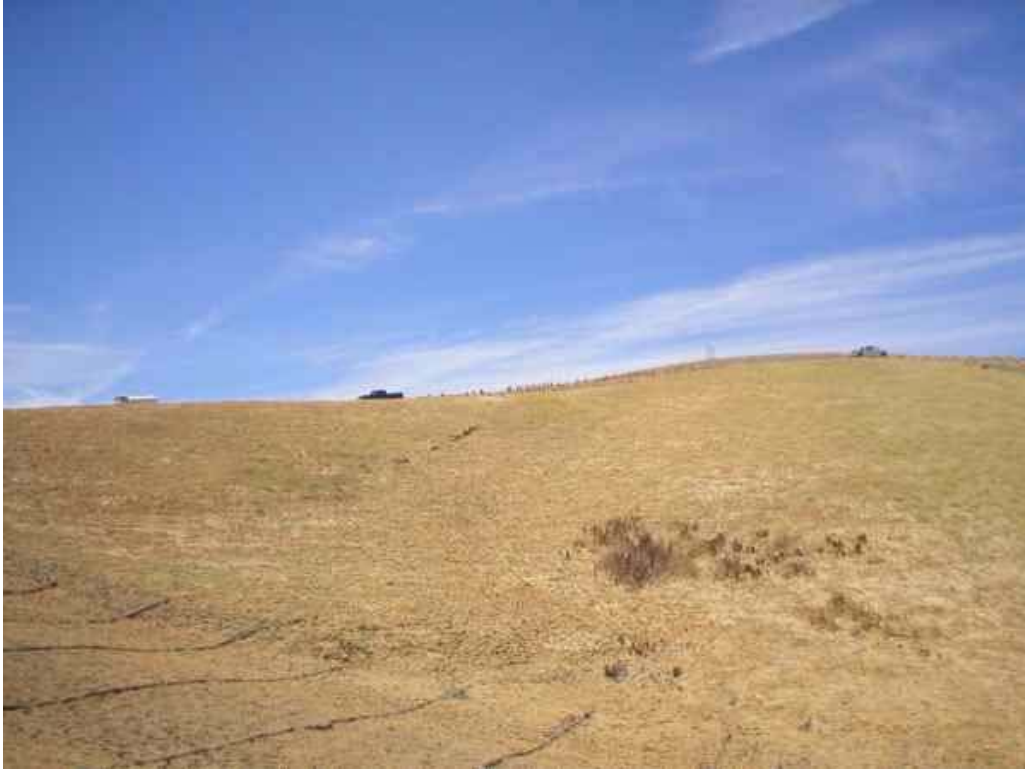
had occurred down slope of the road (see Figure 3). The area occurs outside of the project limit of disturbance. However, during repair work which occurred during the subject week, no grading or earth disturbance occurred. Crews filled and compacted eroded areas to prevent further erosion.

**Figure 3** – Eroded area down slope of Road 6, August 23, 2006.
