PROJECT MEMORANDUM PG&E – TRI-VALLEY 2002 CAPACITY INCREASE PROJECT

To: Jensen Uchida, CPUC
From: Vida Strong, Aspen Project Manager
Date: September 13, 2006
Subject: Weekly Report #124: September 3, 2006 – September 9, 2006
CPUC Environmental Monitor (EM): Anne Sweet Coronado

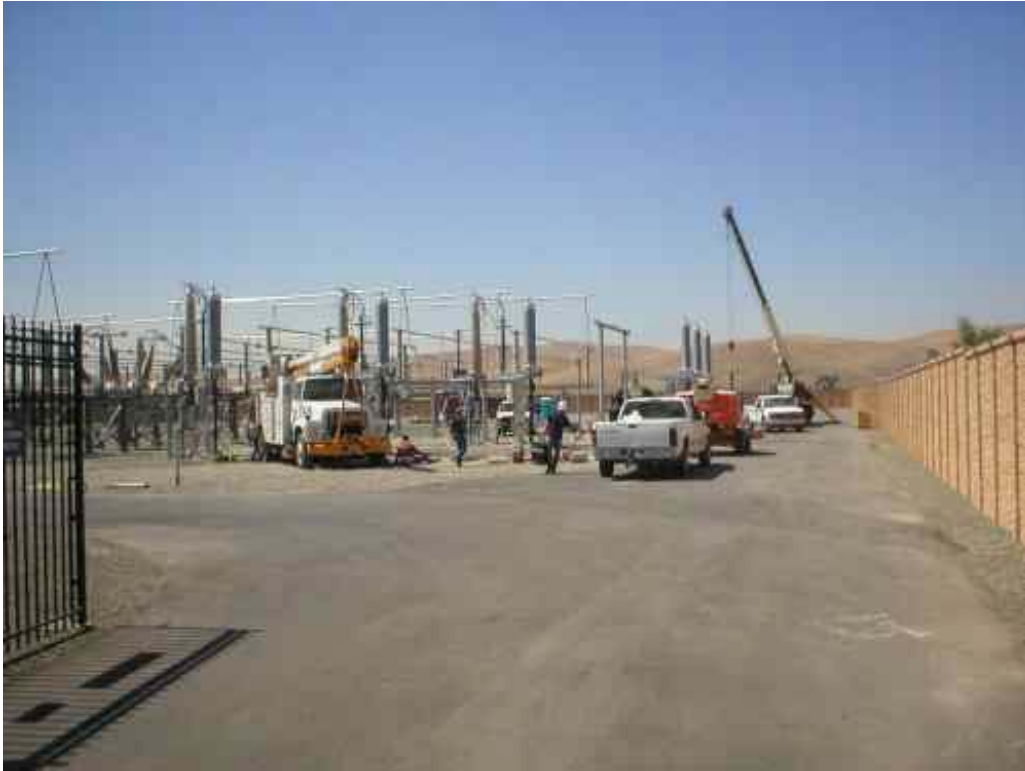
All underground cable pulling work is now complete across the project. Cable splicing continued at vaults by Nexans crews. Nexans crews also worked on pothead installation at the Cayetano Substation. Wilson crews also worked at the Cayetano Substation during the subject week attaching jumpers (see Figure 1).

Figure 1 – Nexans crews worked on pothead installation and Wilson crews attached jumpers at the Cayetano Substation, September 7, 2006.

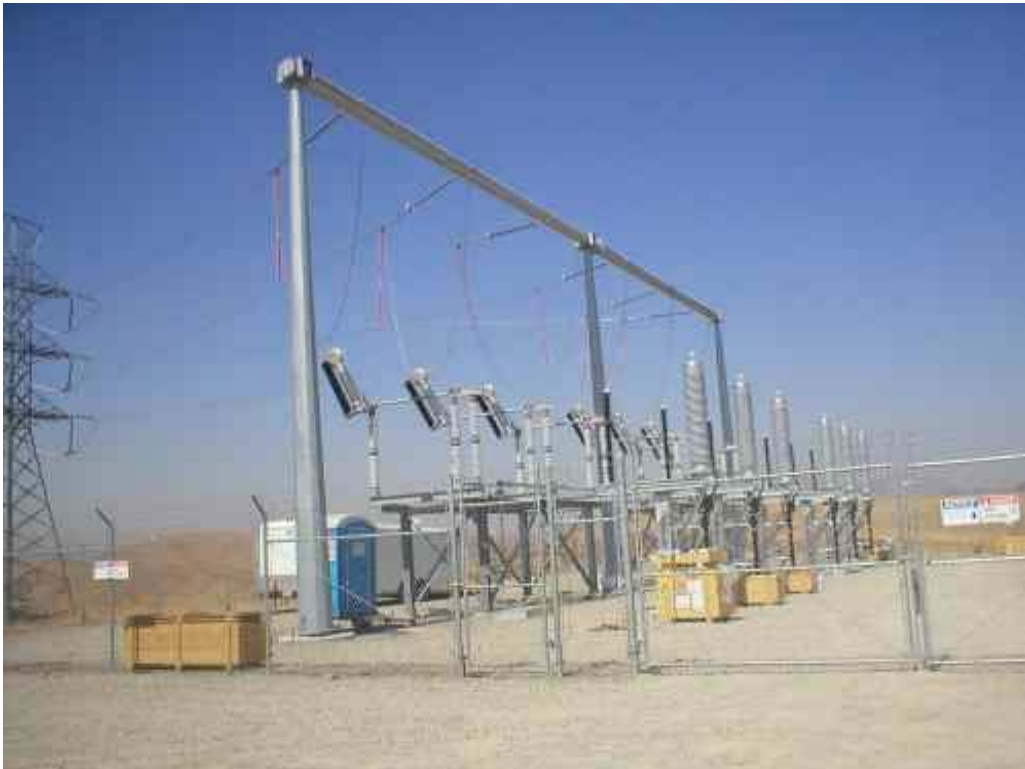
On Monday, May 15th, Wilson Construction re-erected the beam structure at the Transition Station. Per Opus, a “high-frequency line” was installed with the structure in an effort to prevent the beam movement previously caused by wind and resonance. During the subject week both PG&E and Wilson crews conducted grounding work at the Transition Station. Nexans crews conducted fiberwork and splicing (see Figure 2).

Figure 2 – Transition Station, September 7, 2006.

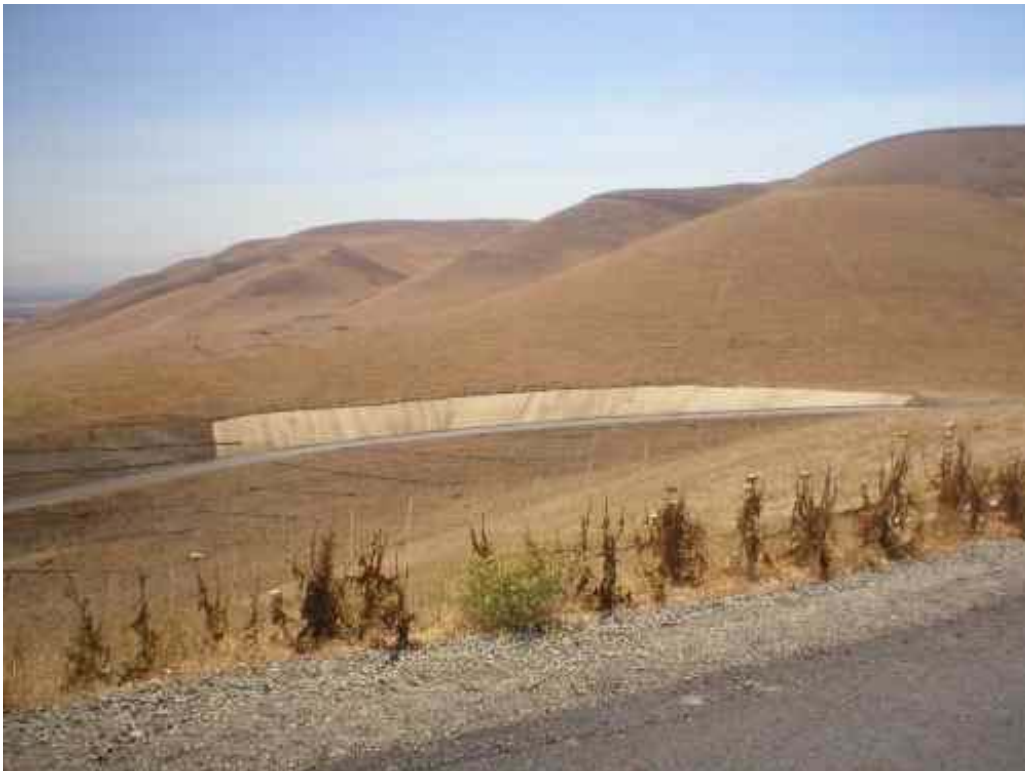
NVC crews completed restoration of the cut slope areas above Road 6 and hydro-seeded the area during the subject week. In addition, they placed geotextile matting over the seeded areas (see Figure 4). The matting was inspected and does not contain the mono-filament mesh that is prohibited by the USFWS BO. NVC re-contoured and seeded another side slope along Road 6 (see Figure 5). In addition, NVC crews installed a steel cage and poured concrete at a culvert inlet along Road 6 (see Figure 6).

Figure 4 – Restored and reseeded area along Road 6, September 7, 2006.

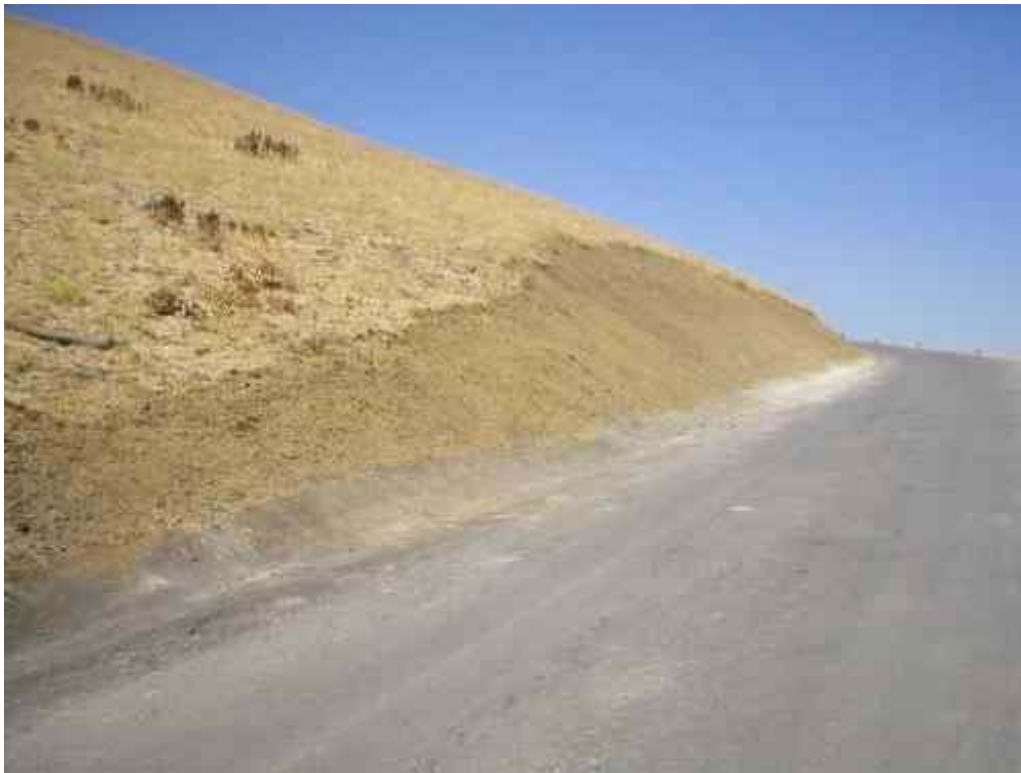
Figure 5 – NVC crews re-contoured and seeded a side slope along Road 6, September 7, 2006.

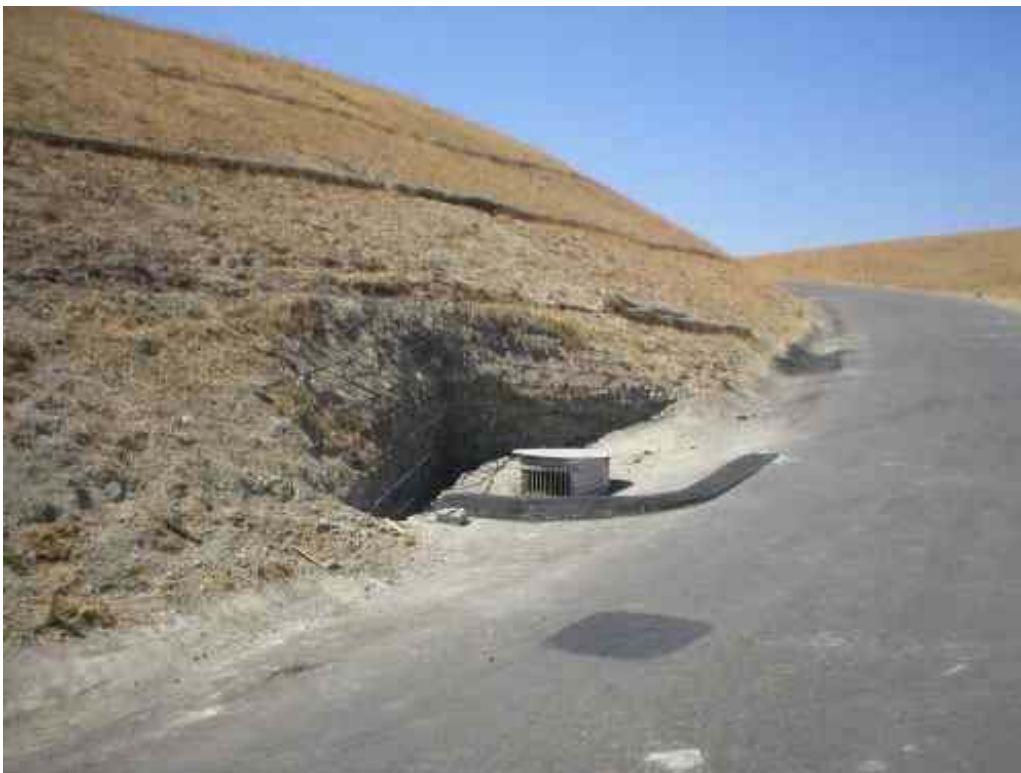
Figure 6 – NVC Crews set a steel cage at a culver inlet along Road 6, September 7, 2006.

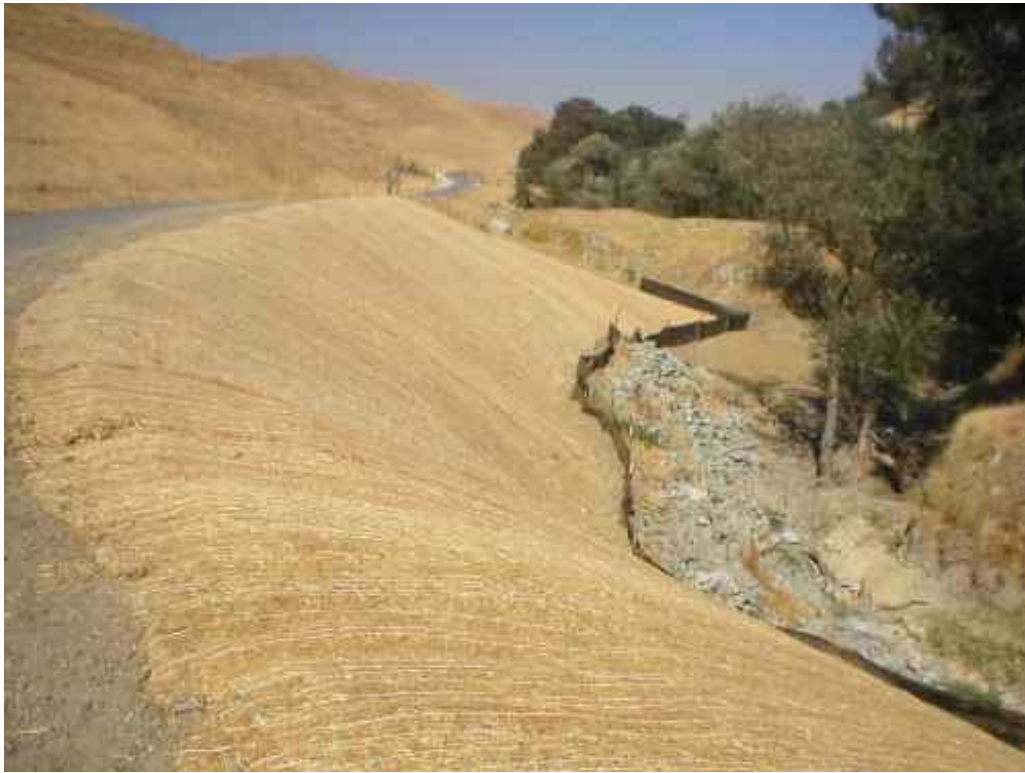
Along Moller Road, NVC completed the restoration on the Tassajara Creek bank stabilization area (see Figure 7). Crews hydro-seeded and placed geotextile matting over the area. The matting was inspected and does not contain the mono-filament mesh that is prohibited by the USFWS BO. NVC finished repair work on culverts located along Moller Road and replaced rocks in the inlets and outlets. In addition, NVC crews removed previously installed erosion controls which are no longer necessary, including sand bags and straw wattles.

Figure 7 – Restored Tassajara Creek bank stabilization area, September 7, 2006.
