PROJECT MEMORANDUM PG&E – TRI-VALLEY 2002 CAPACITY INCREASE PROJECT

To: Jensen Uchida, CPUC
From: Vida Strong, Aspen Project Manager
Date: August 4, 2005
Subject: Weekly Report #69: July 24, 2005 – July 30, 2005
CPUC Environmental Monitors (EMs): Anne Sweet and Jenny Slaughter

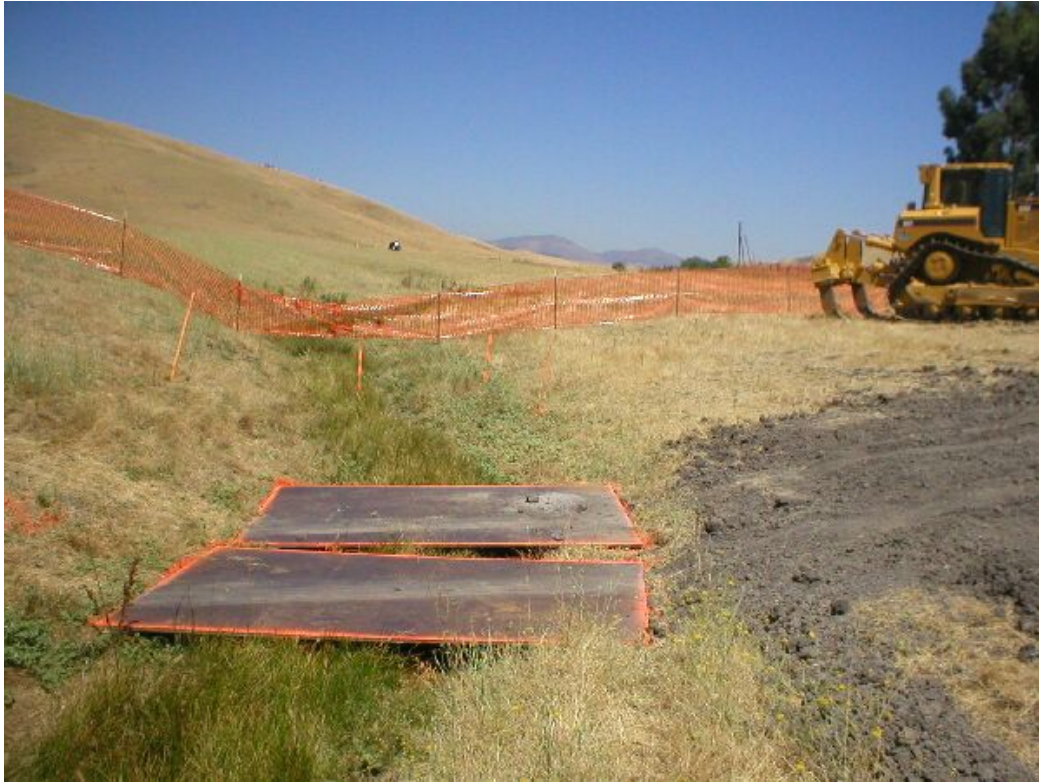
On July 26, the CPUC EMs found that a drainage off Manning Road was bridged by steel plates and the area upslope of the bridge had been graded up to and possibly within the drainage without an approved CDFG Streambed Alteration Agreement (SAA) (see Figure 1). This area had not been cleared for work by the CPUC EM as required in the NTP. A large piece of equipment was staged within 100 feet of the resource (drainage). The CPUC EMs left the site to tour other areas and returned after a couple of hours and had found that the heavy equipment had been moved to the other side of the drainage across the steel plate bridge. Per Opus, the crews had been informed that they could not cross equipment over the drainage. The Environmental Supervisor provided information that the CDFG had been informed about the bridging of the drainage and CDFG responded that only small vehicles could pass over. In addition, the bridge needs to be elevated out of the resource and gravel installed per RWQCB and the pending CDFG SAA requirements. The PG&E EI placed a “No Project Access” sign on the fence leading to the drainage. A Non-Compliance Report (NCR) was issued documenting the events which had occurred. On July 28, during regular monitoring, the PG&E EI discovered that crews had returned to the drainage area and had graded upslope on the opposite previously undisturbed side of the drainage. The CPUC EM toured the site and issued another NCR for repeated non-compliance events.

On July 26, a drainage off Manning Road was bridged by steel plates and the area extending upslope from the bridge has been graded up to and possibly within the drainage without an approved CDFG Streambed Alteration Agreement (SAA) (see Figure 1). This area had not been cleared for work by the CPUC EM. A large piece of equipment was staged within 100-ft of the resource. The bridge needs to be elevated out of the resource and gravel installed per RWQCB and the pending CDFG SAA requirements. The PG&E EI placed a "No Project Access" sign on the fence leading to the drainage. An NCR was issued. On July 28,

during regular monitoring the PG&E EI discovered that crews had returned to the drainage area and had graded upslope on the opposite previously non-disturbed side of the drainage. The CPUC EM toured the site and issued another NCR for repeated non-compliance events.

Figure 1 – Bridged drainage off Manning Road. Note the grading near/possibly within the resource. Phase Three, July 26, 2005.

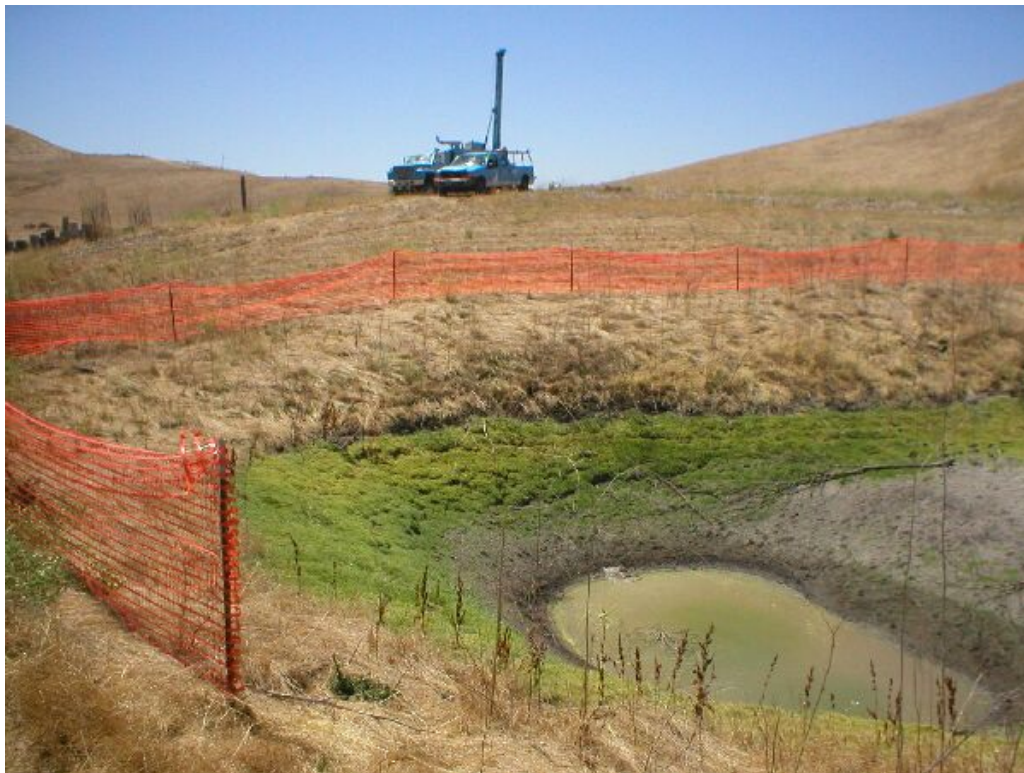
On July 26, the CPUC EMs toured construction at tower location 9, 10, 11 and 12. This construction and the use of associated access roads were started prior to the CPUC EM verifying that proper flagging and exclusion fencing had been installed as required by Project mitigation measures. Directly upslope of a CTS/CRLF breeding pond burrow clusters were not fenced off and the site was left unmonitored though construction was occurring within 200 feet of the pond. In addition crews were using new access routes which were not previously surveyed or approved. An NCR was issued, and corrective actions required that the new access roads be surveyed and that proper flagging be installed and maps provided showing sites, access roads, and resources.

Figure 2 – CTS breeding pond. Note the construction occurring within 200 feet of the resource. Phase Three, July 26, 2005.

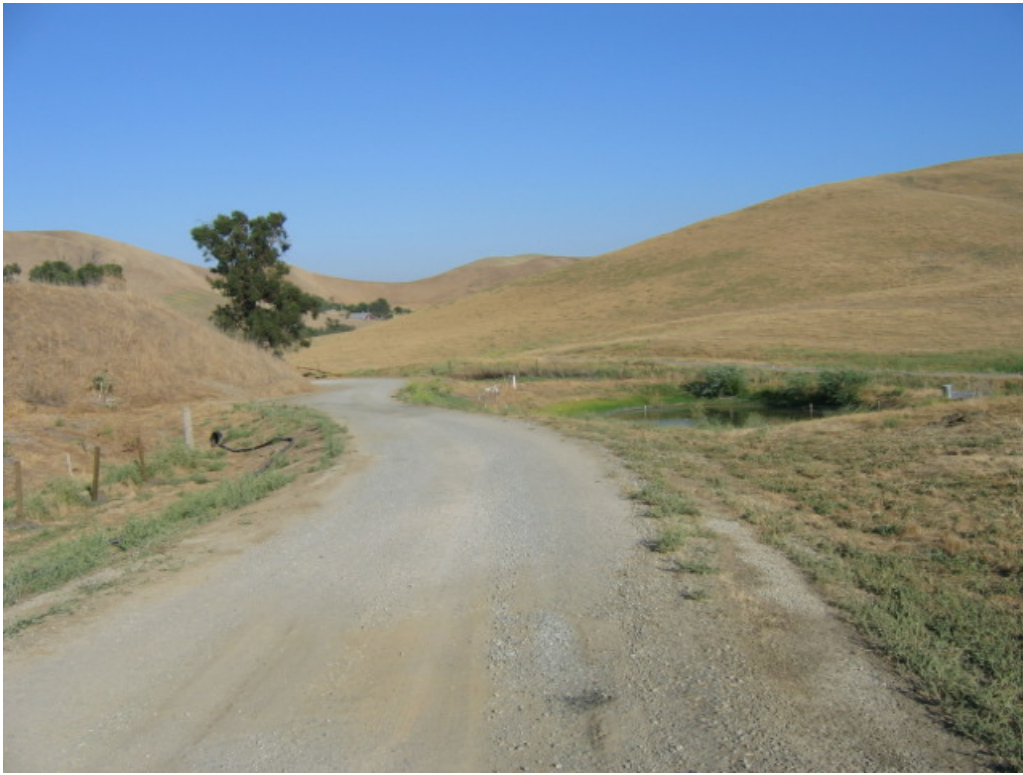
A communication meeting occurred on July 27. Attendees included the CPUC EMs, Opus, CH2MHill, and PG&E. Issues discussed included notification protocol, mitigation measure and permit conditions, necessary flagging, access roads, and recent NCRs. Opus submitted a communication protocol memo. After the meeting, the CPUC EMs toured the access road leading to Towers 9, 10, 11, and 12. The landowner wanted project vehicles to use a different access road than was originally proposed. The new access road was primarily graveled and it was decided that a Temporary Extra Work Space (TEWS) request could be submitted to cover the new access road area, until a Variance Request could be submitted and approved (see Figure 3).

Figure 3 – Access road approved by TEWS 7-27-05. Note the pond to the right of the road. Phase Three, July 28, 2005.

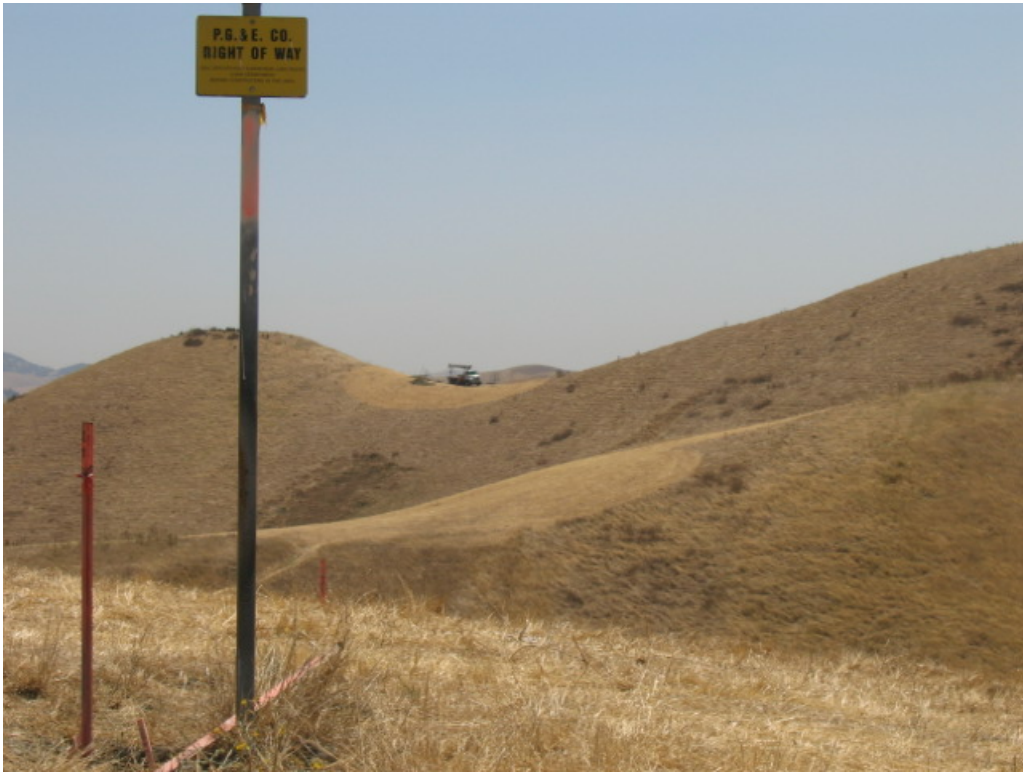
On July 29, CPUC EM attended morning meeting with Opus, Granite, and PG&E. The CPUC EM reiterated the need for approvals prior to use of new areas. A new map was submitted by Opus showing several owl sightings. The CPUC EM looked at Access Roads 5, 6, and 7 (see Figure 4) and walked the areas. The EM found equipment staged outside work area beyond Access Road 5 (see Figure 5). The CPUC informed the crew that they needed to move it to approved areas. The PG&E EI/Biologist surveyed an area within proposed Access Road 7 (see Figure 6) and they moved the equipment. The CPUC reiterated to the EIs, crews, and Environmental Supervisor, that the roads could not be used until the flagging was installed and verified by the CPUC EMs. The CPUC EM also reminded crews to keep all construction related equipment within the approved right-of-way.

Figure 4 – View from Tower #4 location showing cleared areas for Towers 5 and 6. Phase Three, July 28, 2005.

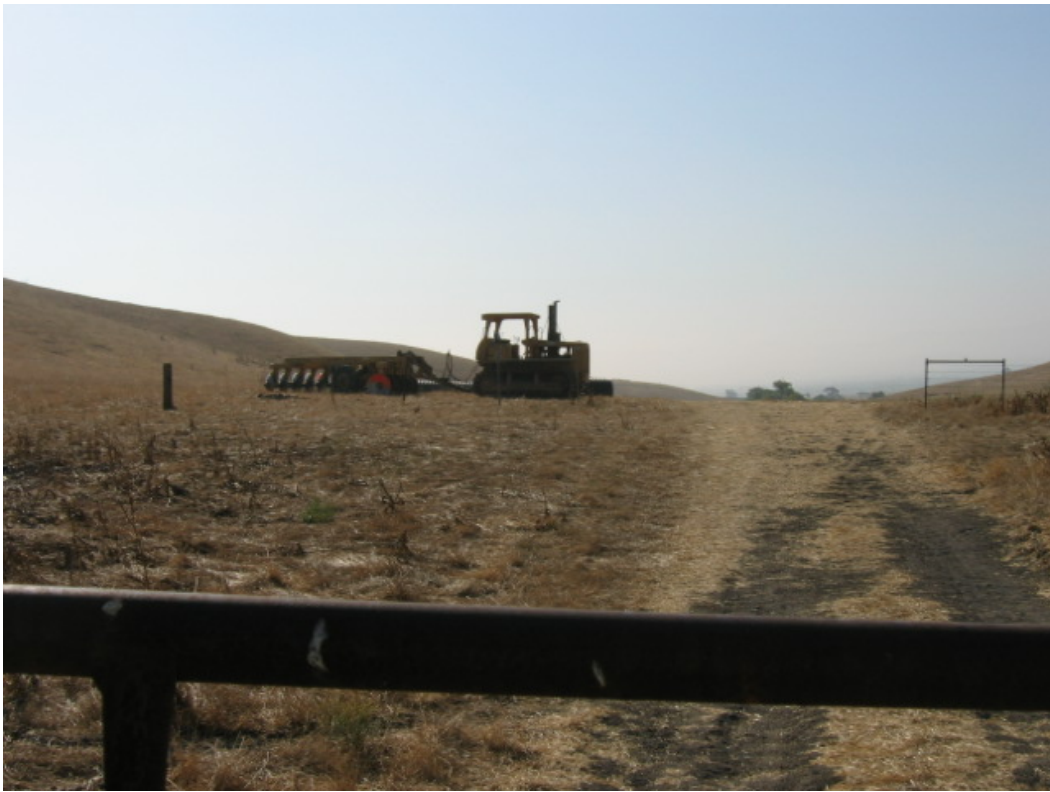
Figure 5 – Equipment staged outside ROW near Access Road 5. Phase Three, July 28, 2005.

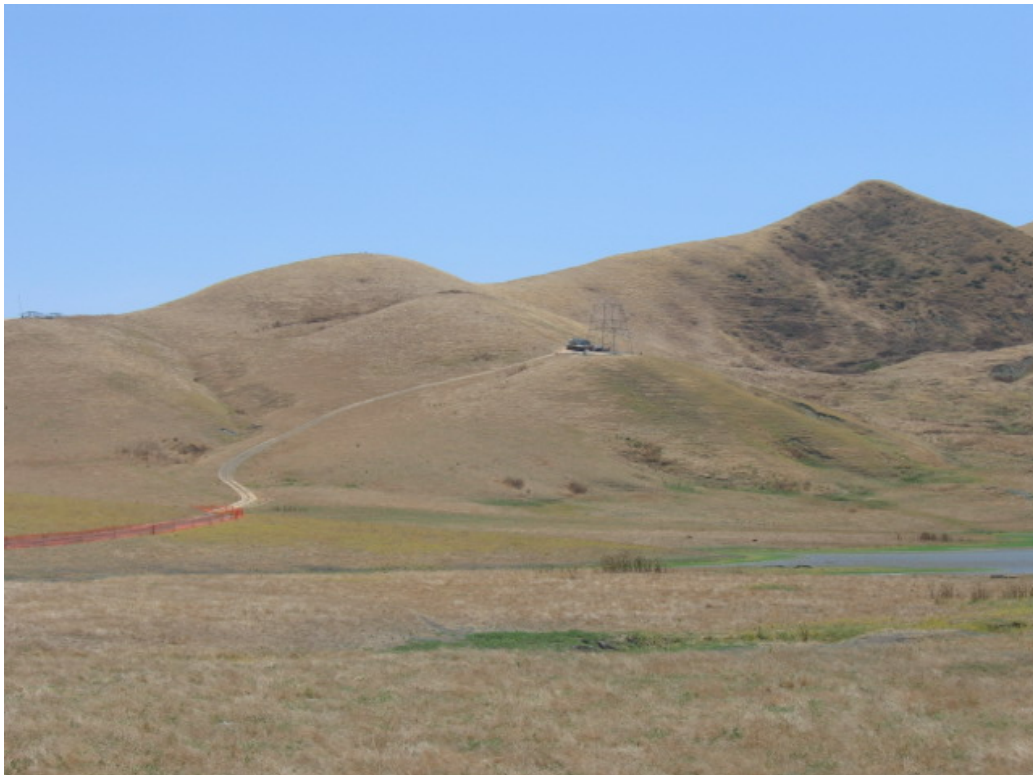
Figure 6 – Access road to reach Towers 7 and 8. Phase Three, July 28, 2005.
