PROJECT MEMORANDUM PG&E – TRI-VALLEY 2002 CAPACITY INCREASE PROJECT

To: Jensen Uchida, CPUC
From: Vida Strong, Aspen Project Manager
Date: October 5, 2005
Subject: Weekly Report #78: September 26, 2005 – October 1, 2005
CPUC Environmental Monitors (EMs): Anne Sweet and Jenny Slaughter

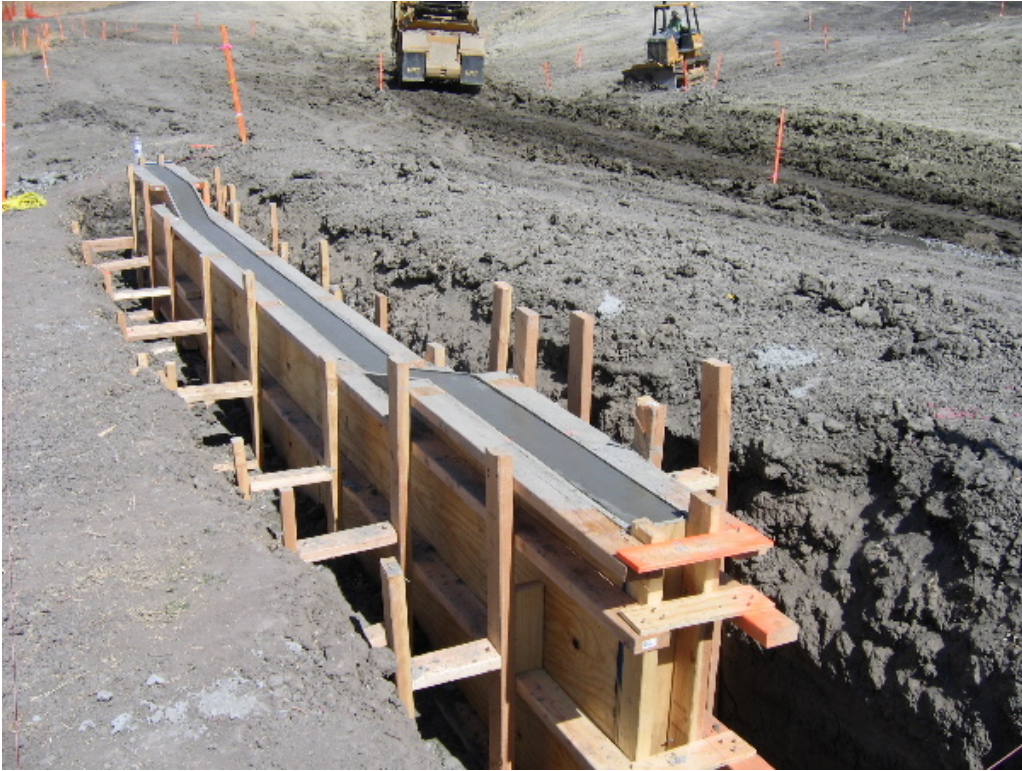
Granite crews continued work in the mitigation pond site. Construction of a concrete wall took place as part of the spillway (see Figure 2). A PG&E EI was present during all the work in the area in order to

Figure 1 – Spillway construction at the Mitigation Pond site, September 27, 2005.

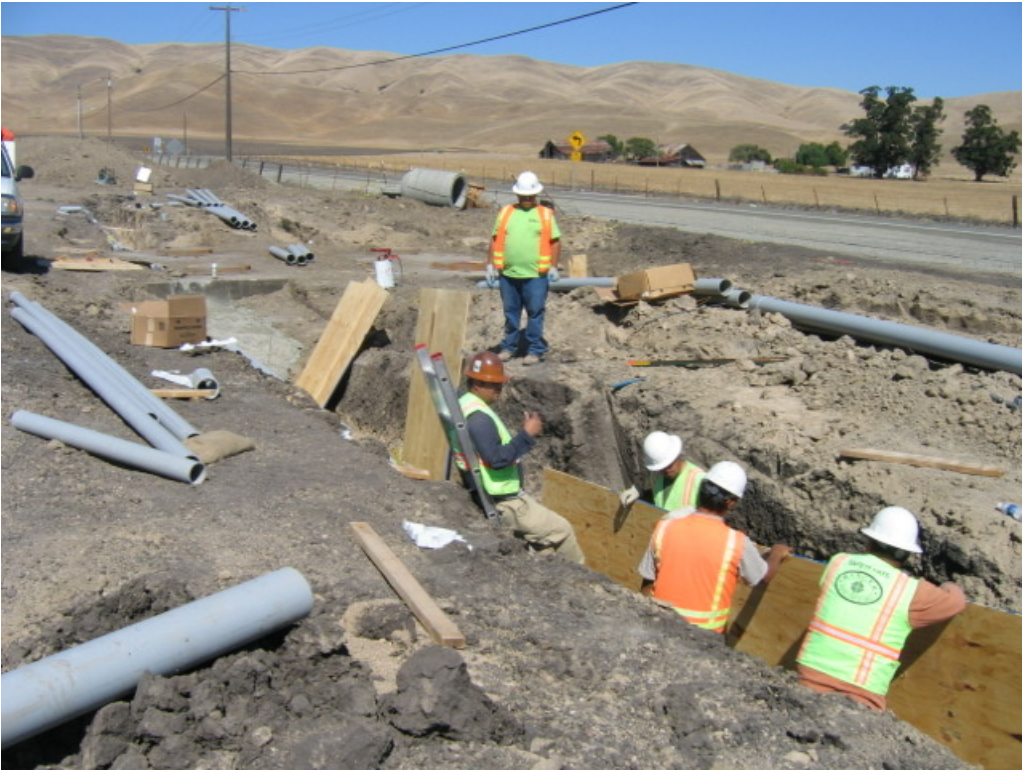
Vault installation and tie-ins continued on the underground portion north of the Cayetano Substation on North Livermore Avenue (see Figure 1). Extending up and over the hill off of Manning Road, crews are finishing up the excavation, conduit installation, and backfill of the second trench of the double circuit line. Crews initially used a disk to break up the soil and then were able to strip the topsoil and stockpile it along the side of the right-of-way. Excavation is being conducted using a trenching machine. Two trenches are being installed 15 feet apart as part of the double circuit project. Trenching through Cayetano Creek, which parallels Road 5, has been completed and is currently being backfilled. California red-legged frogs (CRLF) were identified in the project right-of-way and surrounding areas of the creek. An approved biologist was at the location monitoring for frogs preceding and during construction.

Figure 2 – Crews conducting tie-ins along North Livermore Avenue, September 28, 2005.

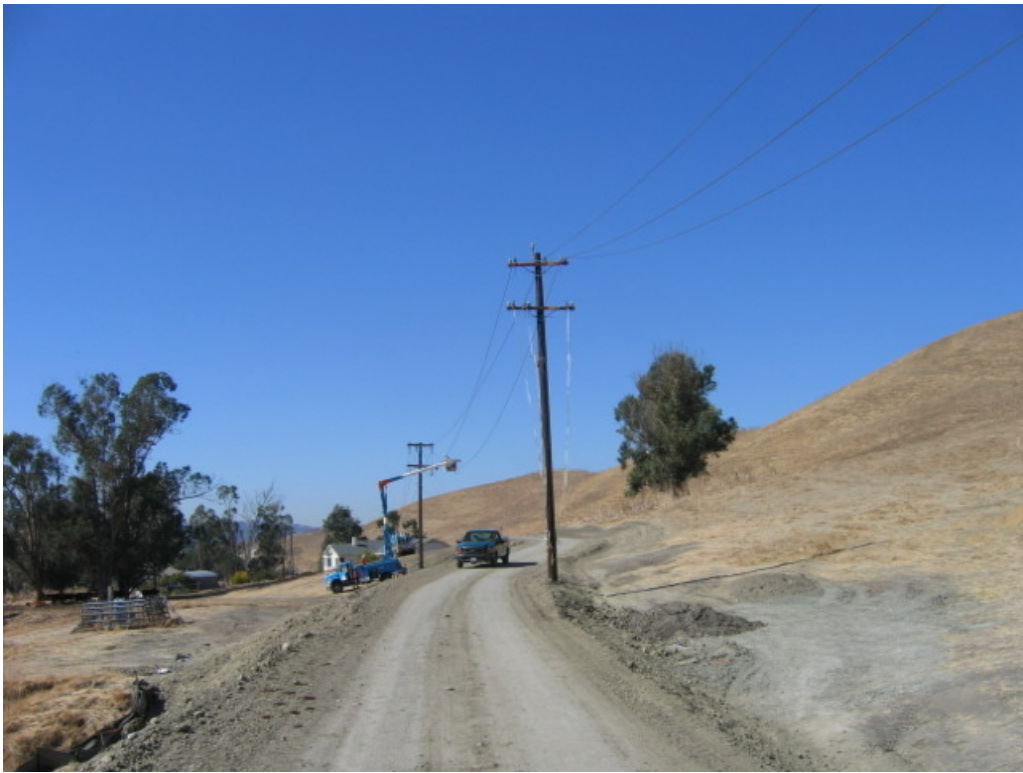
PG&E crews continued to work on completing Towers 1, 2, and 13 during the subject week. Tower assembly is occurring in the lay down yard located off Doolan Canyon Road and onsite at tower locations. Materials are being transported to and from the work sites via helicopter or truck. A biological monitor was on-site with the tower crews during the week. Stringing of lines between power poles took place along Moller Road (see Figure 3).

Figure 3 – Stringing taking place along Moller Road, September 28, 2005.
