## **PROJECT MEMORANDUM PG&E – TRI-VALLEY 2002 CAPACITY INCREASE PROJECT**

**To:** Jensen Uchida, CPUC  
**From:** Vida Strong, Aspen Project Manager  
**Date:** March 3, 2006  
**Subject:** Weekly Report #99: February 19, 2006 – February 25, 2006  
**CPUC Environmental Monitor (EM):** Anne Sweet Coronado

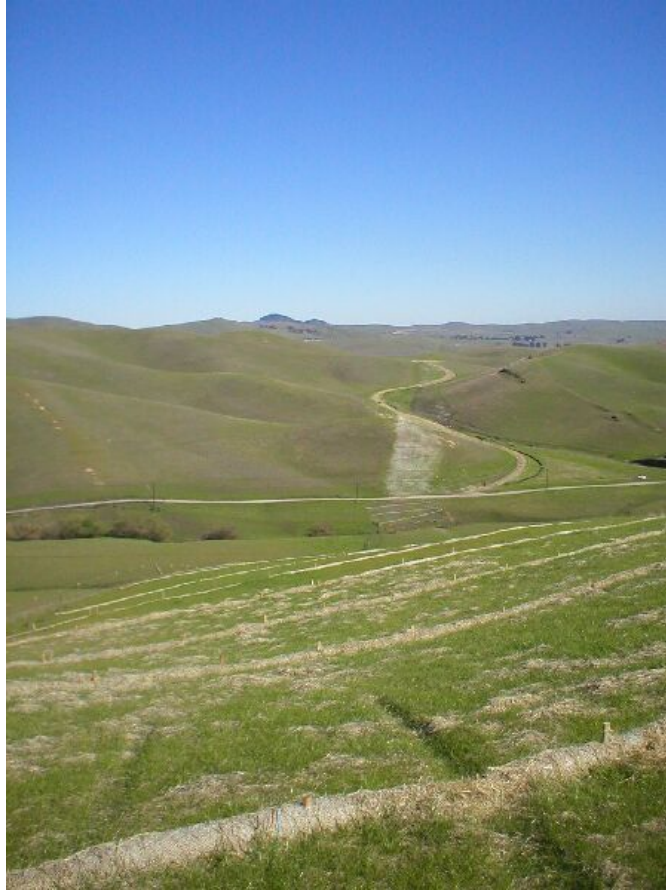
On January 13<sup>th</sup>, a burrowing owl was observed approximately 80 feet northeast of Road 6 at approximate Station 29+00. The owl was sighted repeatedly and again on January 31<sup>st</sup> at the same location. No work other than erosion control maintenance is planned to occur in the area as well as along Road 7 until cable installation begins this spring. During previous tours, the CPUC EM noted that in areas along the construction corridor along Road 6 and Road 7 that grass cover growth is poor. PG&E has provided that re-seeding is planned and shall occur prior to the next significant rain event (see Figure 1).

**Figure 1** – View of the underground alignment and Road 7 extending from the Transition Station – February 21, 2006.

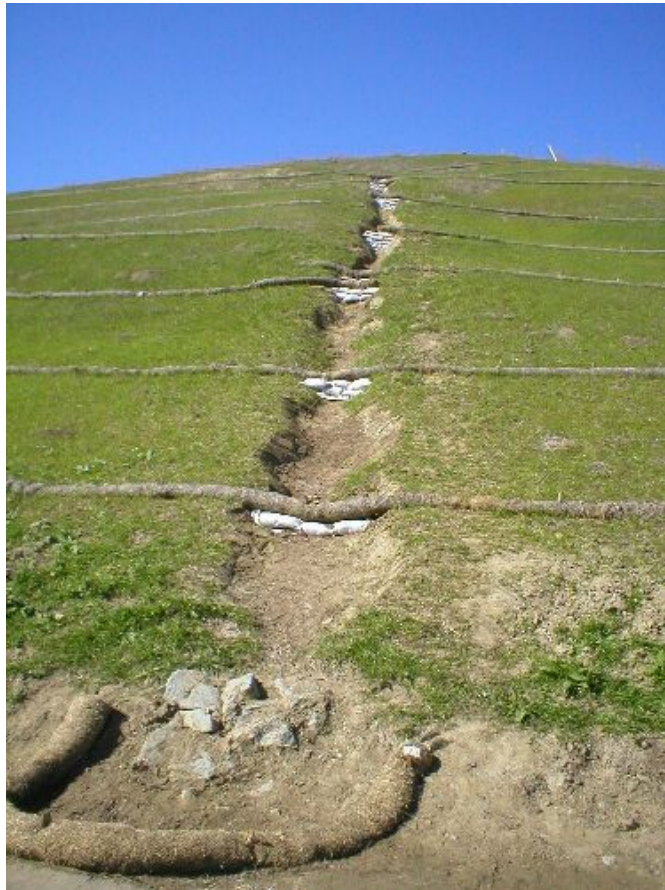
During the previous week, sand bags were placed within the v-ditch along the side of Moller Road which had shown significant erosion. On February 20, crews returned to the v-ditch and contoured and compacted the v-ditch (see Figure 2). In addition, crews later filled in the incised areas with compacted dirt. Along Moller Road two areas of slumping down slope of the road bed remain covered in plastic. Opus and North Valley have been and will continue to take steps to ensure that down slope sedimentation into resource areas does not occur.

**Figure 2**– Re-contoured and compacted v-ditch along Moller Road, February 21, 2006.

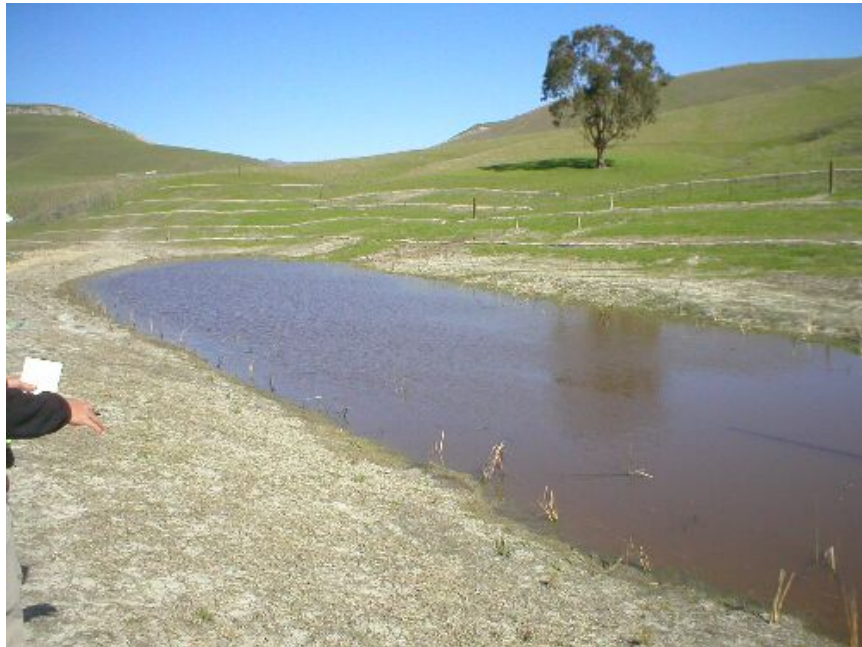
The engineered pond at the mitigation site continues to hold water (see Figure 3).

**Figure 3**– Mitigation site pond - February 21, 2006.
