SCE VALLEY SOUTH SUBTRANSMISSION PROJECT

Date: June 27, 2019
To: Eric Chiang, Project Manager, CPUC
From: Vida Strong, Aspen Project Manager
Subject: Monitoring Report #5: June 9, 2019 to June 22, 2019

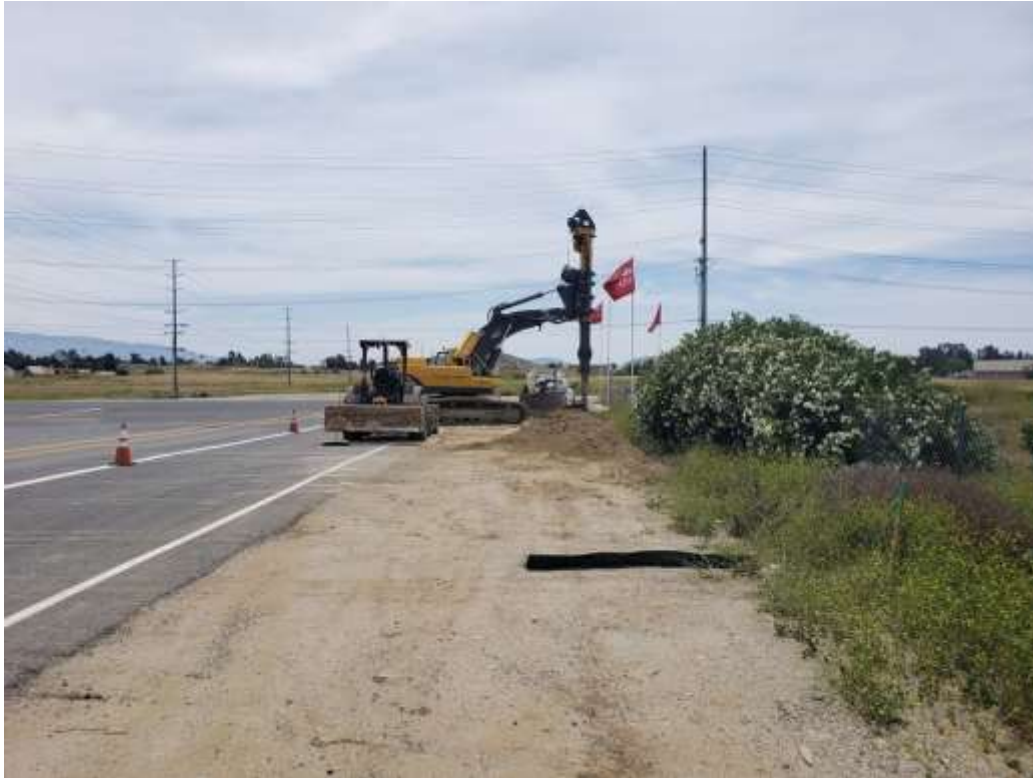
Photo 1 – Foundation drilling at Construction Area UNK247 (June 11, 2019).

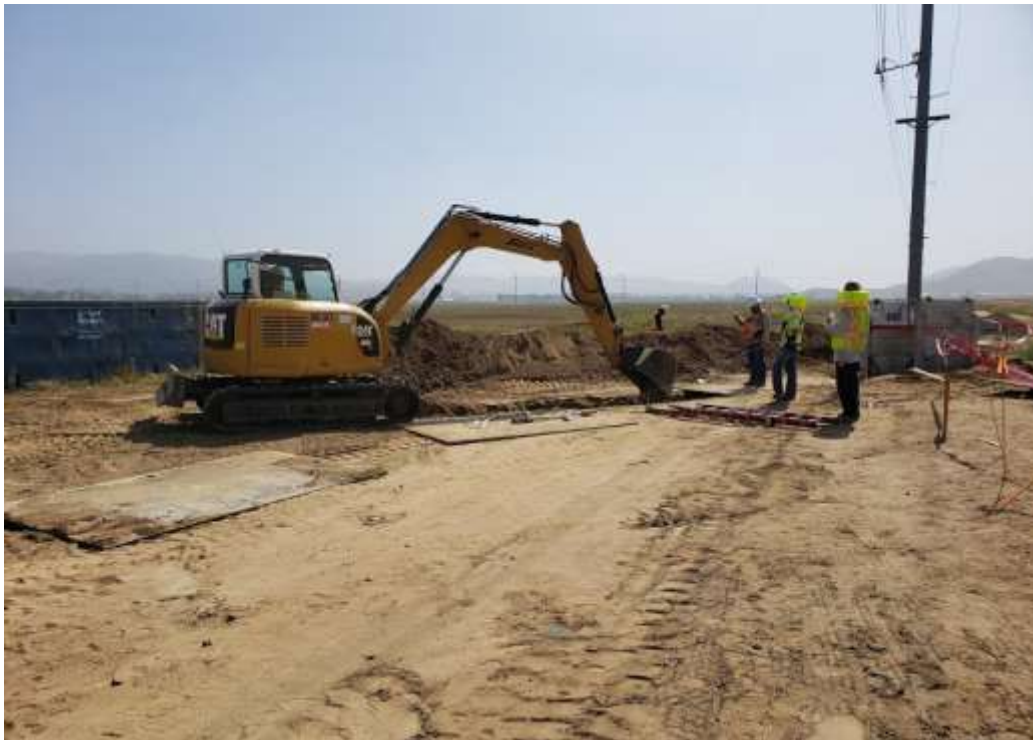
1. Wilson Construction and their subcontractors, Cattrac and KV Structures, are currently using the Valley Substation Contractor Yard for mobile office headquarters and equipment and material storage. Activities associated with the yard included delivery of materials including rebar cages, tubular steel poles (TSPs), and conduit.
2. BMP inspections and maintenance occurred at TSP foundation locations in Segment 1.
3. KV Structures conducted foundation activities at Construction Areas UNK125, UNK155, UNK206, UNK207, UNK222, and UNK247 (see Photo 1).
4. Cattrac continued underground trenching for conduit at the underground section along Valley Substation, west of Menifee Road, as well as placed vault #3 on the east side of Menifee Road, and trenched from the vault to UNK250 (see Photo 2).

Photo 2 – Underground trenching from Menifee Road to Construction Area UNK250 (June 18, 2019).

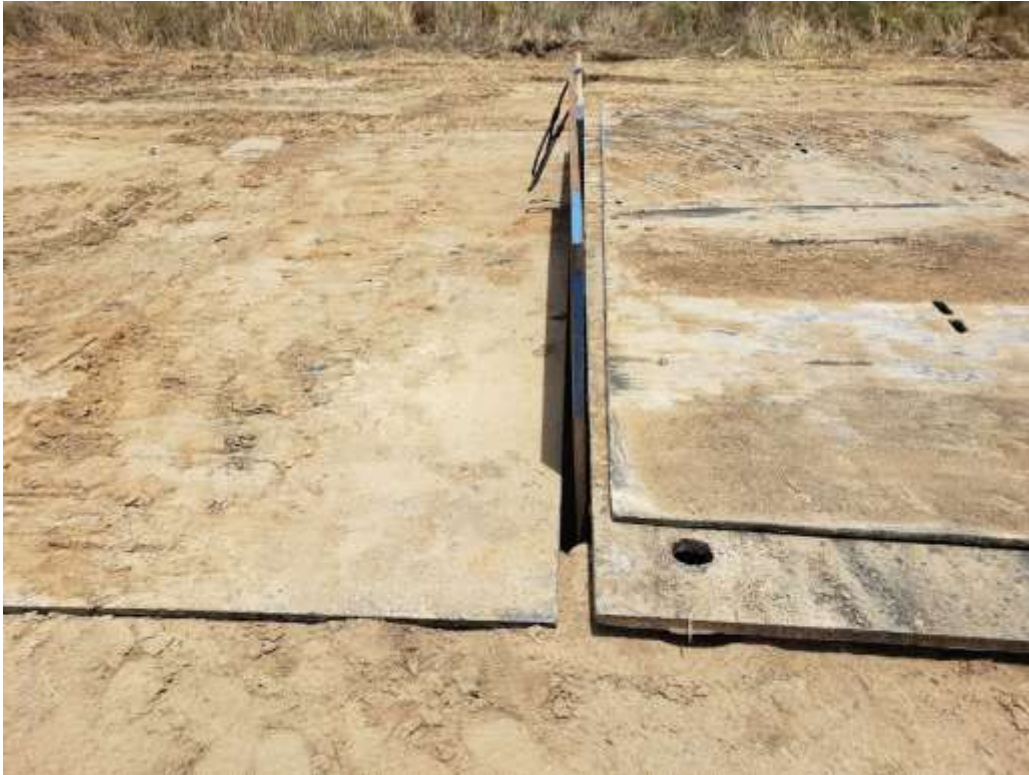
1. On June 11, CPUC EMs observed gaps between plates covering the open vault on the east side of Menifee Road near Construction Area UNK250 (see Photo 3). The SCE Environmental Manager was informed of the observations and responded with photos showing the vault gaps covered.

Photo 3 – Vault #3 excavation with gaps in steel plate coverings (June 11, 2019).

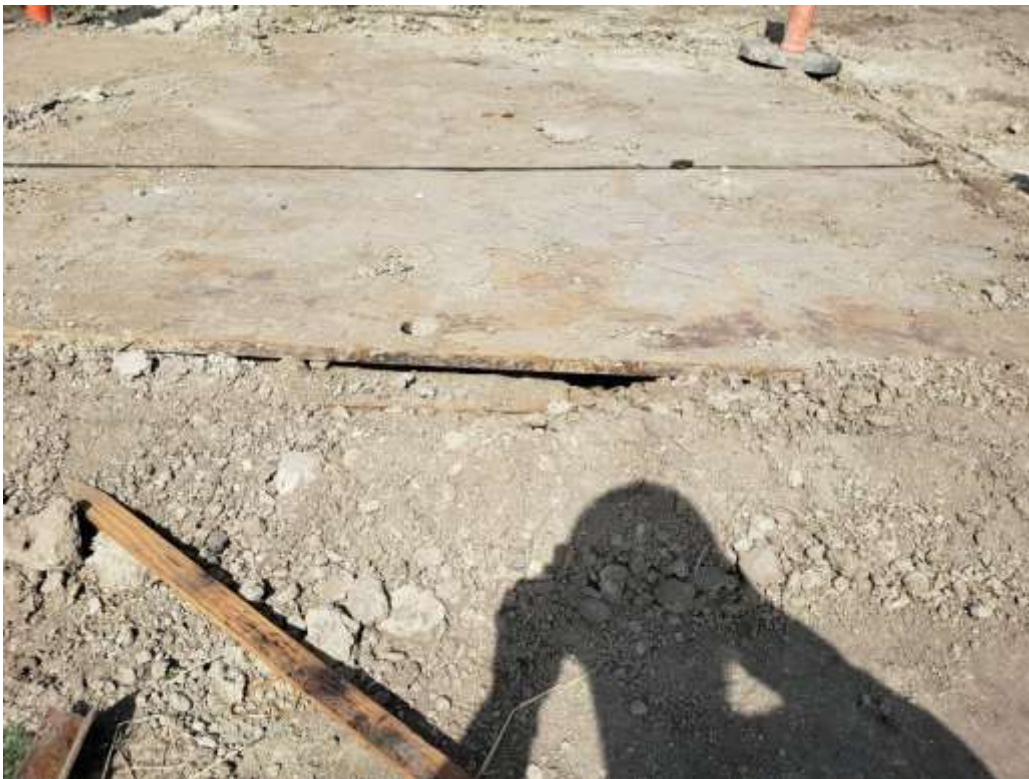
2. On June 18, the CPUC EM observed an open excavation at Construction Area UNK155 that had gaps between the foundation excavation and the covering (see Photo 4). The SCE Environmental Manager and the contractor's environmental manager were informed of the observation. The contractor's Environmental Manager sent the CPUC EM a photo of the excavation covered later in the day.

Photo 4 – Gaps between covering and excavation hole at Construction Area UNK155 (June 18, 2019).

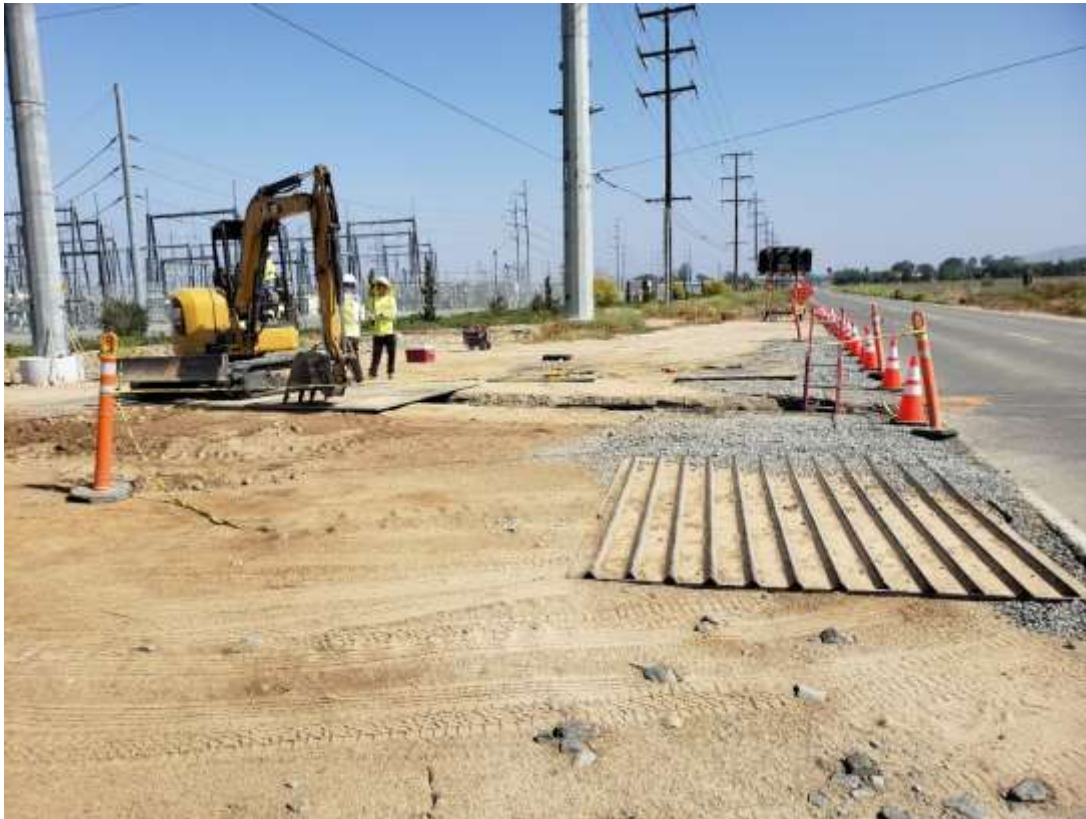
8. There were no SCE self-reported incidents and no CPUC incidents documented for construction activities throughout the monitoring period.
9. There were no SWPPP maintenance items associated with construction activities reported throughout the monitoring period. On June 11, CPUC EMs observed construction entrances adjacent on both sides of Menifee Road near Valley Substation that were not consistent with the SWPPP TC-1 requirements (Stabilized Construction Entrance) (see Photo 5). This issue, and rock accumulation on the shaker plates, was discussed with the SCE Environmental Manager via email the same day. During the June 18 site visit, the construction entrance remained sufficiently un-stabilized although the rock accumulation was taken care of (see Photo 5). As of the end of the monitoring period, the construction

Photo 5. Un-stabilized construction entrance on west side of Menifee Road near the underground trenching (June 18, 2019).

entrances remain inconsistent with the specifications listed in TC-1; however, on June 27, the SCE Environmental Manager noted that the subject entrances (and any future entrances where continued use would occur) would be stabilized in accordance with TC-1 requirements and that the SWPPP mapping would be updated.
