PROJECT MEMORANDUM SCE – VIEJO SYSTEM PROJECT

To: Michael Rosauer, CPUC
From: Vida Strong, Aspen Project Manager
Date: August 10, 2004
Subject: Weekly Report #1: August 1, 2004 – August 7, 2004
CPUC Environmental Monitor (EM): Christopher Meyer

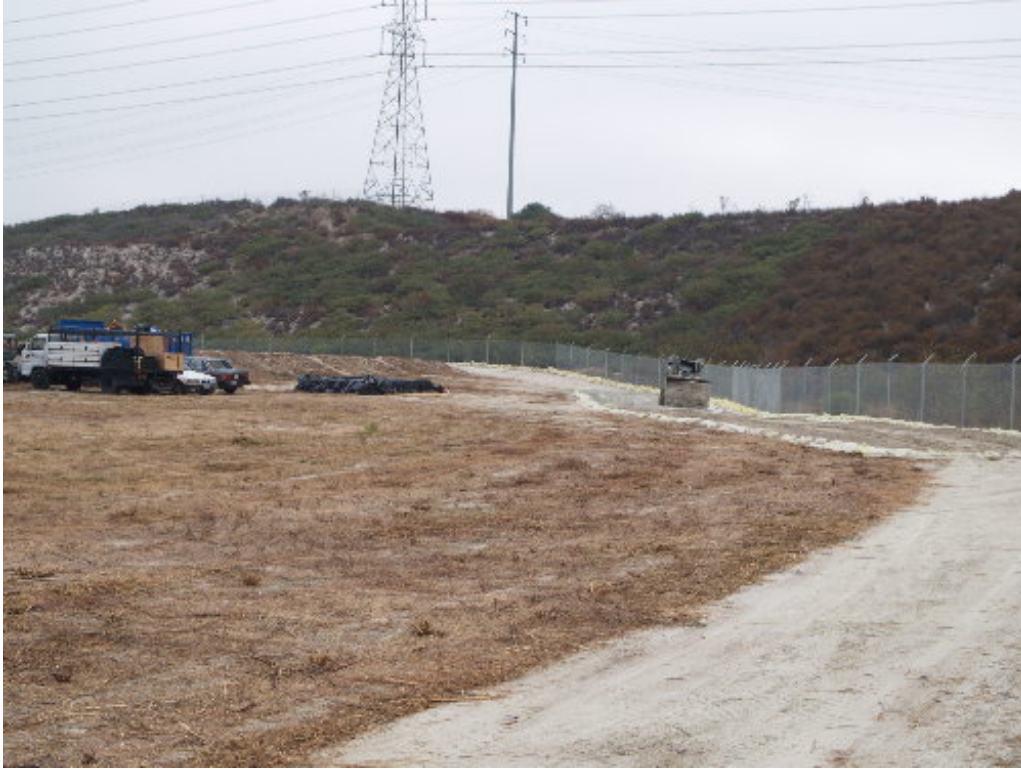
The LSA Environmental Inspector (EI) and the paleontological inspector were on-site to review the pre-construction status of the substation site with the CPUC EM. The LSA EI walked the site ahead of grubbing to flush whiptail lizards out of the project area. The sensitive resources on the hillside are separated from the construction activities by a cyclone fence (see Figure 1).

Figure 1 – Cyclone fencing surrounds the site and limits access to sensitive habitat on the adjacent hillside.

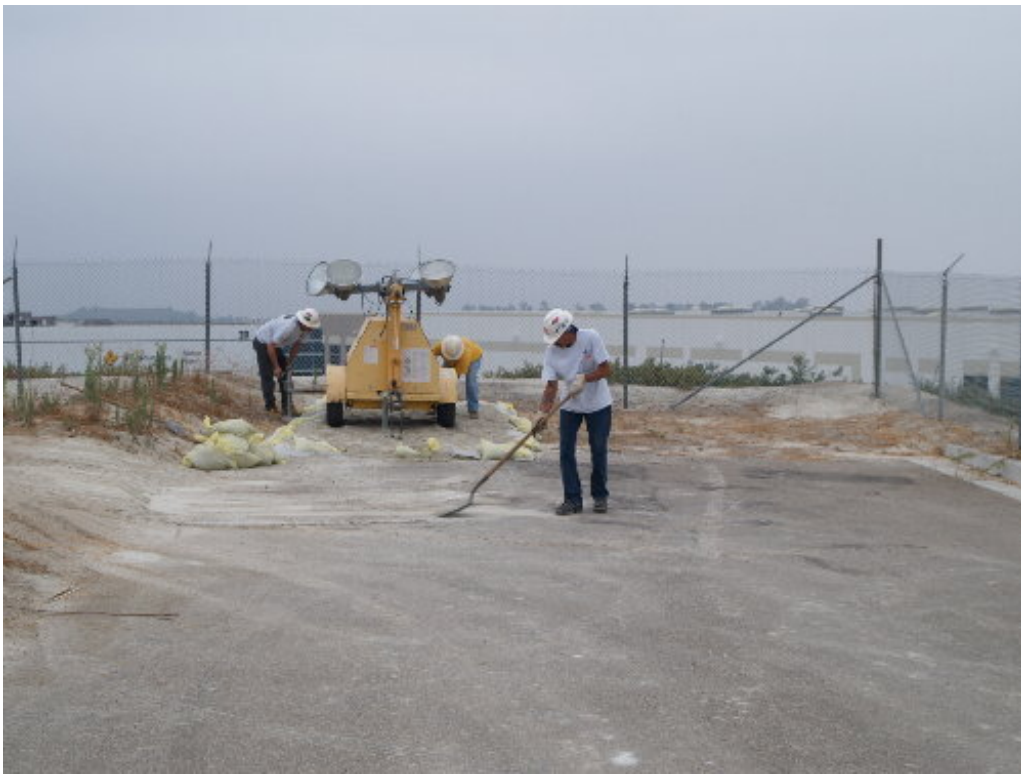
The portable light towers on-site were placed in sandbag containment structures; however, the structures were filled nearly to the top with loose sand. The idea was for the sand to absorb any leaking fluids, but also reduced the capacity of the containment basins (see Figure 2). The Construction Manager instructed the crews to place another row of sandbags around the structure to increase the volume. A containment area for working on equipment and parking graders, similar to the basins for the light towers, was created in the triangle area south of the main substation pad. Crews were working on capping one storm drain inside the pad area and were placing sandbags around the storm drains along the edge of the substation pad (see Figure 3). Filter fabric will be added to the storm drains during the subject week.

Figure 2 – Containment berm for the portable light plant filled with sand (contractor will place additional layer of sandbags to increase capacity of berm).

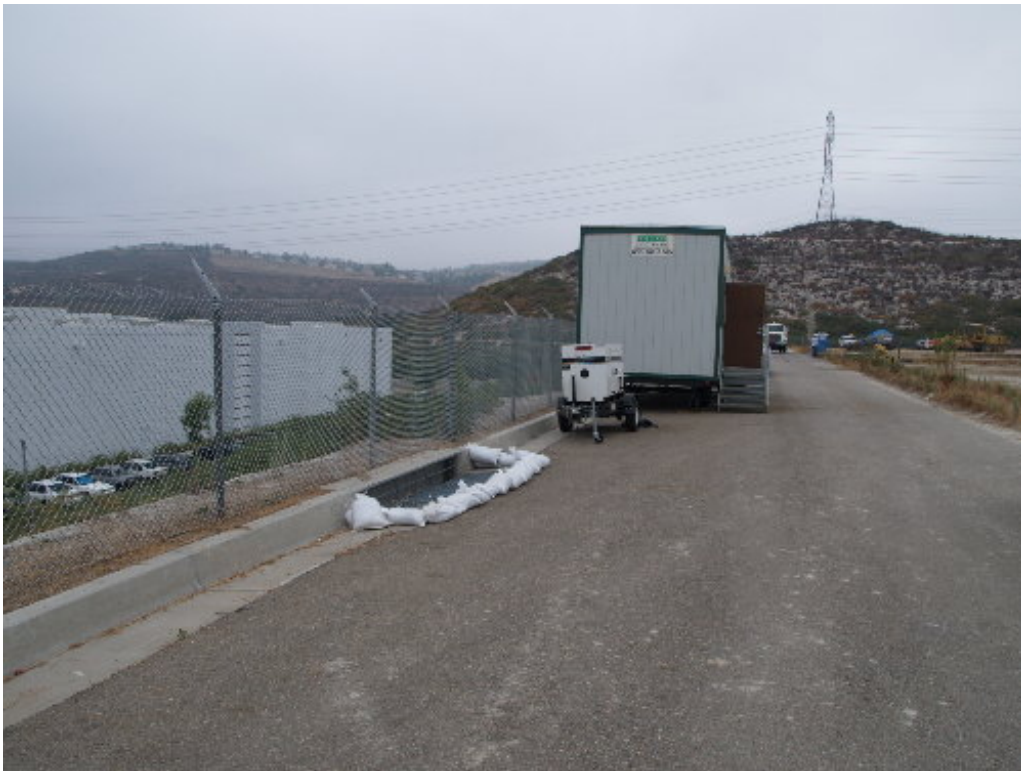
Figure 3 – Sandbags placed around storm drains.
Filter fabric will be placed over drain and secured by the sandbags.

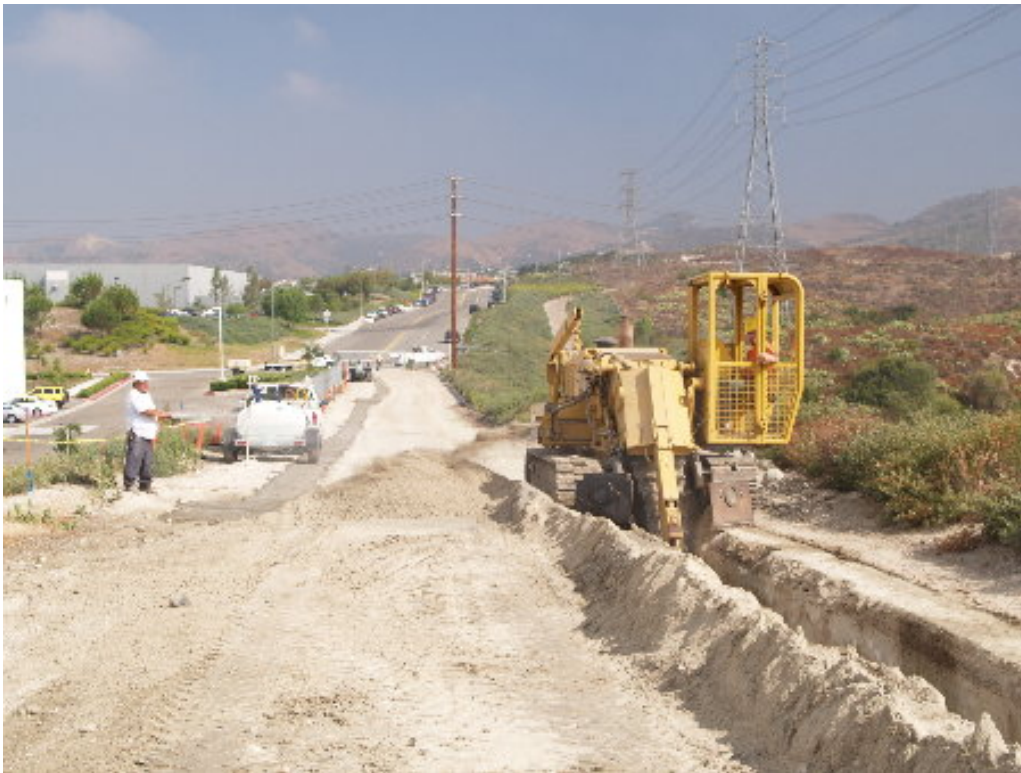
The only earthwork observed at the site was the trenching for the 66 kV line under the access road. A trenching machine was used on the straight segment of the access road and a backhoe was used on the curve (see Figure 4). A water trailer was used at both locations to control fugitive dust (see Figure 5). A second trench along the access road for site utilities had been excavated and backfilled prior to the site visit by the CPUC EM. The trenches will be backfilled with a concrete slurry and the displaced soil will be used to fill low areas on the substation site.

Figure 4 – Trenching machine operating down access road for future 66 kV connection.
Utility connection already made and trench backfilled with a grout slurry
(see trenchline along the roadway).

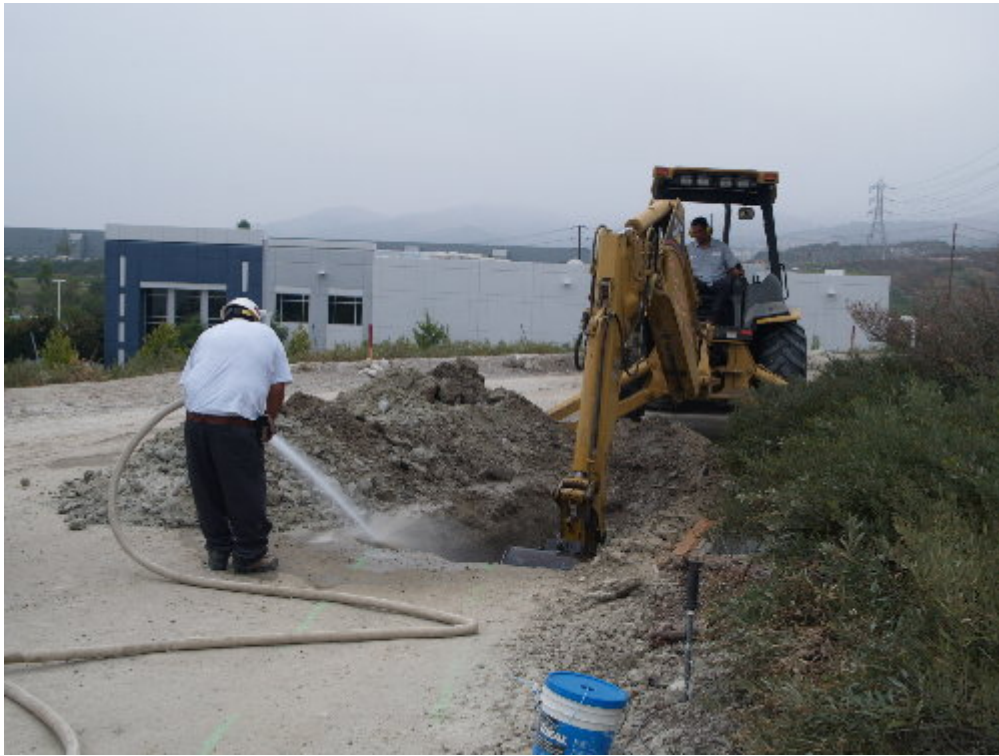
Figure 5 – A trailer-mounted water system was used to control fugitive dust during the trenching operation.
