## **PROJECT MEMORANDUM SCE – VIEJO SYSTEM PROJECT**

**To:** Michael Rosauer, CPUC  
**From:** Vida Strong, Aspen Project Manager  
**Date:** August 18, 2004  
**Subject:** Weekly Report #2: August 8, 2004 – August 14, 2004  
**CPUC Environmental Monitor (EM):** Christopher Meyer

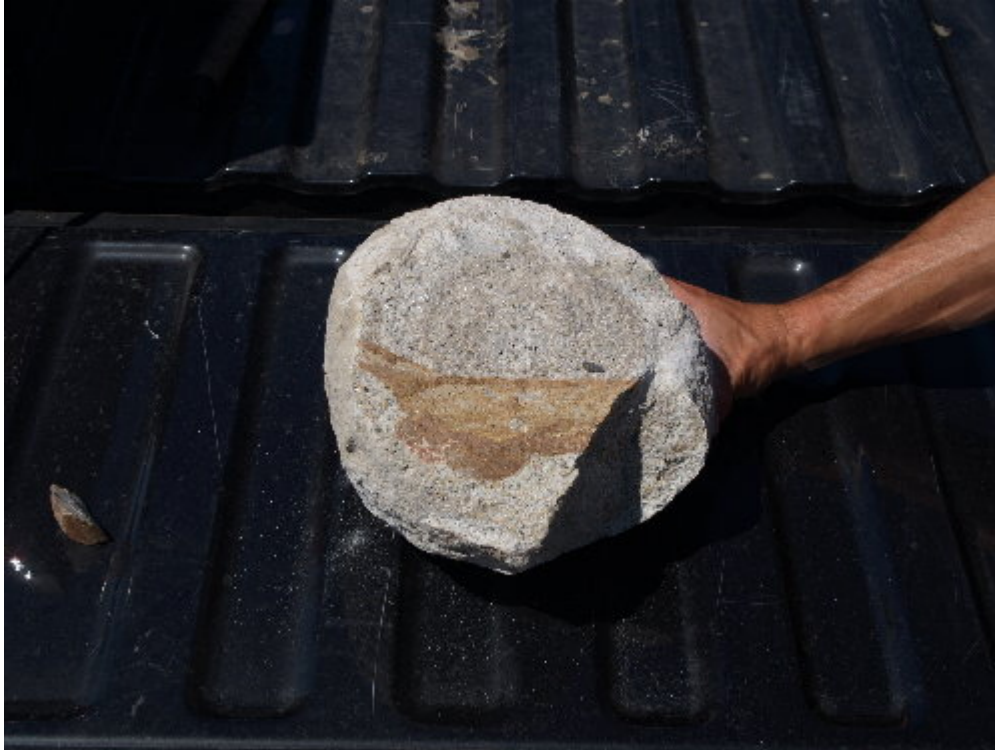
The paleontological inspector was on-site to monitor grading activities at the substation site. Two fossils were discovered during grading activities, a fish fossil (see Figure 1) and a fragment of sea cow bone. The pad for the site has been severely disturbed and it is very likely that the fossil has been moved from its original location prior to the start of project construction. The site vegetation has been removed and LSA Environmental Inspector will not be on-site full-time. The sensitive resources on the hillside are separated from the construction activities by a cyclone fence.

**Figure 1** – Fish fossil discovered during grading of the substation site by paleontological inspector.

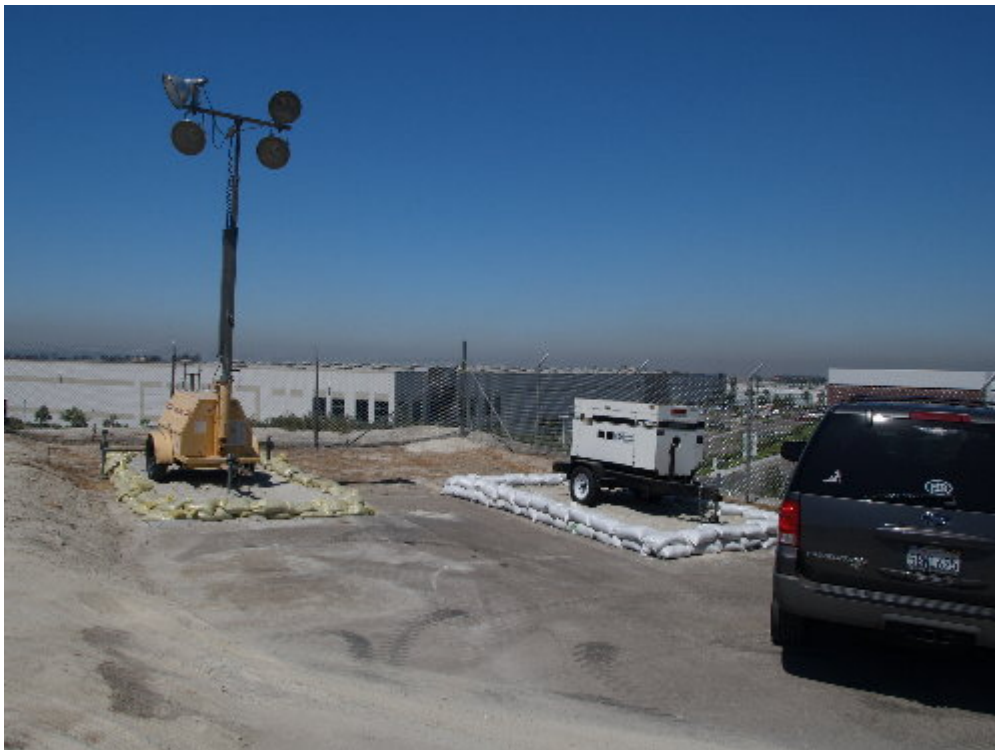
The crews have placed another row of sandbags around the structures to increase the volume containment structures for the portable light towers and storage areas in response to the comments from the previous week (see Figure 2). Crews had added filter fabric to the sandbag structures around the storm drains along the edge of the substation pad.

**Figure 2** – Containment berm for the portable light plant increased with additional layer of sandbags.

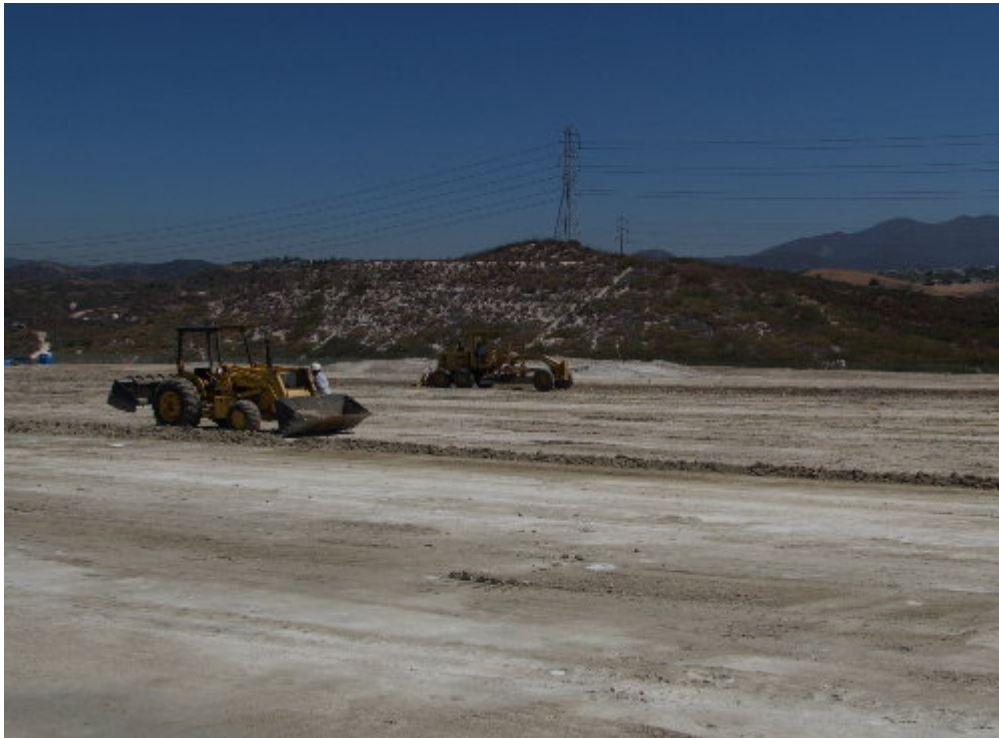
The only earthwork observed at the site was grading on the west section of the pad (see Figure 3). The operators reported that the soil compacted very well but is filled with rocks that must be removed. A water truck was on-site to address fugitive dust (see Figure 4). The electric conduit trench along the access road was being backfilled with concrete slurry and the proper washout site was located on the substation site (see Figure 5).

**Figure 3** – Operators worked with a motor grader and backhoe to grade the site and remove larger rocks.

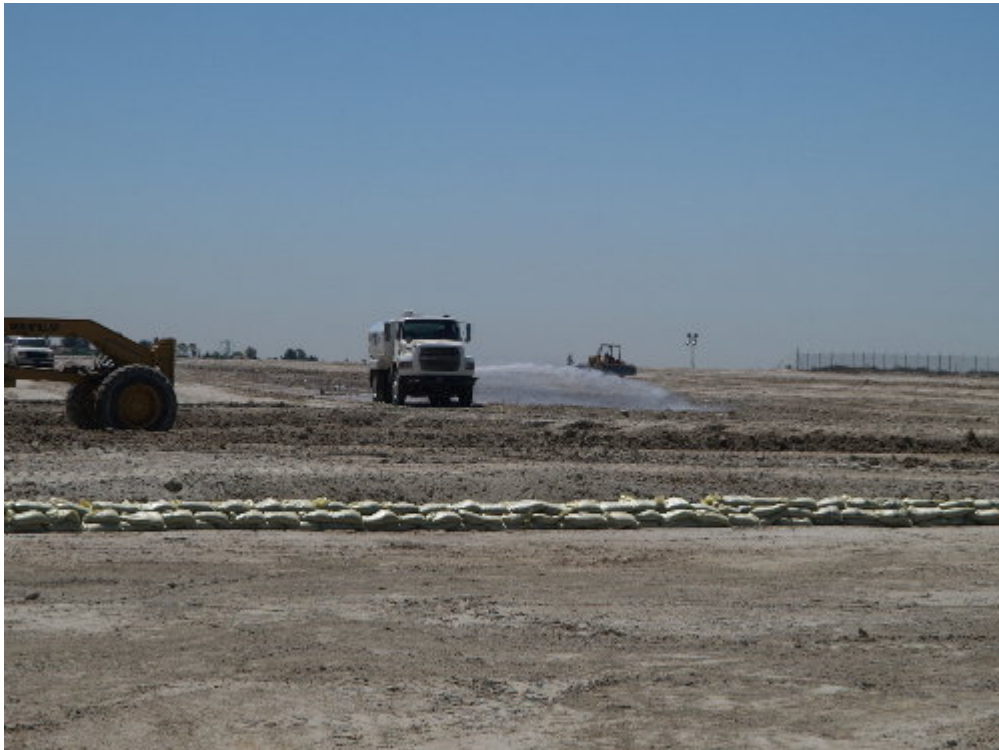
**Figure 4** – Water truck working at substation site to control fugitive dust.

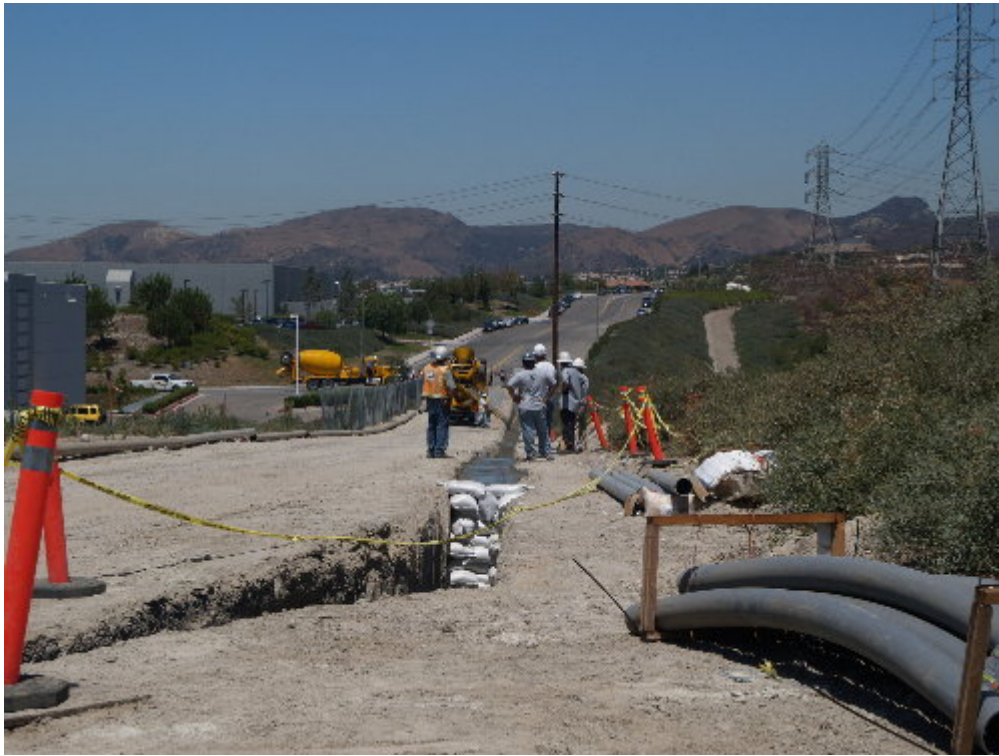
**Figure 5** – The electric conduit trench along the access road was being backfilled with concrete slurry.
