PROJECT MEMORANDUM SCE – VIEJO SYSTEM PROJECT

To: Jensen Uchida, CPUC
From: Vida Strong, Aspen Project Manager
Date: February 1, 2005
Subject: Weekly Report #26: January 23, 2005 – January 29, 2005
CPUC Environmental Monitor (EM): Christopher Meyer

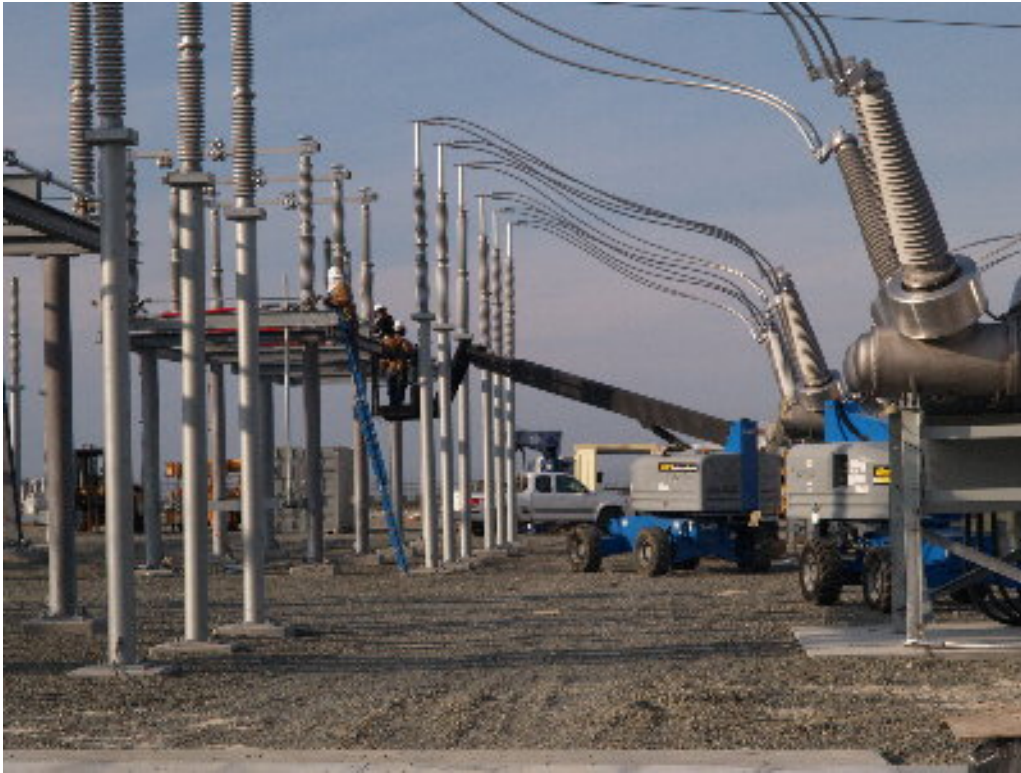
A small crew worked with a lift to prepare sections of the 220 kV circuit (see Figure 1). The concrete pouring crew placed concrete in the 12 kV foundations, set the anchor bolts, and finished the surface (see Figure 2). The concrete trucks for the operation were correctly washing out in the southern extra workspace (see Figure 3).

Figure 1 – A small crew worked with lifts to prepare the 220 kV circuits.

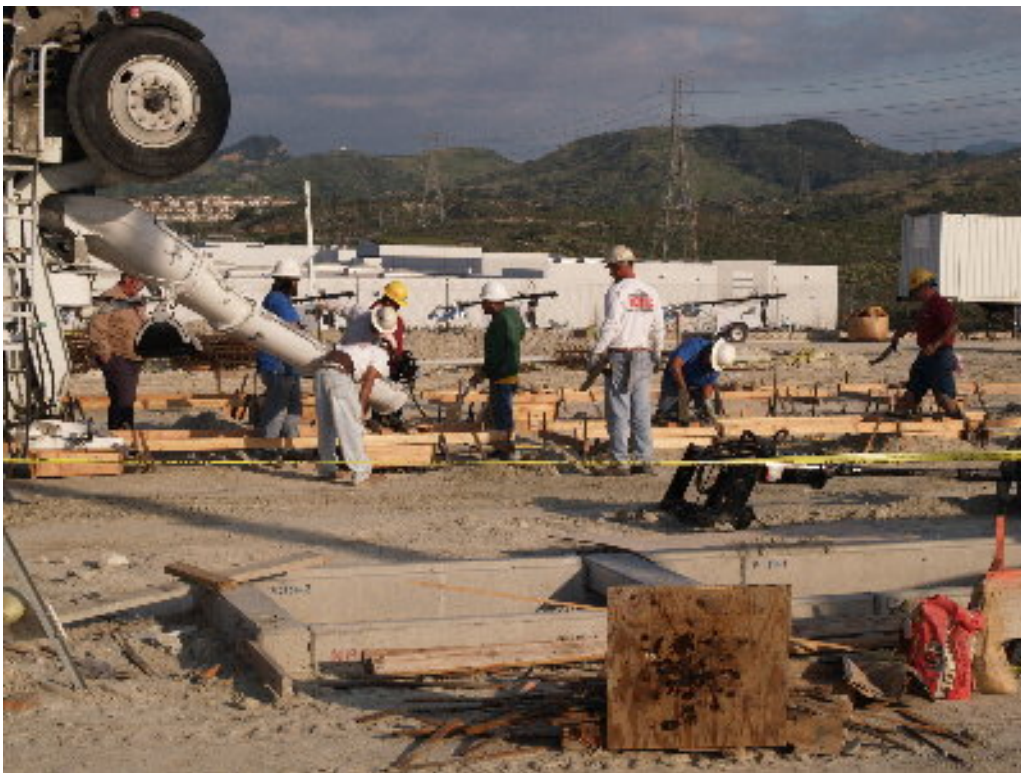
Figure 2 – The 12 kV foundations were poured and the anchor bolts set.

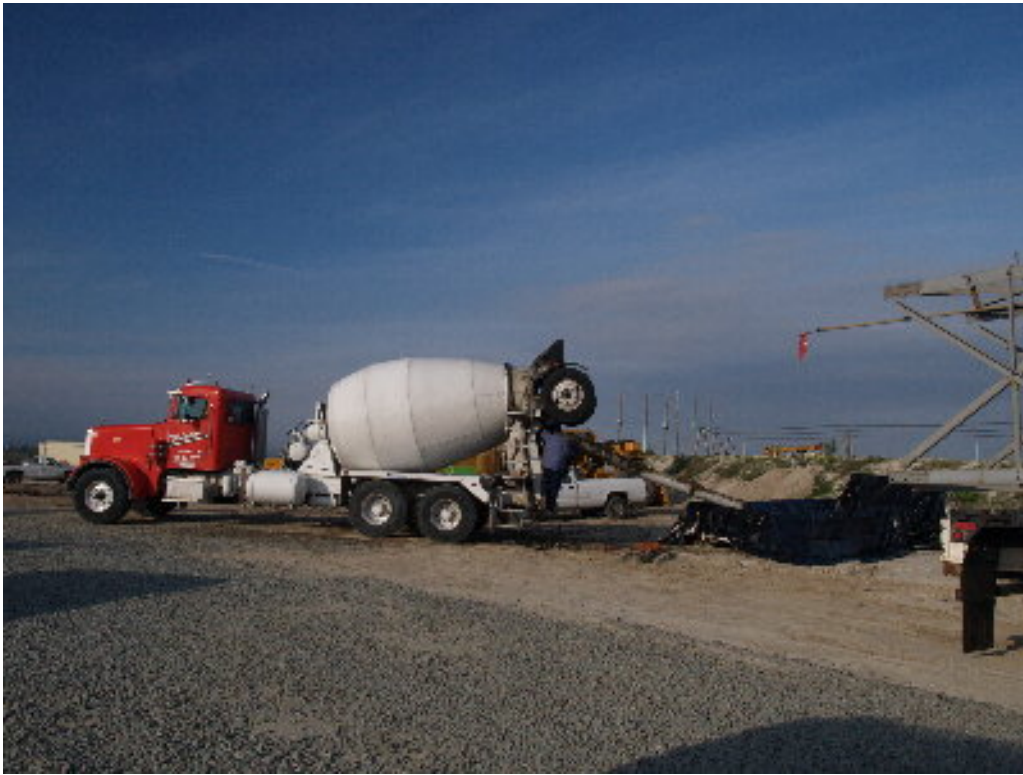
Figure 3 – The concrete drivers correctly washed-out in the prepared area after pouring the 12 kV foundations.

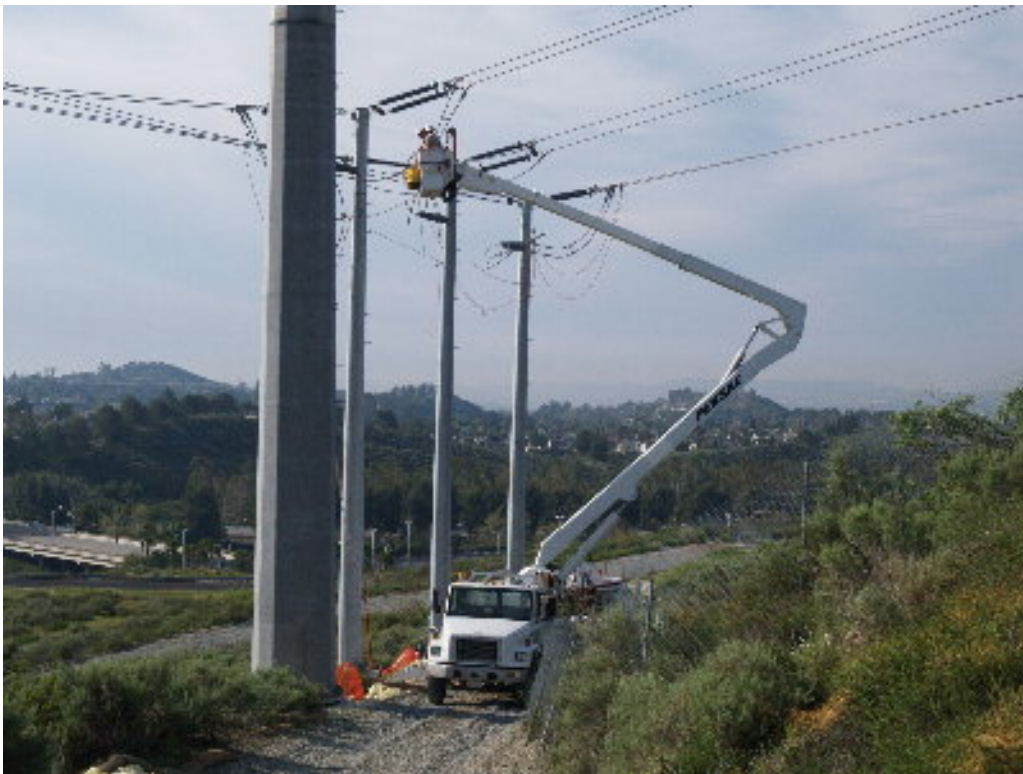
Several crews were working on the 220 kV transmission line right-of-way during the CPUC EM site visit to complete work within the outage period. Two crews worked in man-lifts to attach cable to the insulators on the center and southern towers (see Figure 4). A crew worked to attach the connections to the ends of the measure cable prior to lifting them into place (see Figure 5).

Figure 4 – The transmission line crews worked in man-lifts to attach cable to the insulators.

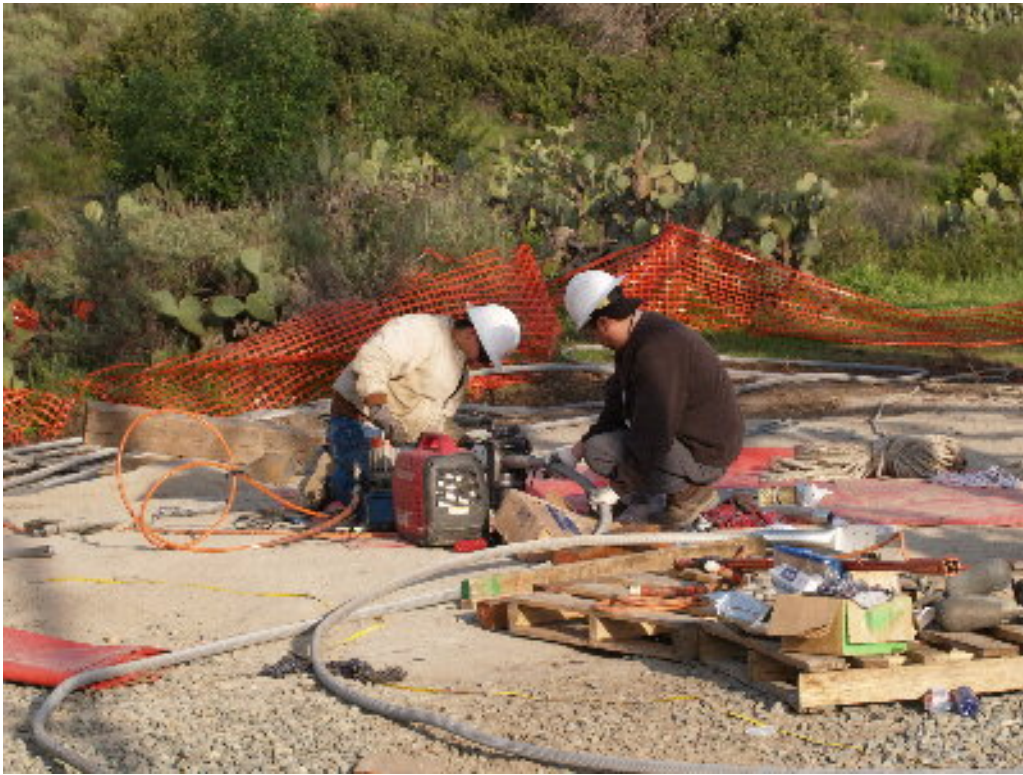
Figure 5 – Workers on the 220 kV transmission line attached connectors to the measured cable.

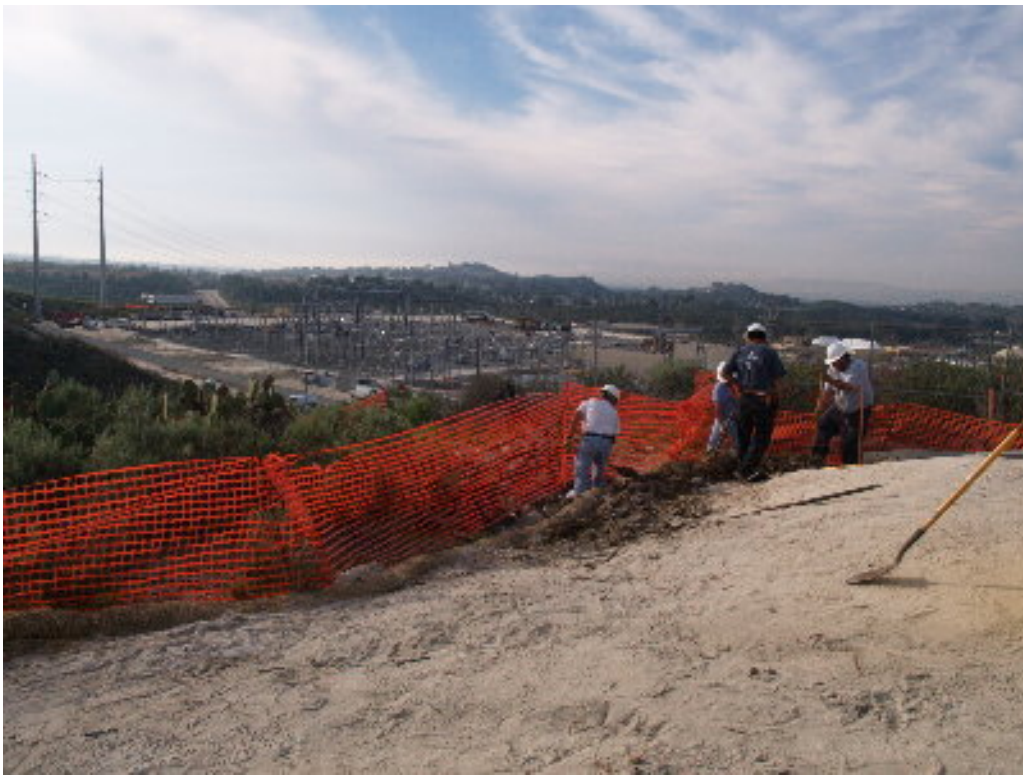
A small crew worked throughout the 220 kV transmission line segment installing and repairing BMPs. Silt fencing was being installed at the northern lattice tower during the site visit (see Figure 6). Some of the fencing placed prior to the site visit is a type of ground-cloth not designed to be used as silt fencing. Some of this cloth was used across a small drainage and on a slope (see Figure 7). The SCE Biologist will address the proper use of silt fencing to prevent resource damage in case of a storm event. Gravel was being placed or spread on the access road.

Figure 6 – A small crew installed silt fencing on the 220 kV transmission line corridor.

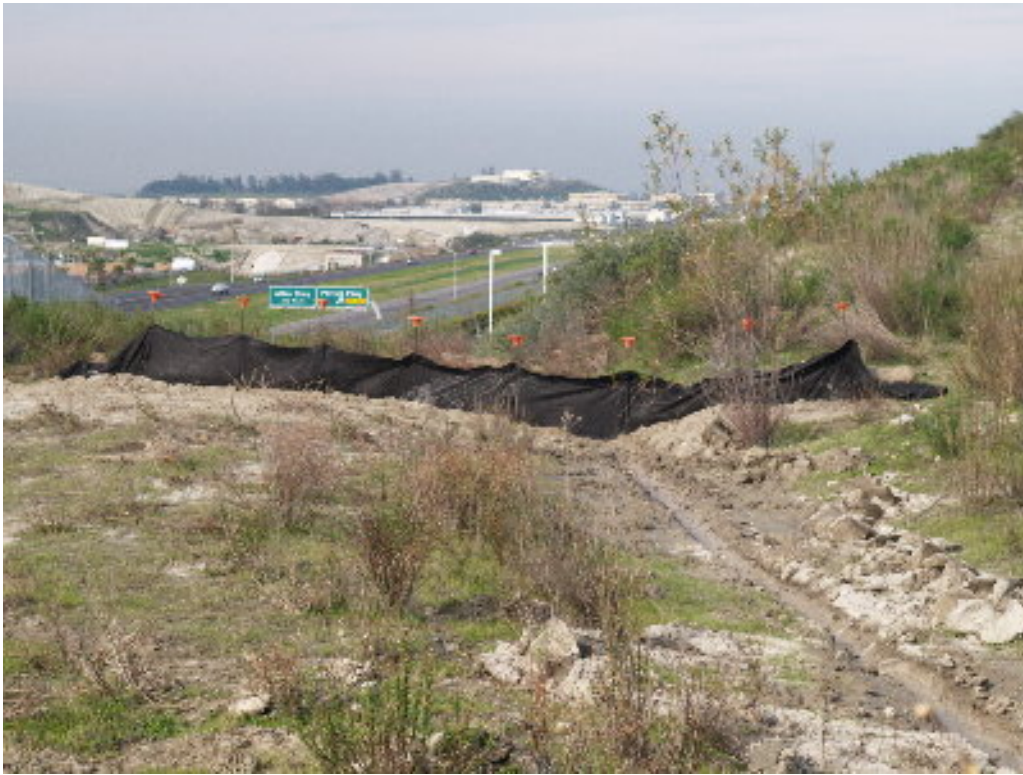
Figure 7 – A dense fabric was used as silt fencing across a small drainage. It will be replaced with appropriate BMPs.

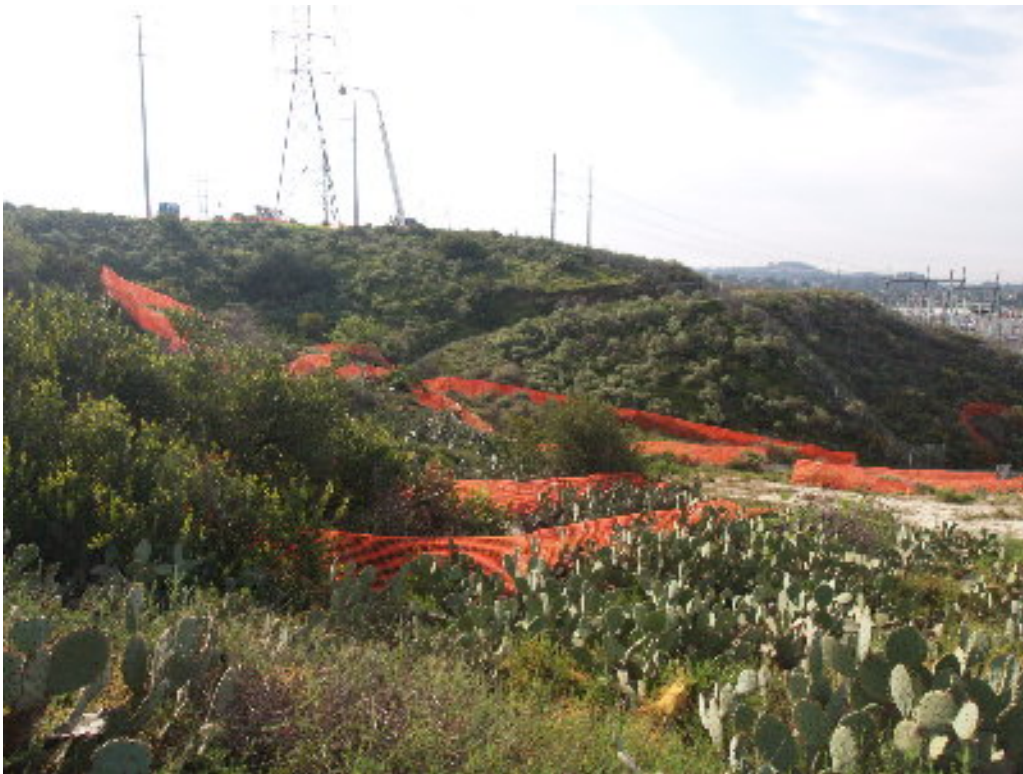
The CPUC EM met with the SCE Biologist to review the habitat fencing and access roads for the 66 kV transmission line segment adjacent to the substation site (see Figure 8). Some of the habitat fencing may need to be altered due to the type of equipment used by the contractor. Any shifts in the footprint of the fencing that remain within the studied Area of Potential Effect (APE) will be addressed in the field with the CPUC EM.

Figure 8 – Biological exclusion fencing has been placed in preparation for construction on the 66 kV segment.
