PROJECT MEMORANDUM SCE – VIEJO SYSTEM PROJECT

To: Jensen Uchida, CPUC
From: Vida Strong, Aspen Project Manager
Date: March 22, 2005
Subject: Weekly Report #33: March 13 – March 19, 2005.
CPUC Environmental Monitor (EM): Christopher Meyer

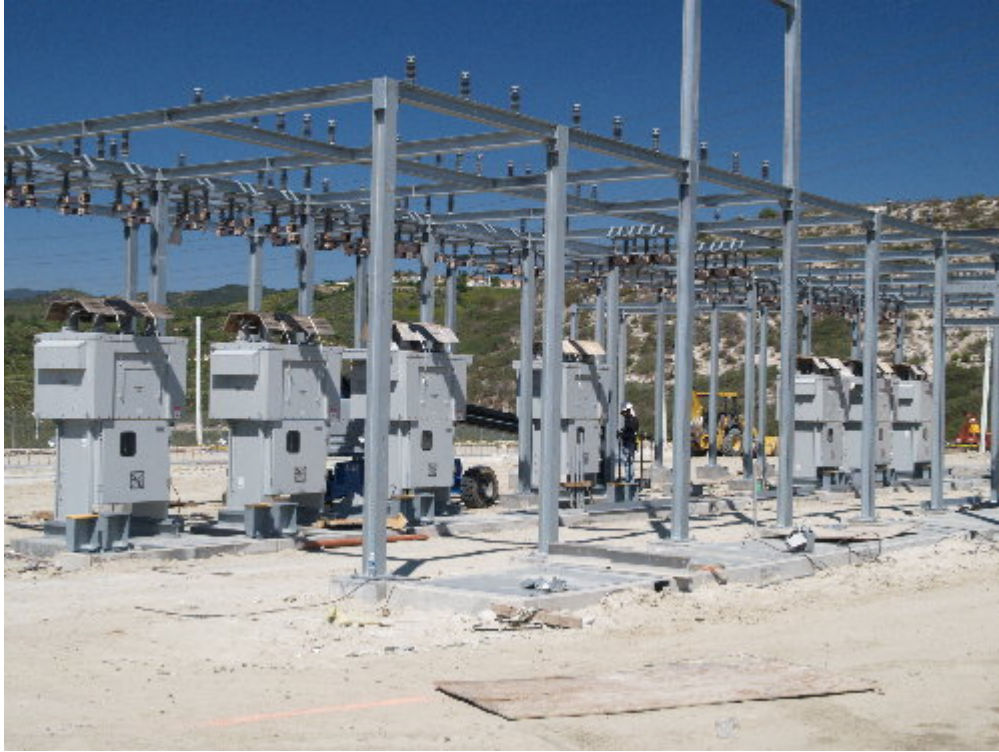
Figure 1 – The disconnects for the 12 kV portion of the substation site have been set.

1. SCE continued working on the A-bank transformers and preparing the second A-bank transformer during the site visit.
2. The disconnects for the 12 kV section of the substation have been set on their foundations and will be connected to the system (see Figure 1).

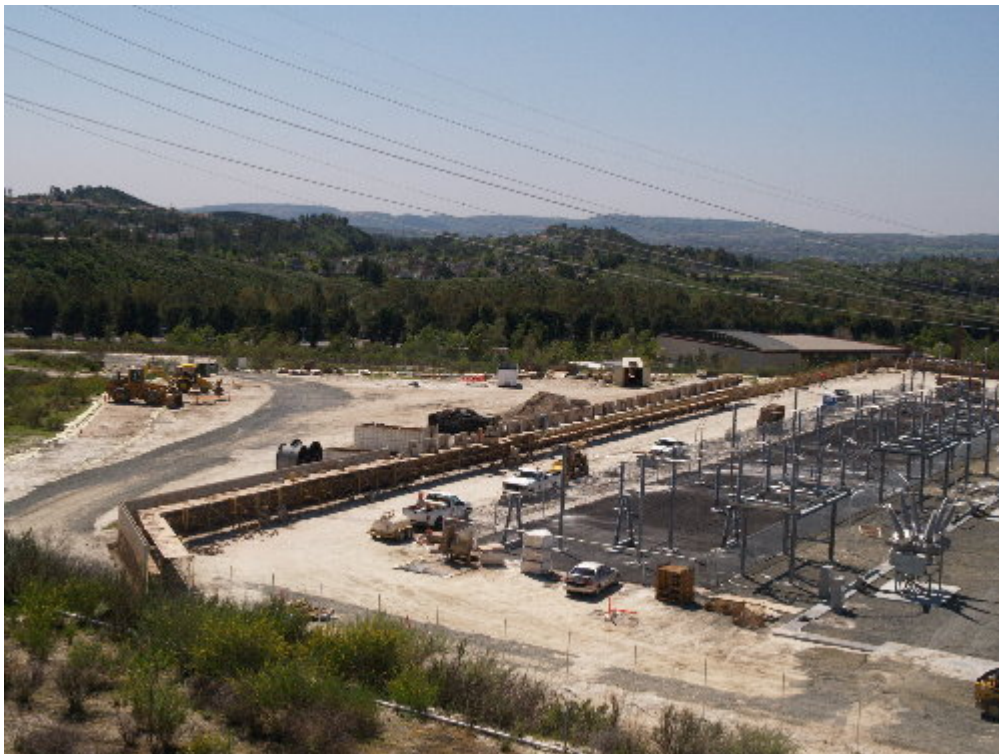
Figure 2 – A specialized crew with Reycon set the upper section of concrete blocks on the south side of the substation during the site visit.

3. Union has completed the excavation and pouring of the foundation for the block wall that will eventually surround the substation site and their subcontractor, Reycon, worked to set the second level of concrete blocks during the site visit (see Figure 2). The wall has been grouted to approximately 3 feet in elevation; however, a section of the wall was poured after being inspected by the Deputy City Inspector before the City informed SCE that the City Inspector was required to sign off on the inspection personally. The pattern of the wall can be seen now that the upper level has been set (see Figure 3). Ramparts will be added to the wall at intervals, as a design feature, once the blocks have been set.

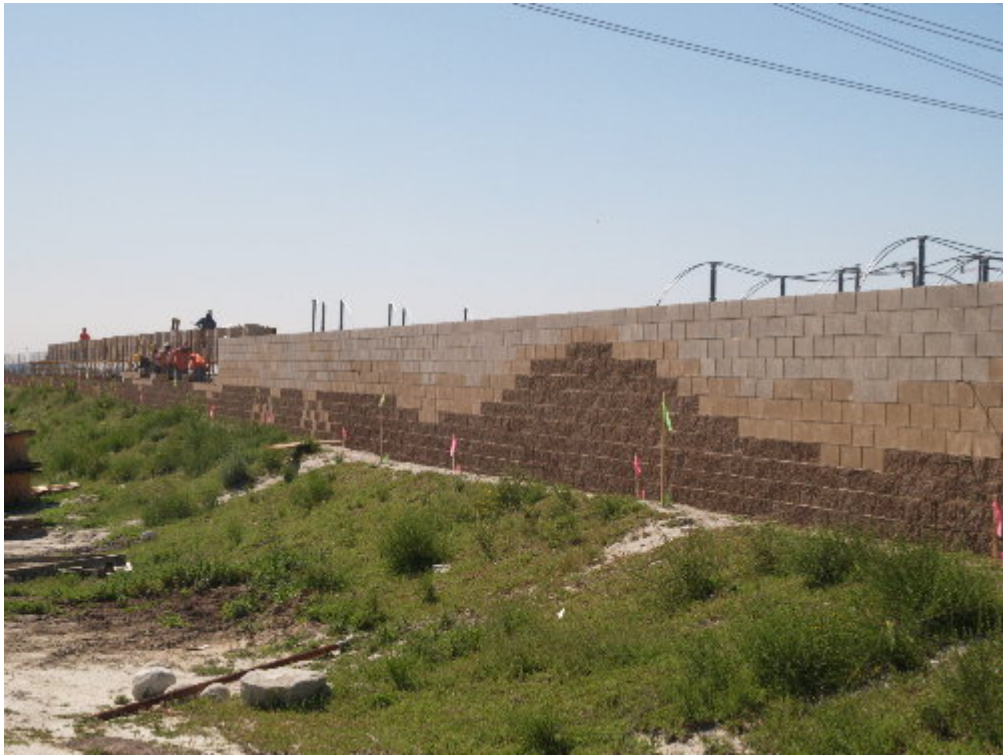
Figure 3 – The pattern of the block wall can be seen now that the upper level has been set. The berm in the foreground will be removed to maintain the required wall height.

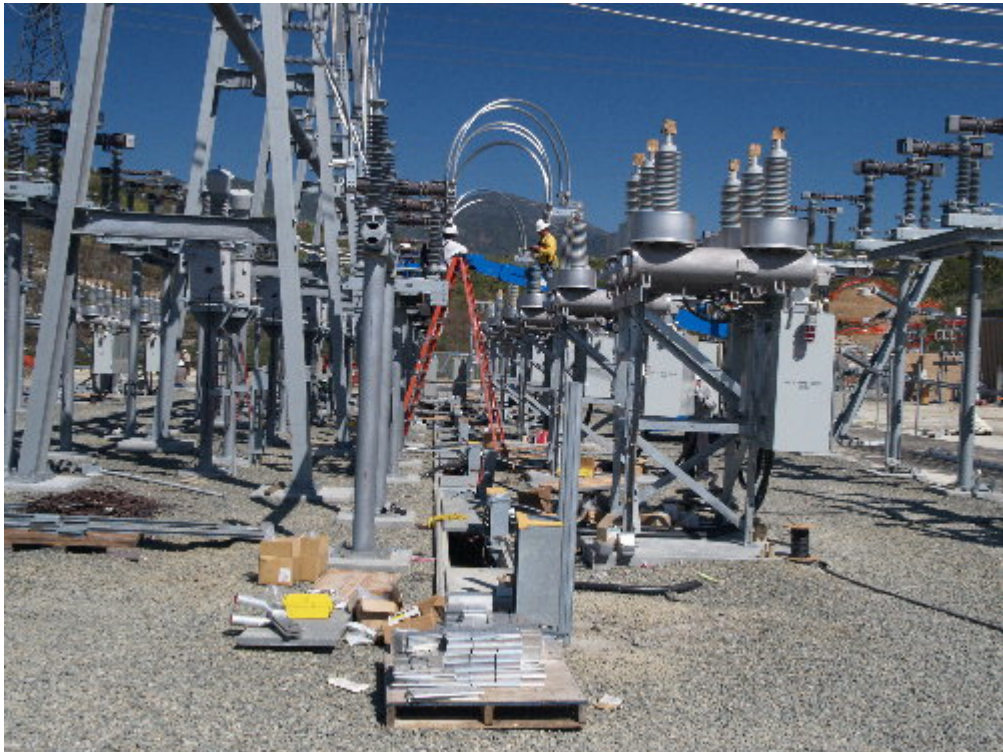
Figure 4 – A small crew with NRG worked on connections on the 66 kV portion of the substation site.

4. Several small crews with NRG worked on the 66 kV section of the substation site to connect various components to the system (see Figure 4).
5. The poles for the cyclone fencing that will be on the eastern side of the substation site were being set during the site visit (see Figure 5).

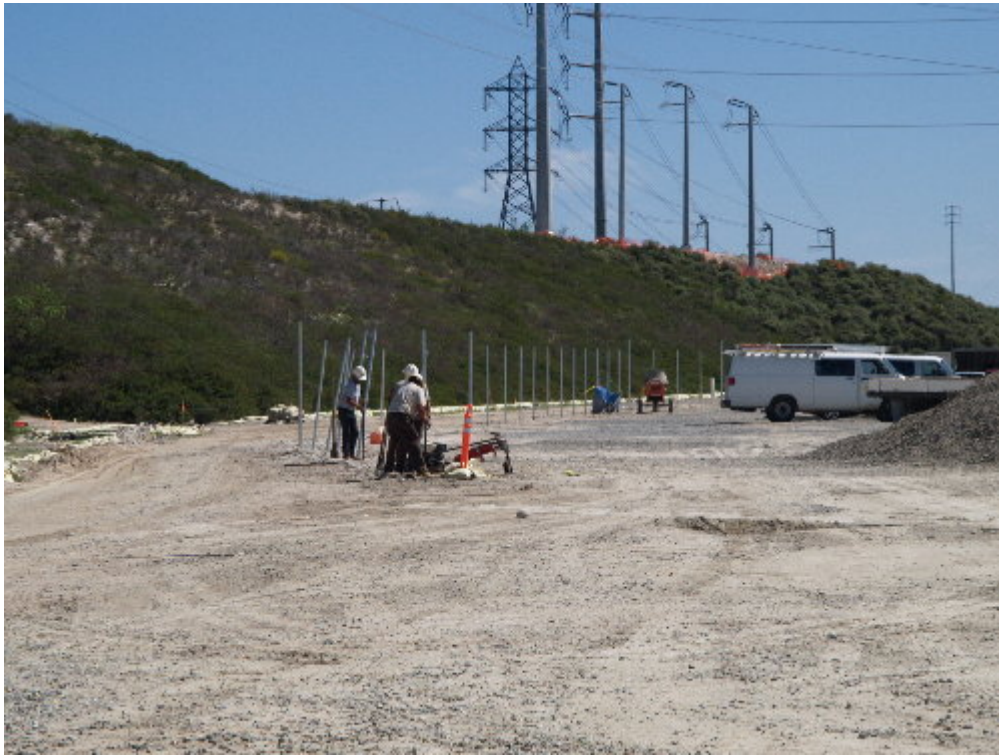
Figure 5 – The poles for the cyclone fence were being set during the site visit. The cyclone fencing will only be on the eastern portion of the substation site and will not be visible from the public right-of-way.
