PROJECT MEMORANDUM SCE – VIEJO SYSTEM PROJECT

To: Jensen Uchida, CPUC
From: Vida Strong, Aspen Project Manager
Date: June 1, 2005
Subject: Weekly Report #43, May 22 – May 28, 2005.
CPUC Environmental Monitor (EM): Christopher Meyer

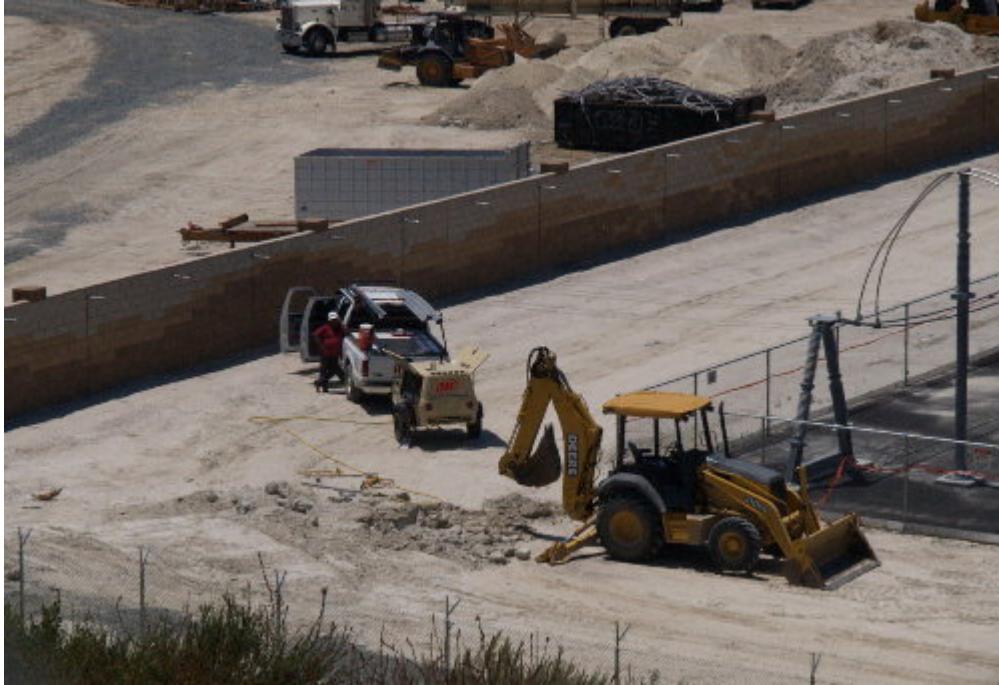
2. KGC crews continued working to excavate foundation for additional light standards within the substation site (see Figure 1). Most of these foundations have been formed and poured, or are ready for concrete pours that will occur the following week.

Figure 1 – NRG crews worked on excavating for light standards during the site visit.

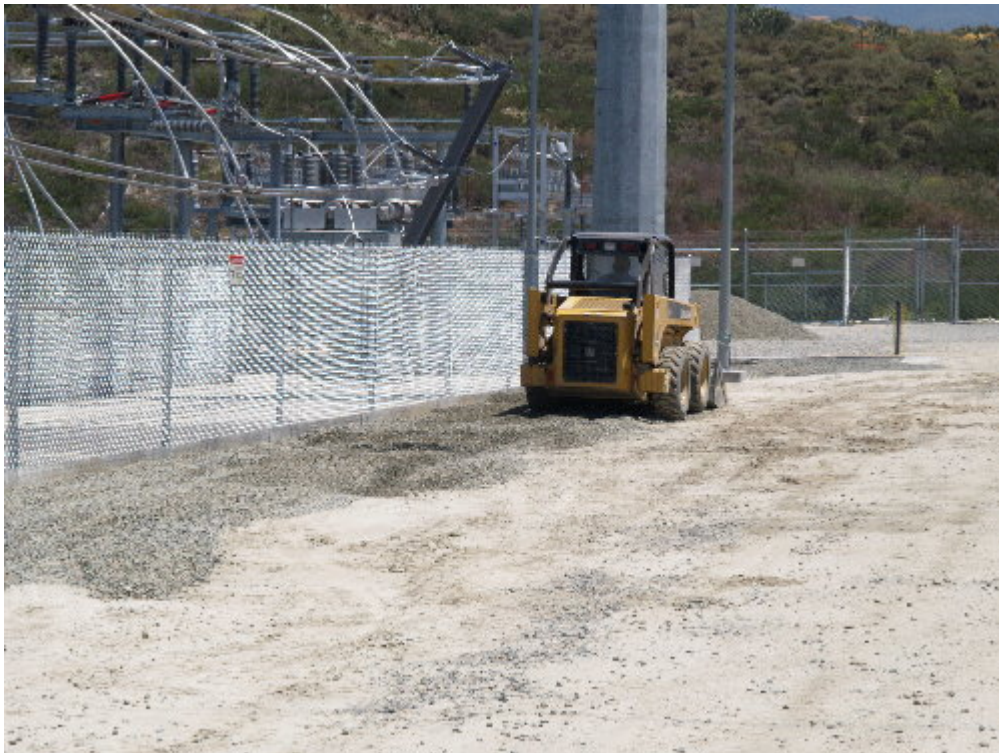
3. A small crew worked to spread rock around the completed sections of the substation site (see Figure 2). The sections of the 66 kV portion of the substation site that will be energized have been fenced and the rock placed up to the fenceline.

Figure 2 – Rock was placed around completed structures within the substation site.

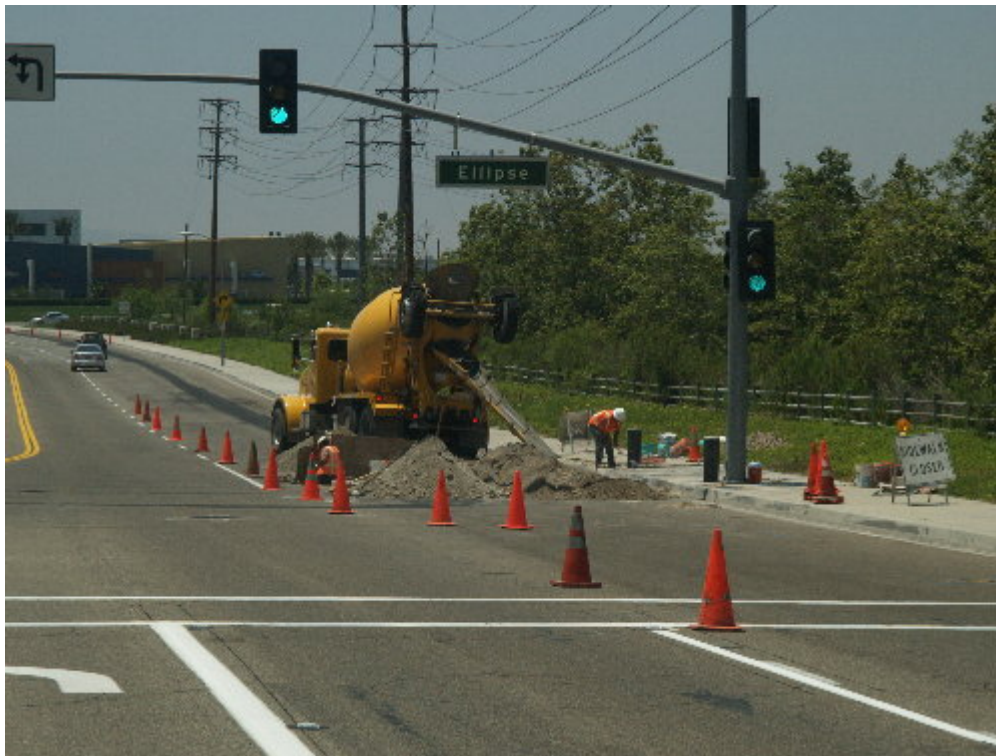
4. A crew with Arizona Pipeline worked on Definition Road finishing the insides of the vaults for the 12 kV buried cables connecting the substation to the distribution network. The crew cleaned the interior of the vaults and painted areas that could not easily be cleaned. A crew also worked to install the vents and vent pipes for the underground vaults (see Figure 3).

Figure 3 – Arizona Pipeline installed the vents and vent piping for the 12 kV vaults.

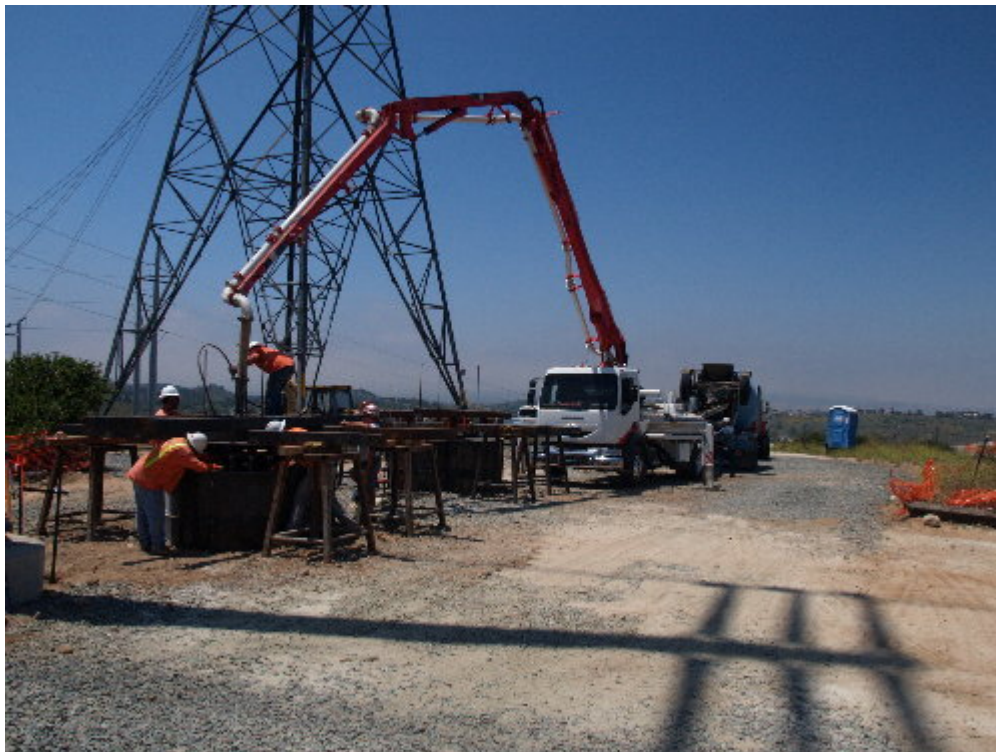
1. A crew worked with a concrete pumper to pour the second foundation for H-Structure 12 (see Figure 4). The structures are numbered 1 through 13, with Structure 13 immediately adjacent to the Viejo Substation. The first of the two foundations for Structure 13 has been poured and a curing agent added to the surface. Each batch of concrete was inspected and a sample collected for testing (see Figure 5).
2. The excavations for the H-structure nearest the substation site, Structure 13, was completed but then determined to have been incorrectly placed. The two excavations were backfilled with a two-sack slurry the previous week and the foundations will be re-excavated with the correct angle.

Figure 4 – Arizona Pipeline poured the second foundation for H-Structure 12 during the site visit.

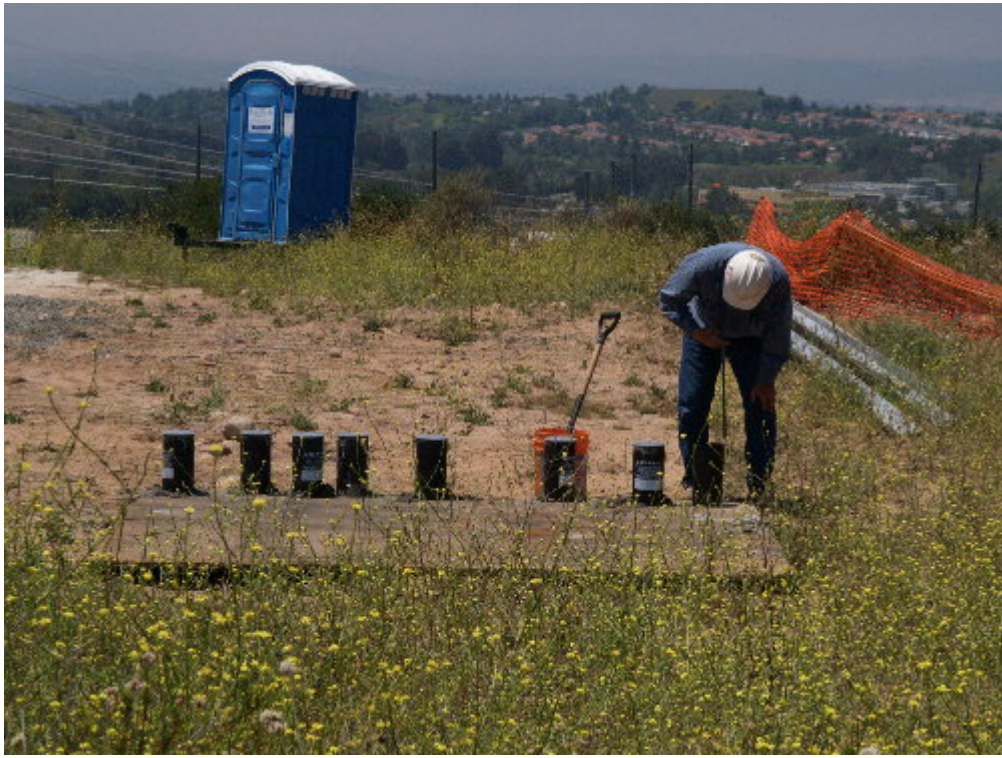
Figure 5 – Each batch of concrete is inspected and samples collected for testing.
