PROJECT MEMORANDUM SCE – VIEJO SYSTEM PROJECT

To: Jensen Uchida, CPUC
From: Vida Strong, Aspen Project Manager
Date: June 7, 2005
Subject: Weekly Report #44, May 29 – June 4, 2005.
CPUC Environmental Monitor (EM): Christopher Meyer

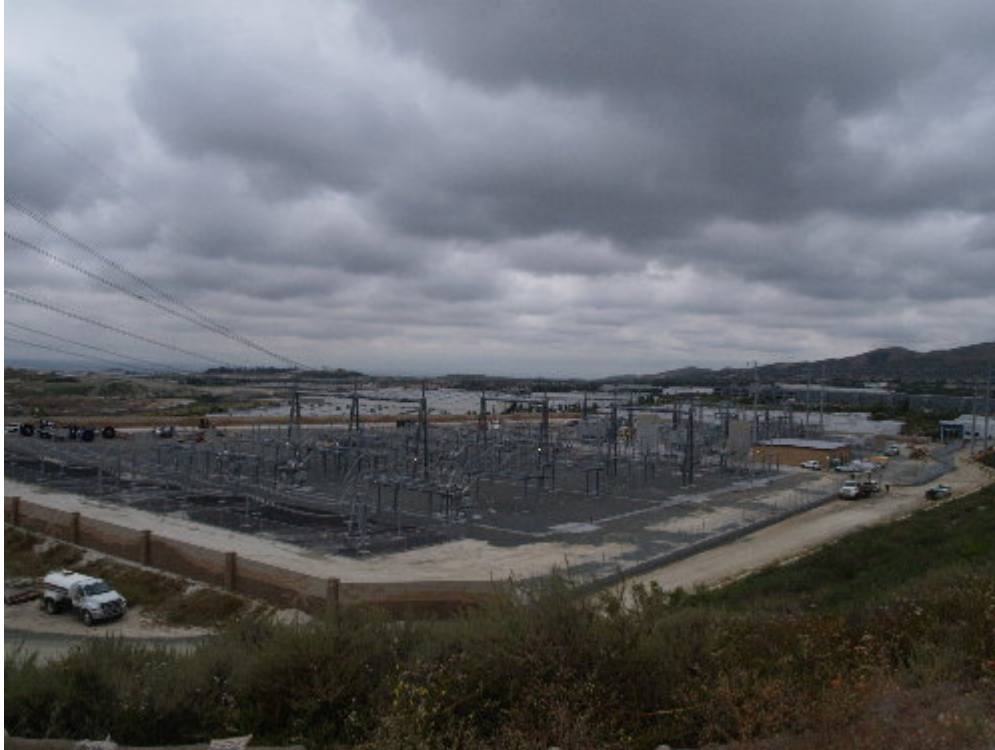
Figure 1 – Overview of the substation site after the 220 kV and 66 kV portions have been energized (66 kV section energized on May 31st).

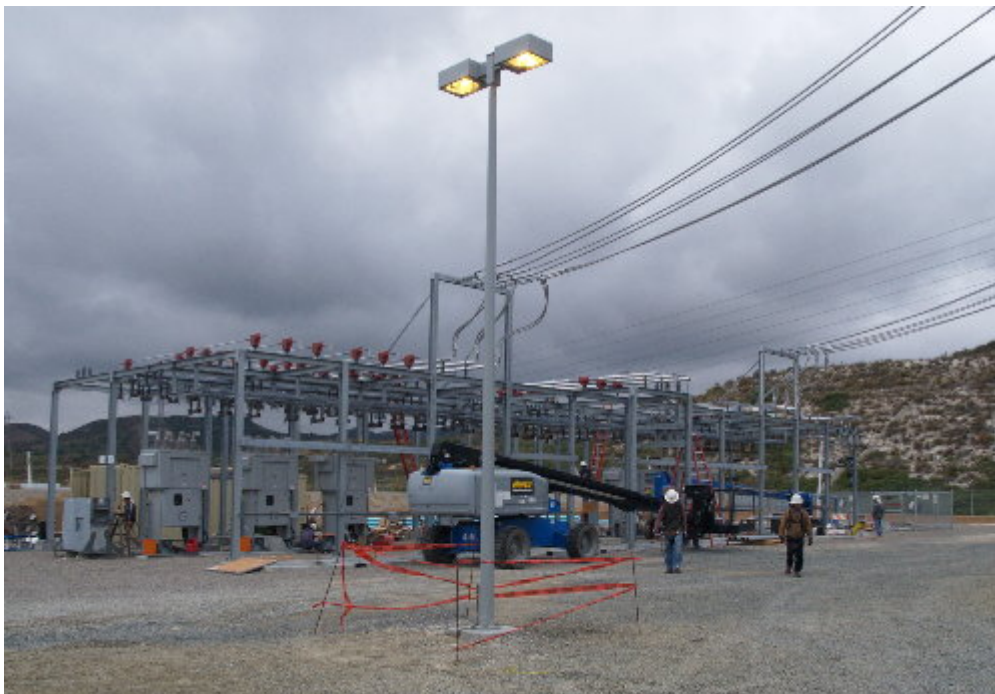
1. Several small NRG crews worked on making connections within the 12 kV section of the substation site. The crews focused on the disconnects and associated systems during the site visit (see Figure 2). The 66 kV section of the substation has been energized and is marked by safety tape.

Figure 2 – NRG worked on the disconnects for the 12 kV portion of the substation.

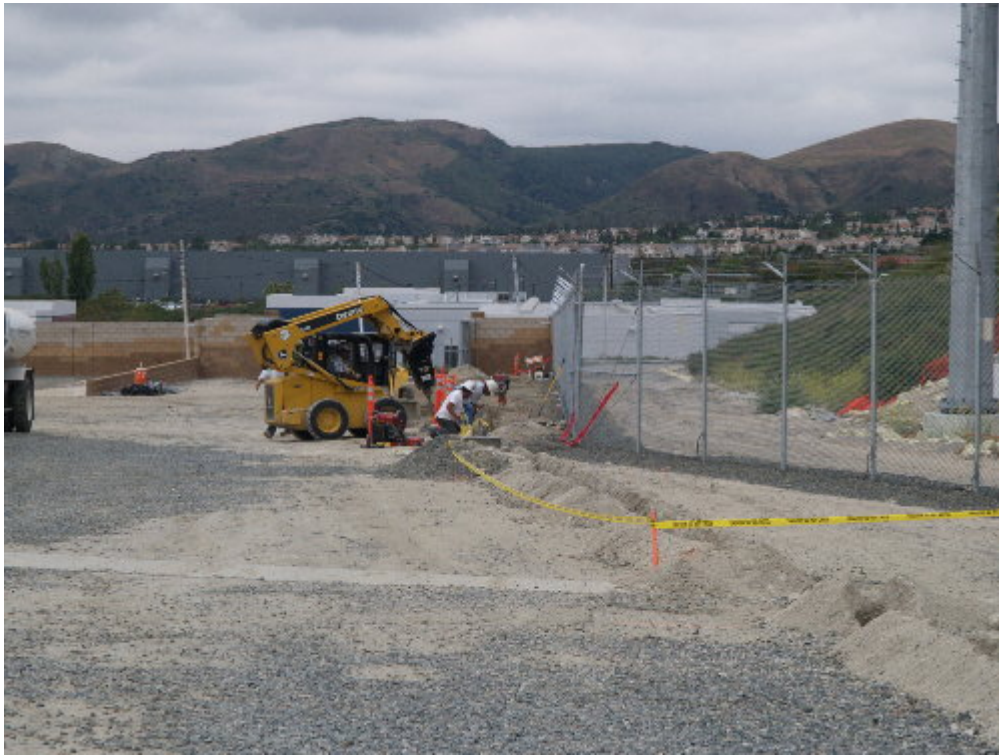
2. KGC crews continued working to excavate the trench to connect the light standards within the substation site (see Figure 3). The crew needed to remove a section of the v-ditch on the east side of the substation site and will repair the v-ditch after the electrical line has been installed.

Figure 3 – KGC continued working on the trenching for the electrical needed for the light standards around the substation site.

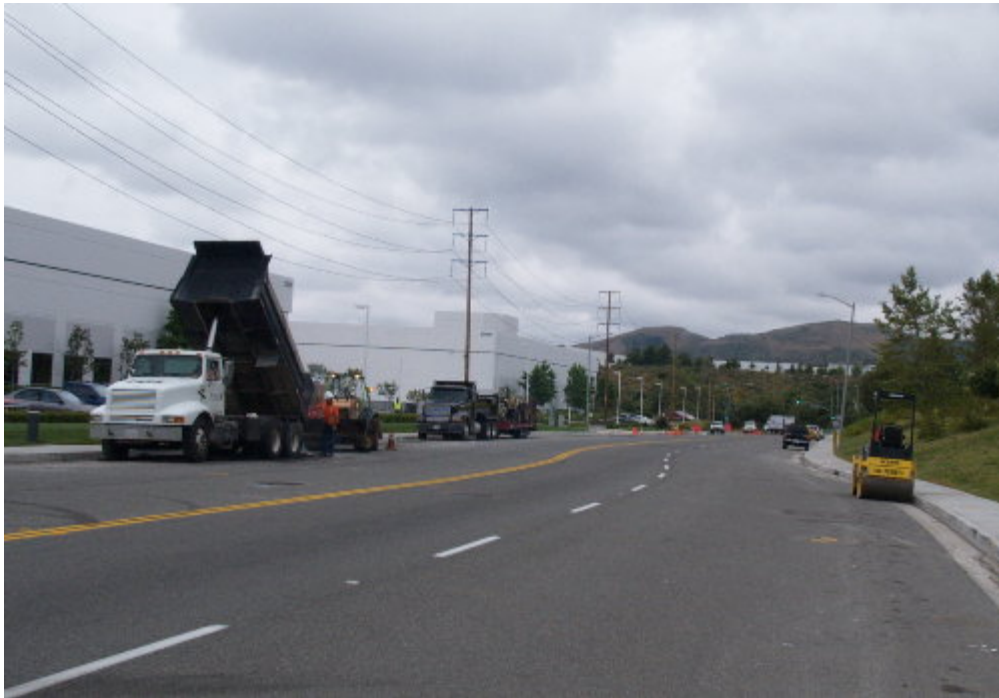
3. A crew with Arizona Pipeline worked on Ellipse Road and across the intersection at Glenn Ranch Road paving the narrow trench-line and vault locations (see Figure 4).

Figure 4 – Arizona Pipeline paved the trench-line and vault locations on Ellipse Road and across the intersection of Glenn Ranch Road.

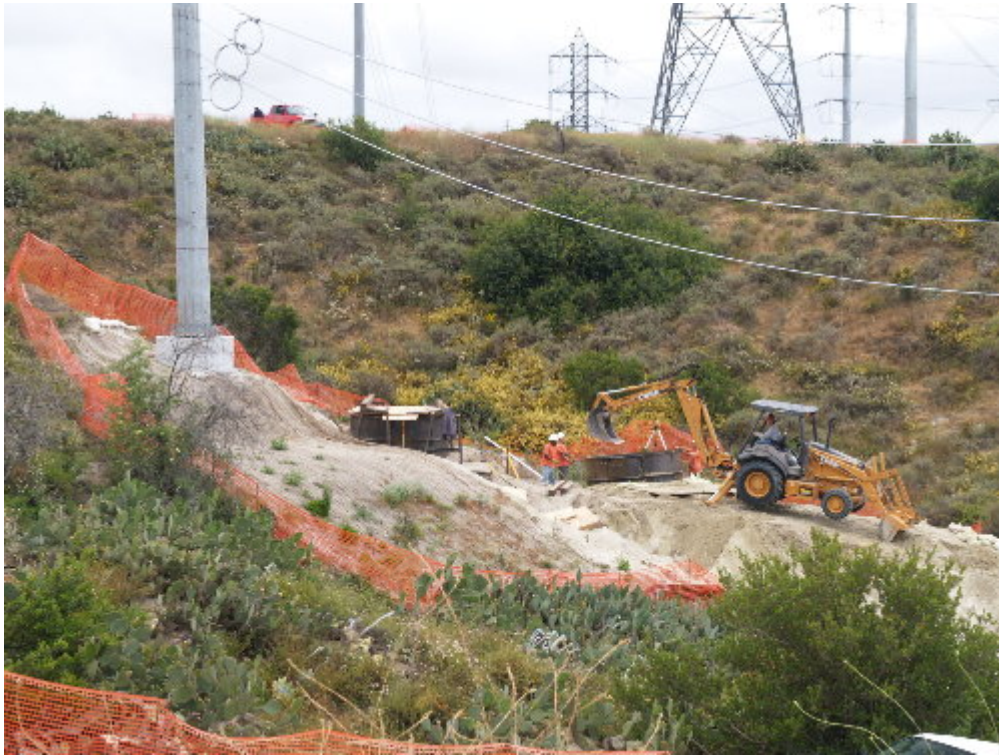
1. The foundation for the H-structure nearest the substation site, Structure 13, has been re-excavated in the proper alignment and the crew work to set the forms in preparation for the concrete pour (see Figure 5). The two foundations for Structure 12 have been poured and will be ready for the structures once the foundations have cured.
2. Crews moved to Structure 10 during the subject week to start excavating the foundations (see Figure 6). Structure 10 is on the outskirts of Mission Viejo and no involvement with the public was noted by the CPUC EM.

Figure 5 – The forms for the new foundations for Structure 13 were set during the site visit. The tops of the forms were covered for safety.

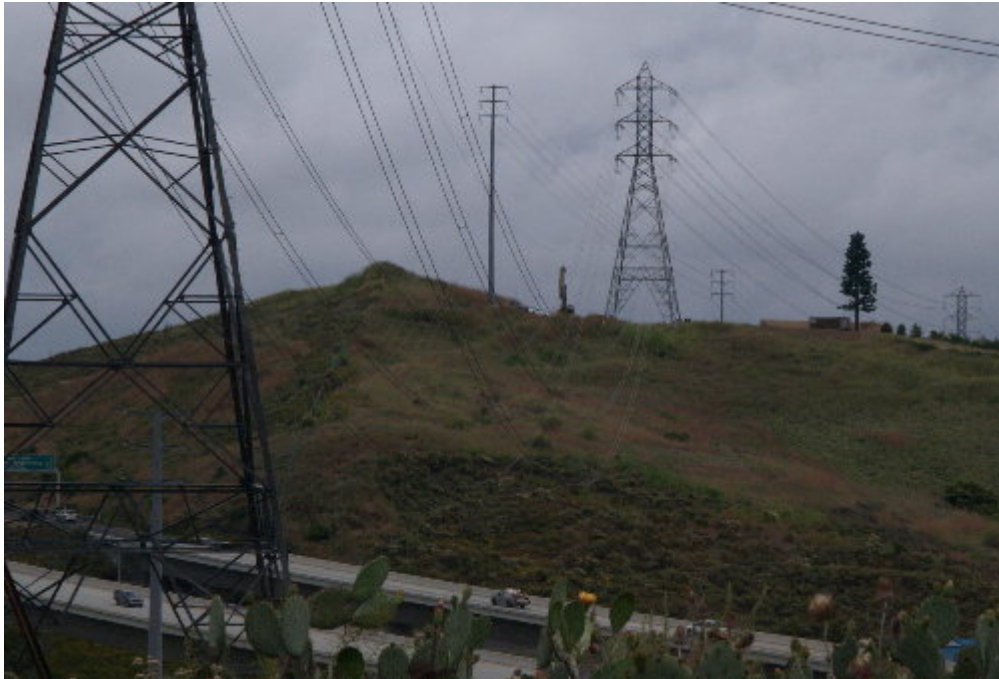
Figure 6 – Work started on the foundations for Structure 10, in the City of Mission Viejo.
