PROJECT MEMORANDUM SCE – VIEJO SYSTEM PROJECT

To: Jensen Uchida, CPUC
From: Vida Strong, Aspen Project Manager
Date: June 29, 2005
Subject: Weekly Report #47, June 19 – June 25, 2005.

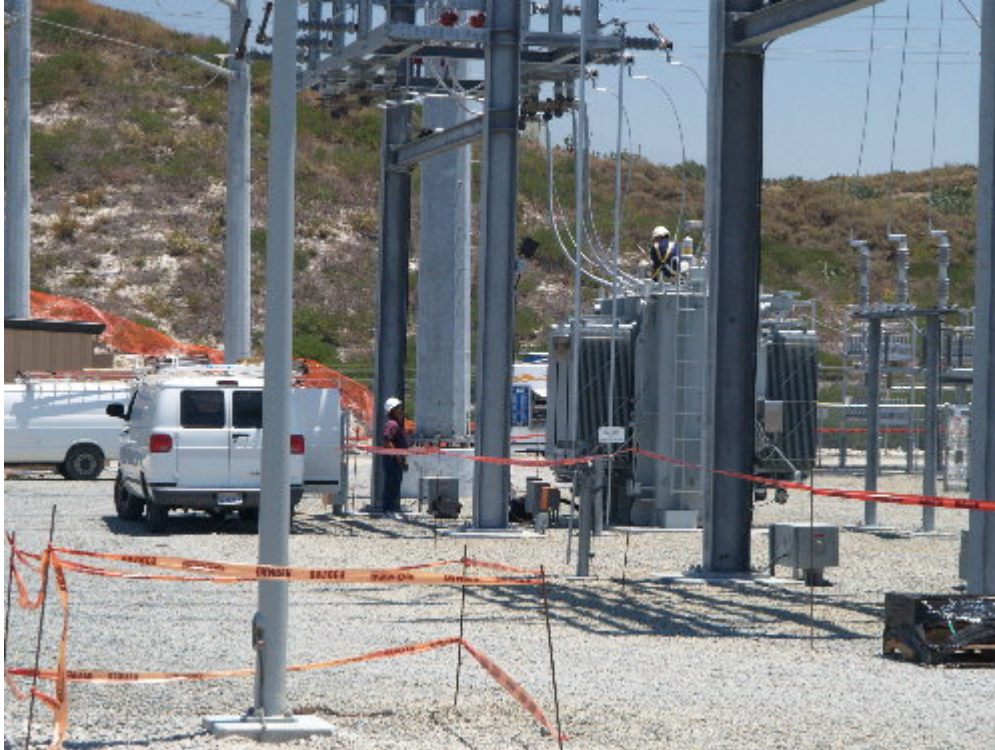
1. Several small NRG crews continued working within the 12 kV section of the substation site. The B-bank transformers are not energized and NRG crews worked on them during the site visit (see Figure 1). These smaller transformers run between the 66 kV and 12 kV sections of the substation. The 66 kV section of the substation has been energized and is marked by safety tape.
2. The 220 kV section of the substation site has been marked off with caution tape now that it is energized. The several sections of the 66 kV portion of the site, which are energized, have been surrounded with cyclone fencing and caution tape as well. With the completion of the majority of the civil work, the remaining crews at the substation site have experience working in energized stations. SCE previously provided the CPUC EM was provided with an orientation on visiting an energized station.

Figure 1 – NRG crews worked on the B-bank transformers during the site visit.

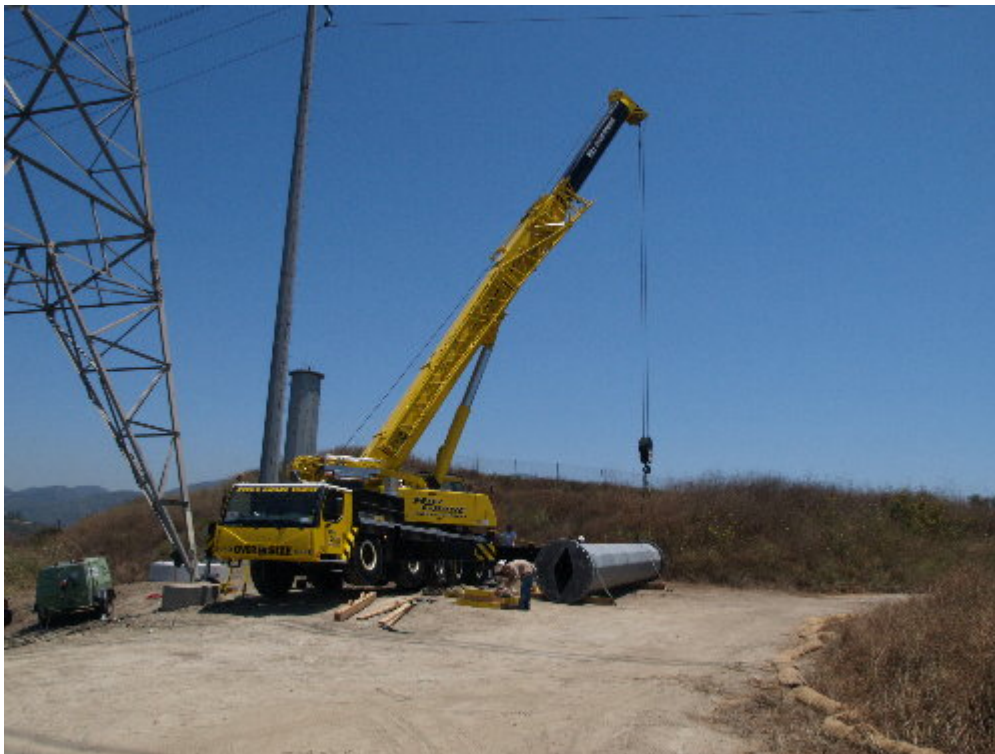
1. The H-structure nearest the substation site, Structure 13, has been completed and will be ready for conductor after the concrete has fully cured and is ready for the stress.
2. The crew at Structure 10 used a mobile crane to set the lower sections of the H-Structure (see Figure 2). The construction area was very dry and fugitive dust was an issue; however, no residences were in the immediate area.
3. Crews at H-Structure 8 prepared for concrete pouring by setting rebar cages and aligning the anchor bolts (see Figure 3).

Figure 2 – Arizona crews worked with a mobile crane to set the second base for H-Structure 10.

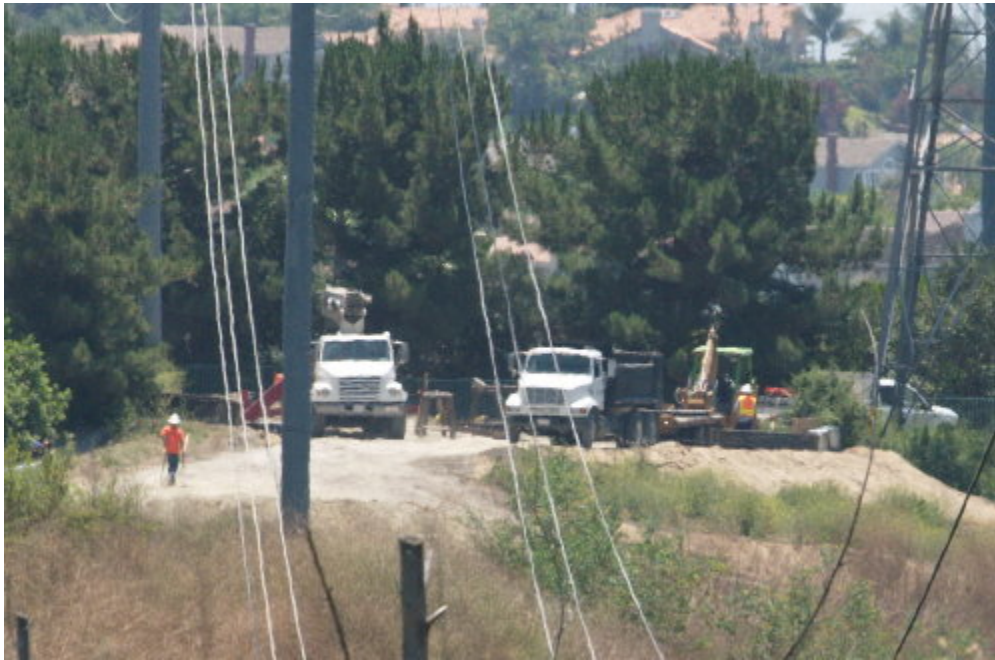
Figure 3 – Crews worked at H-Structure 8 to prepare for concrete pouring.

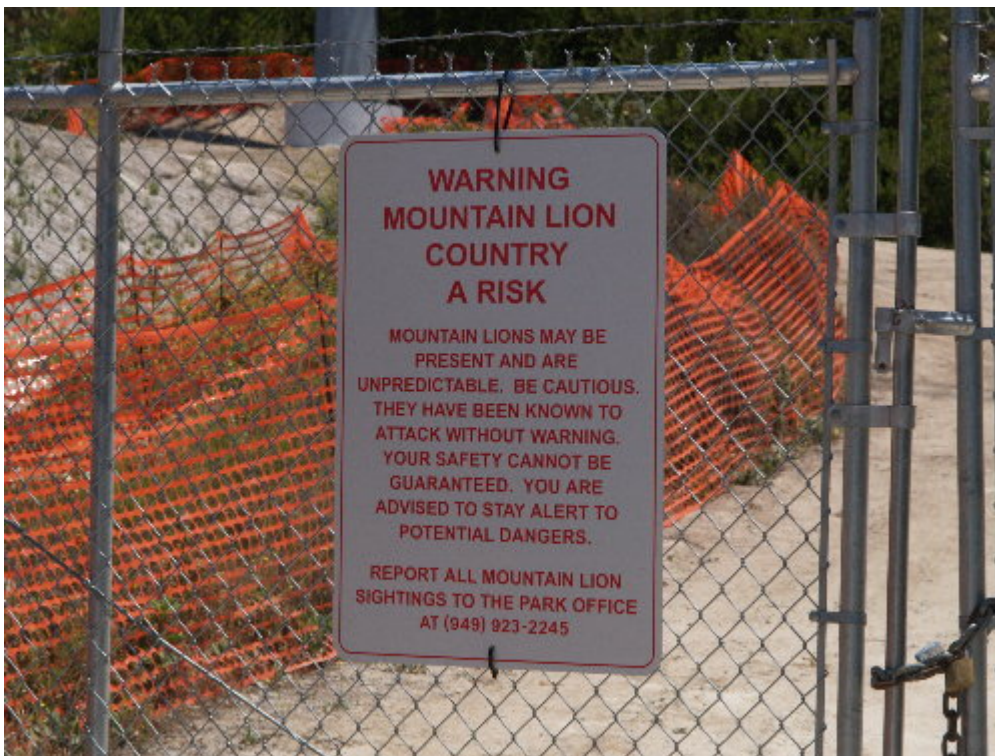
Warning signs have been placed on the gates leading into the habitat conservation area where mountain lions have been observed. The signs warn people of the hazards associated with mountain lions (see Figure 4).

Figure 4 – A mountain lion warning sign was placed on the gate leading into the habitat conservation area.
