PROJECT MEMORANDUM SCE – VIEJO SYSTEM PROJECT

To: Jensen Uchida, CPUC
From: Vida Strong, Aspen Project Manager
Date: July 13, 2005
Subject: Weekly Report #49, July 3 – July 9, 2005.

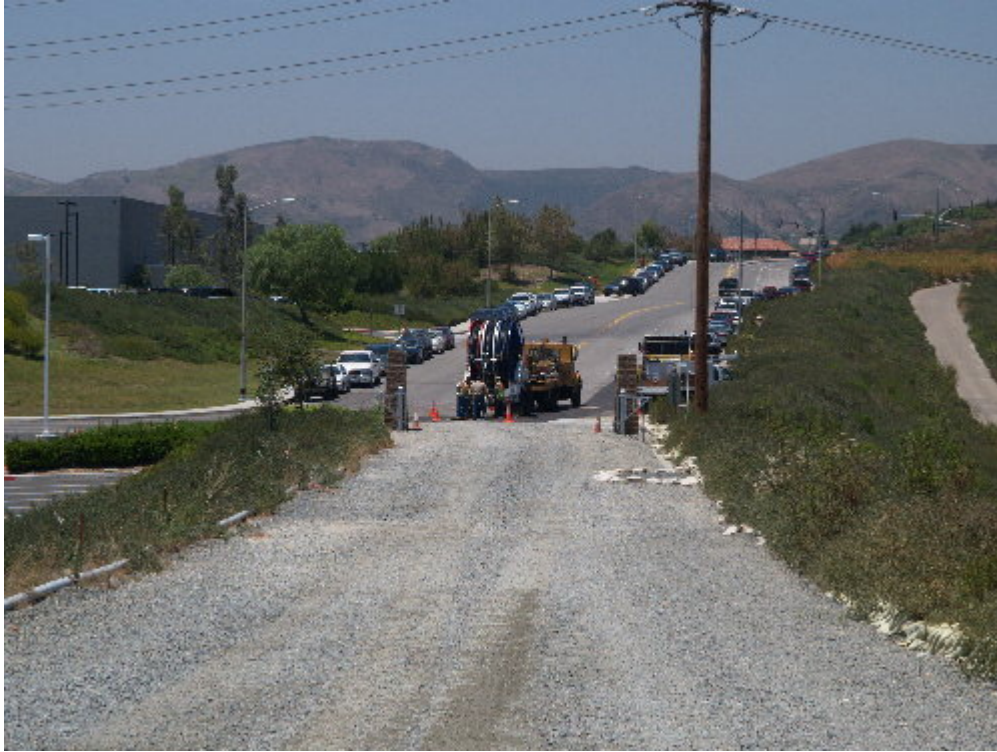
Figure 1 – A crew worked with a reel truck to pull the underground cables that will take the 12 kV power to customers.

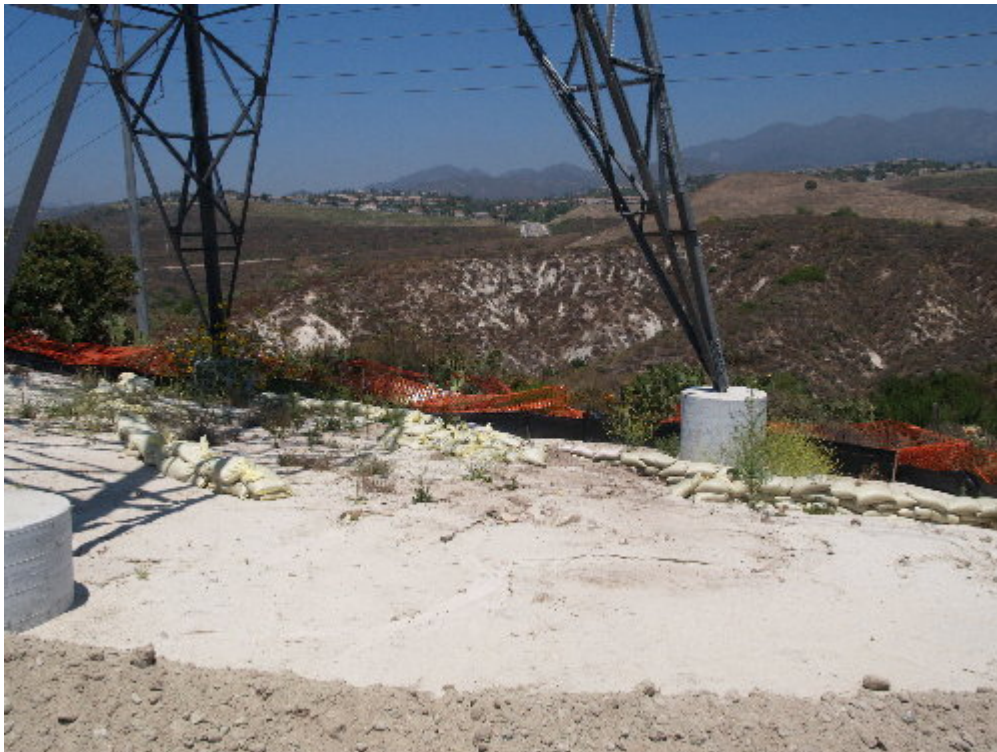
The invasive plant species in the recontoured area of the 220 kV right-of-way, adjacent to the native plant communities, are re-sprouting and will need to be addressed (see Figure 2). Ideally, the plants would be removed before seed production to reduce the amount of seed in the soil for the next growing season. The area adjacent to the project is dominated by native species and is part of a habitat conservation area.

Figure 2 – Weeds have returned to the disturbed area on the 220 kV right-of-way.

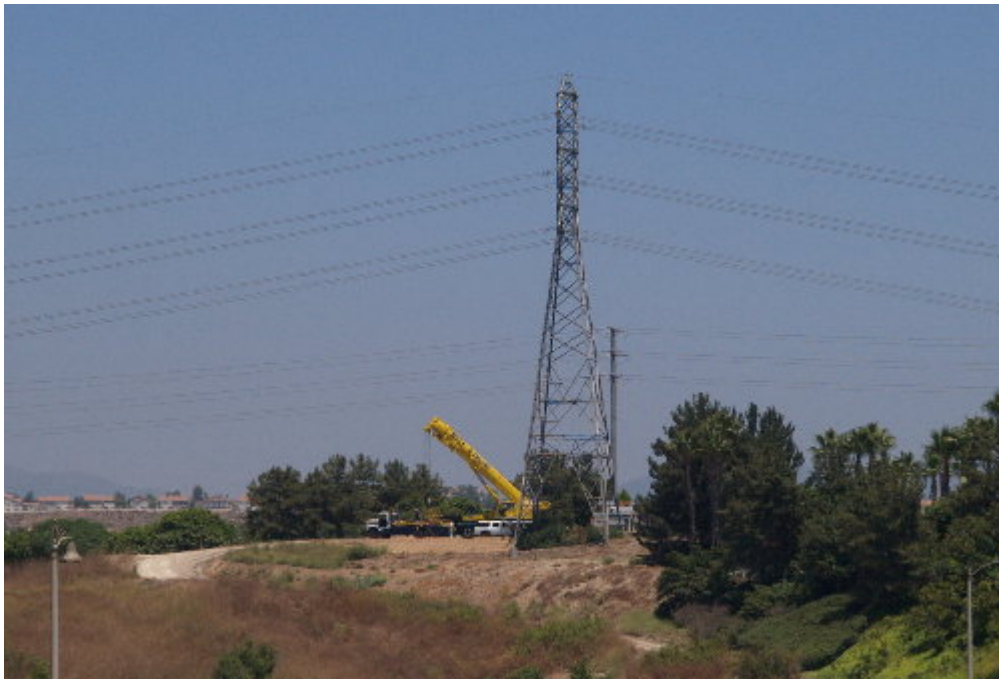
1. The Hill Crane crew worked at H-Structure 8 to set up the large mobile crane during the site visit (see Figure 3). The construction activities were within the disturbed area and no issues were noted. Once the crane has been prepared, crews will raise the steel towers for H-Structure 8 and attach the cross members.
2. H-Structures 10 and 9 have been raised and the cross members attached (see Figure 4). H-Structure 9 is in the foreground and H-Structure 10 is in the distance, overlooking the 241 toll road.

Figure 3 – The Hill Crane crew worked to prepare the mobile crane at H-Structure 8.

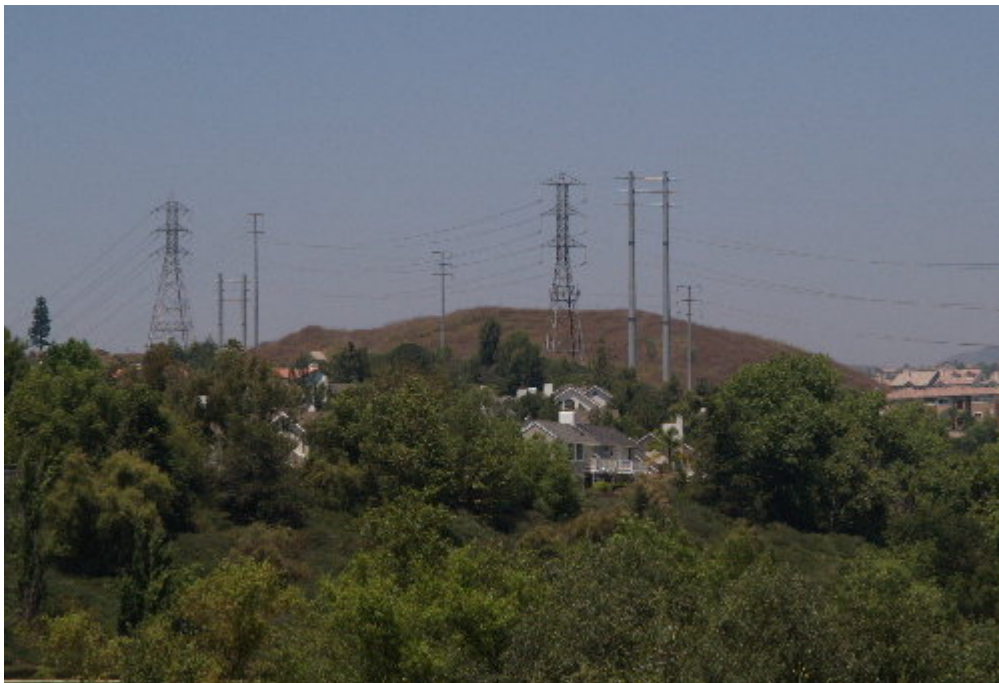
Figure 4 – Raised H-Structures 9 and 10, looking to the north.
H-Structure 9 is in the foreground.
