PROJECT MEMORANDUM SCE – VIEJO SYSTEM PROJECT

To: Jensen Uchida, CPUC
From: Vida Strong, Aspen Project Manager
Date: October 12, 2005
Subject: Weekly Report #61, October 2 – October 8, 2005.
CPUC Environmental Monitor (EM): Christopher Meyer

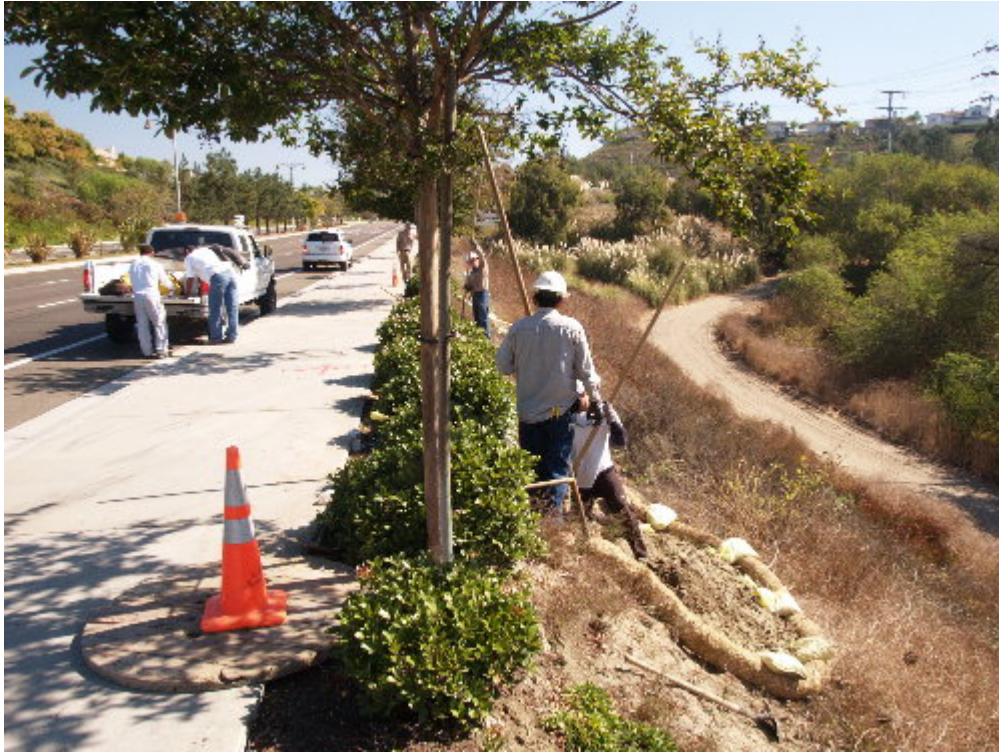
Figure 1 – The transmission line crew used a truck mounted auger and hand tools to excavate for the guard structures.

1. SCE transmission line crews worked to set guard structures between Olympiad Park and H-Structure 1 during the site visit. The crews worked with a truck-mounted auger and hand tools to excavate holes for the guard structures (see Figure 1). Guard structures have already been placed on the north side of the park to protect the road to the gated community. Anchors may be required downslope from the guard structures. The CPUC EM informed the foreman that any work outside the disturbed areas needs to be coordinated with the SCE biologist. The rest of H-Structure 1 has been set in place and half the arms have been attached (see Figure 2). The remaining arms on H-Structure 1 and the poles to the north will be attached once the adjacent conductor has been taken down.

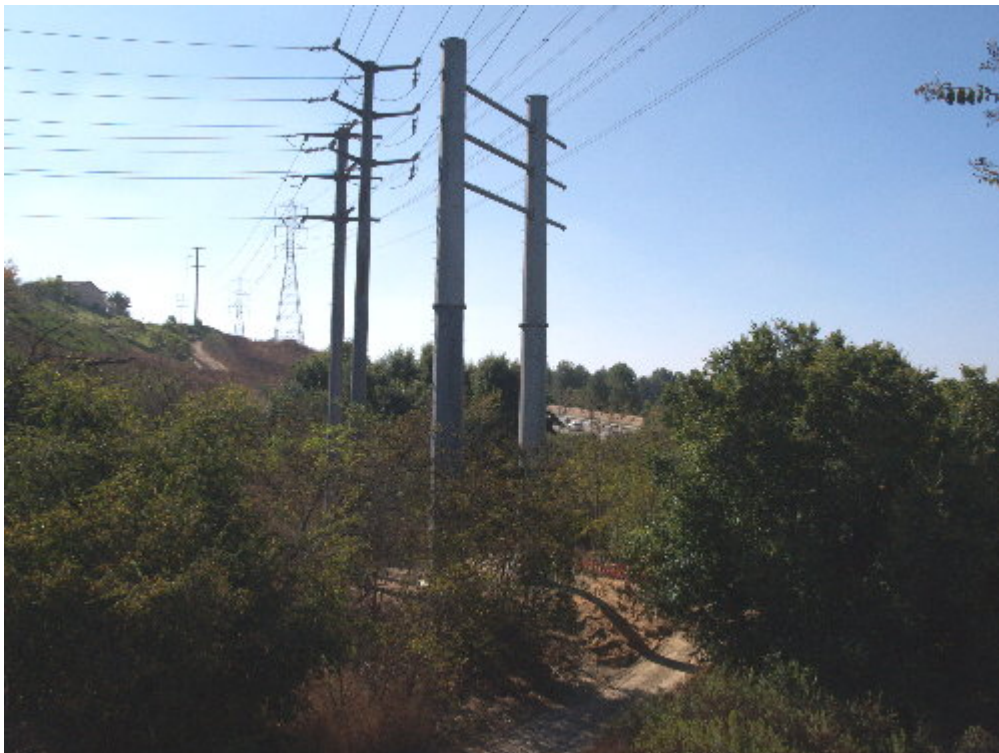
Figure 2 – The remainder of H-Structure 1 has been raised. The remaining arms will be attached once the other line has been removed.
