PROJECT MEMORANDUM SCE – VIEJO SYSTEM PROJECT

To: Jensen Uchida, CPUC
From: Vida Strong, Aspen Project Manager
Date: October 24, 2005
Subject: Weekly Report #63, October 16 – October 22, 2005.
CPUC Environmental Monitor (EM): Christopher Meyer

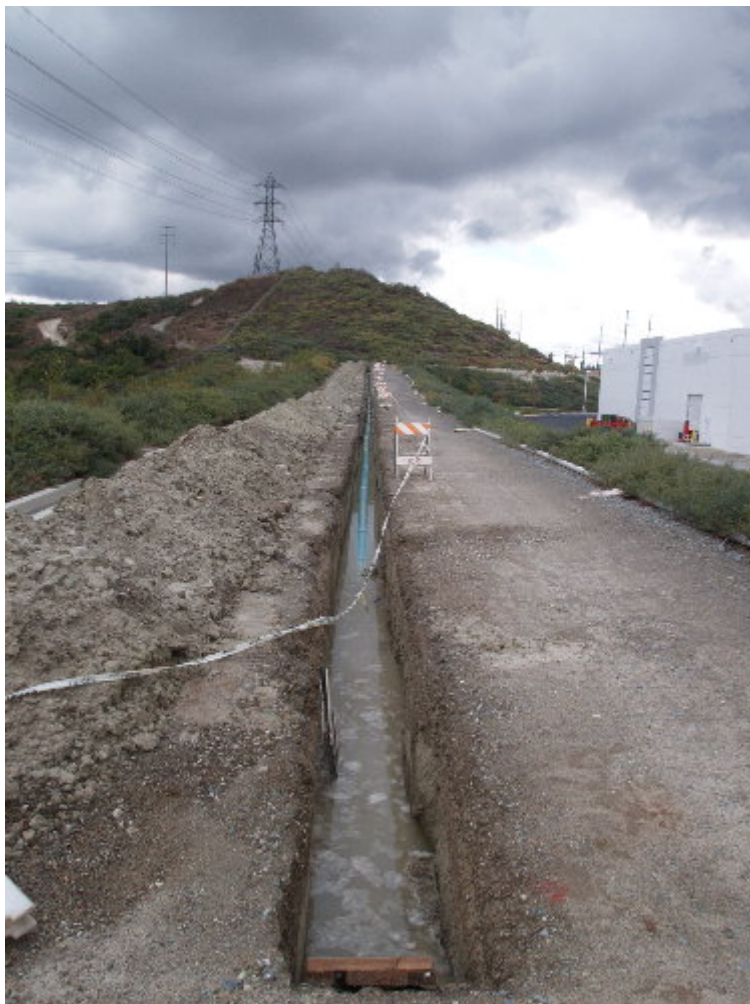
1. No progress was observed on the water line leading into the substation site during the subject week. Sections of the open trench on the south end of the access road have been covered with steel plates for safety and to provide access. SCE engineers are working to make the second set of revisions required by the Water Department and resubmit the permit application so that the water line work can resume. The CPUC EM informed SCE that the trench and pipe will need to be examined by a biologist prior to work resuming. Animals may have taken up residence in the trench or pipe since work was suspended. With the recent rains, SCE will have to address dewatering and sediment control now that water has entered the trench (see Figure 1). The dirt road was saturated during the site visit, but no evidence of sediment leaving the right-of-way was observed.

Figure 1 – The open trench on the main entrance to the Viejo Substation has partially filled with water.
