PROJECT MEMORANDUM SCE – VIEJO SYSTEM PROJECT

To: Jensen Uchida, CPUC
From: Vida Strong, Aspen Project Manager
Date: December 14, 2005
Subject: Weekly Report #69, December 4-10, 2005.
CPUC Environmental Monitor (EM): Jenny Slaughter

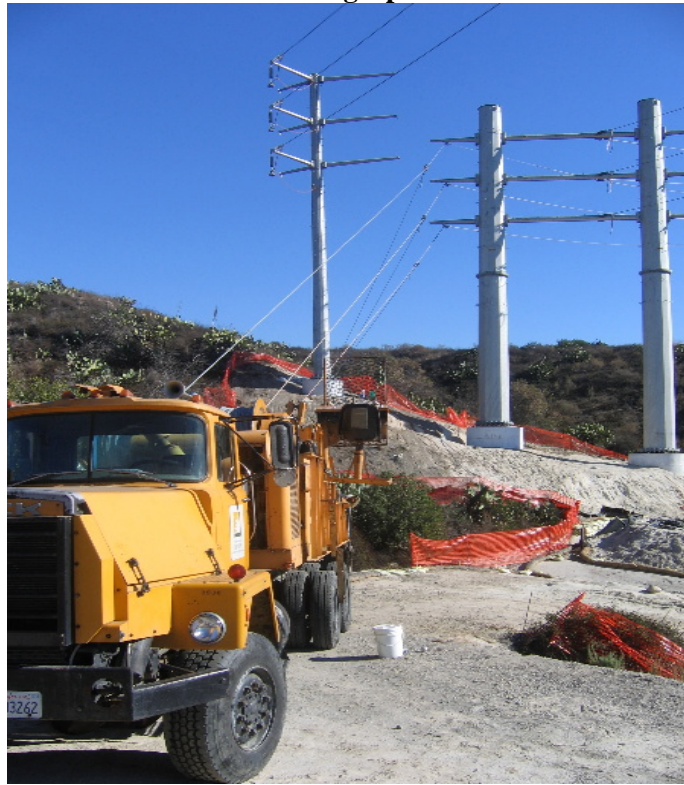
Figure 1 – Stringing activities at Tower HF-13

1. SCE transmission line crews continued to pull conductor on the east arm of the H-Structures during the site visit (see Figure 1). Most of the old 66 kV steel poles have been wrecked out to make room for the east arms on the H-Structures and the stringing of the eastern circuit (see Figure 2).
2. SCE has contracted a larger crane on-site for the removal of those old 66 kV steel poles that will require a greater reach to the pole site or have other complications that the previous crane could not address.

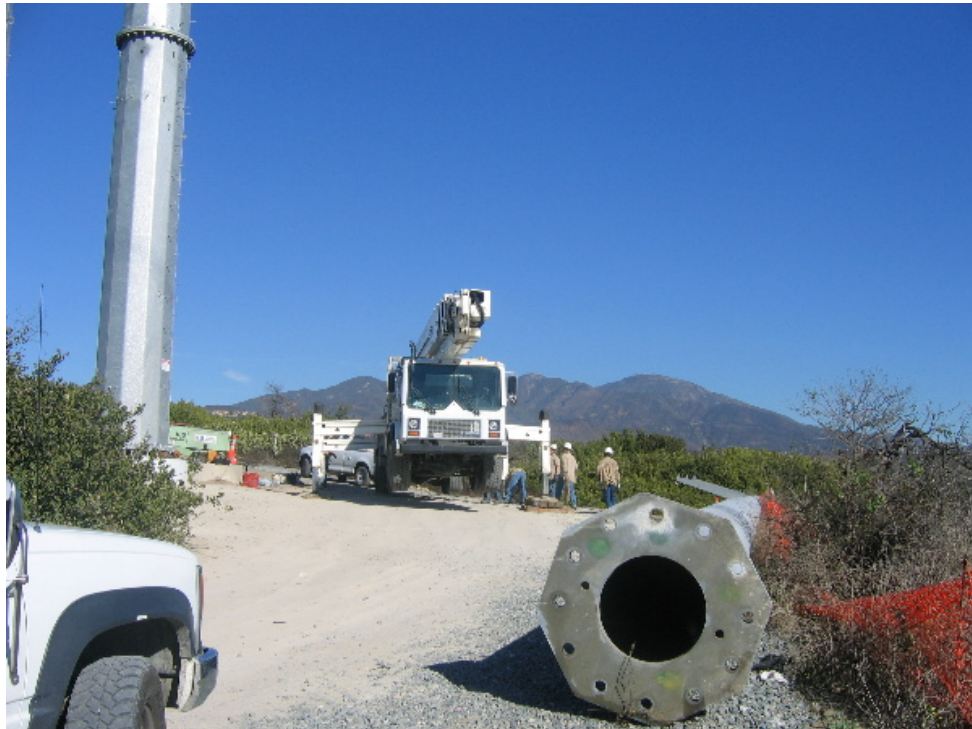
Figure 2 – Pole dismantling at Station M2-P2, near the Viejo Substation.
