PROJECT MEMORANDUM SCE – VIEJO SYSTEM PROJECT

To: Jensen Uchida, CPUC
From: Vida Strong, Aspen Project Manager
Date: December 22, 2005
Subject: Weekly Report #70, December 10-17, 2005.
CPUC Environmental Monitor (EM): Jenny Slaughter

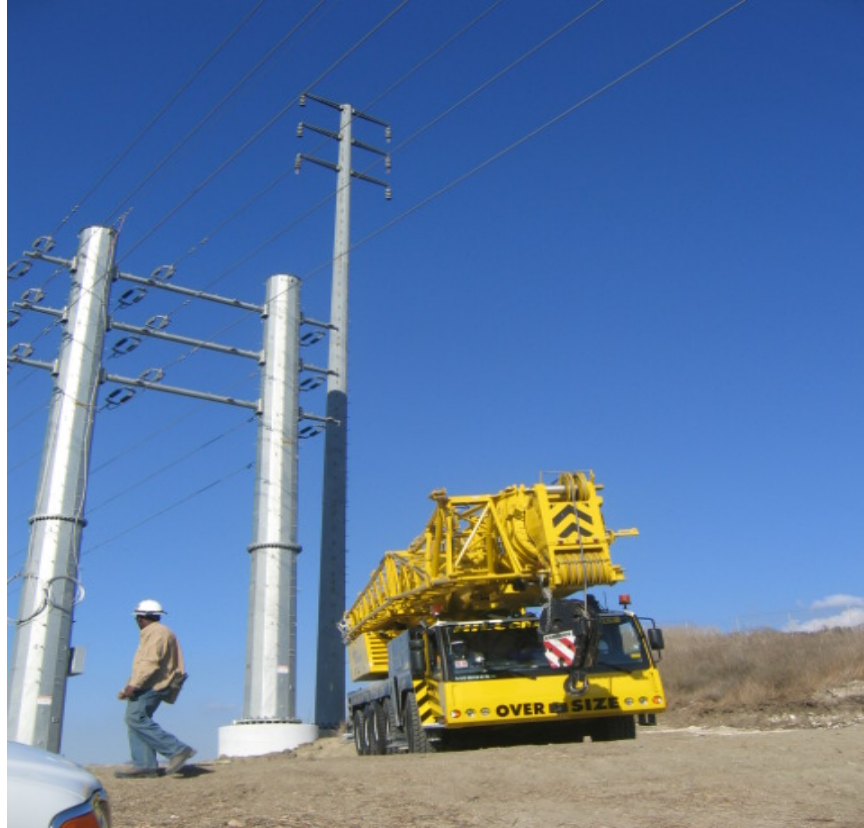
2. SCE has contracted a larger crane on-site for the removal of the old 66 kV steel poles that will require a greater reach to the pole site or have other complications that the previous crane could not address (see Figure 1). Clean up and removal of the old 66 kV poles will involve cutting them into pieces and removing them off site. Crews are scheduled to remove old tower footings later in the week.

Figure 1 – Crew prepares to dismantle and remove an old 66 kV steel pole along the right-of-way, December , 2005.

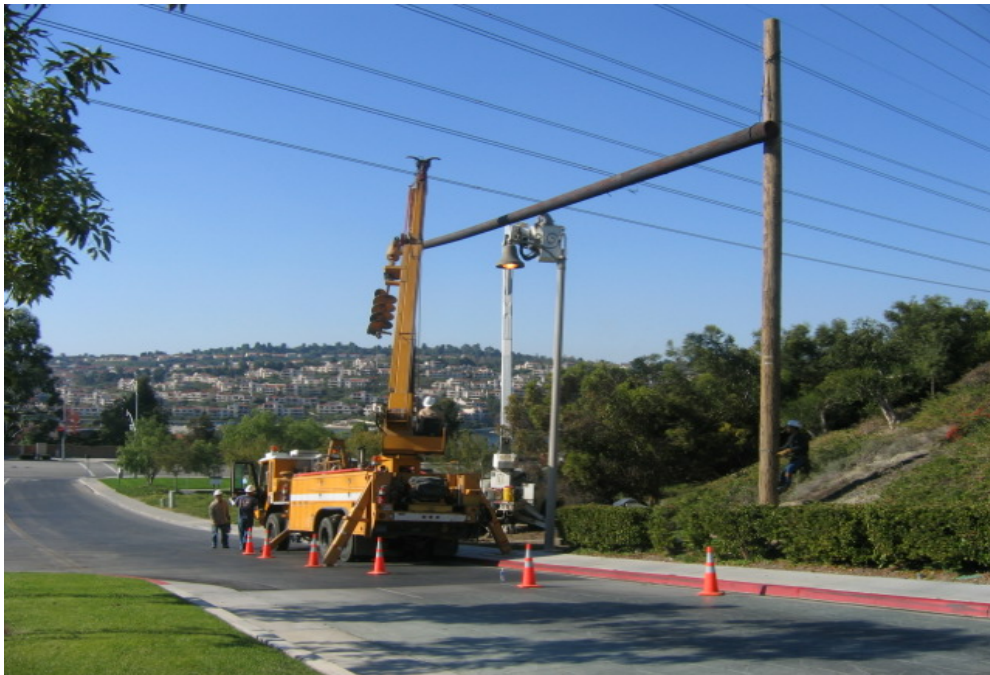
3. Edison crews worked on the removal of street crossing guard structures during the site visit (see Figure 2).

Figure 2 – Guard structure dismantling at Olympiad Road and Applegate, December 12, 2005.
