PROJECT MEMORANDUM SCE – VIEJO SYSTEM PROJECT

To: Jensen Uchida, CPUC
From: Vida Strong, Aspen Project Manager
Date: January 10, 2006
Subject: Weekly Report #71, January 1 - January 7, 2006.
CPUC Environmental Monitor (EM): Christopher Meyer

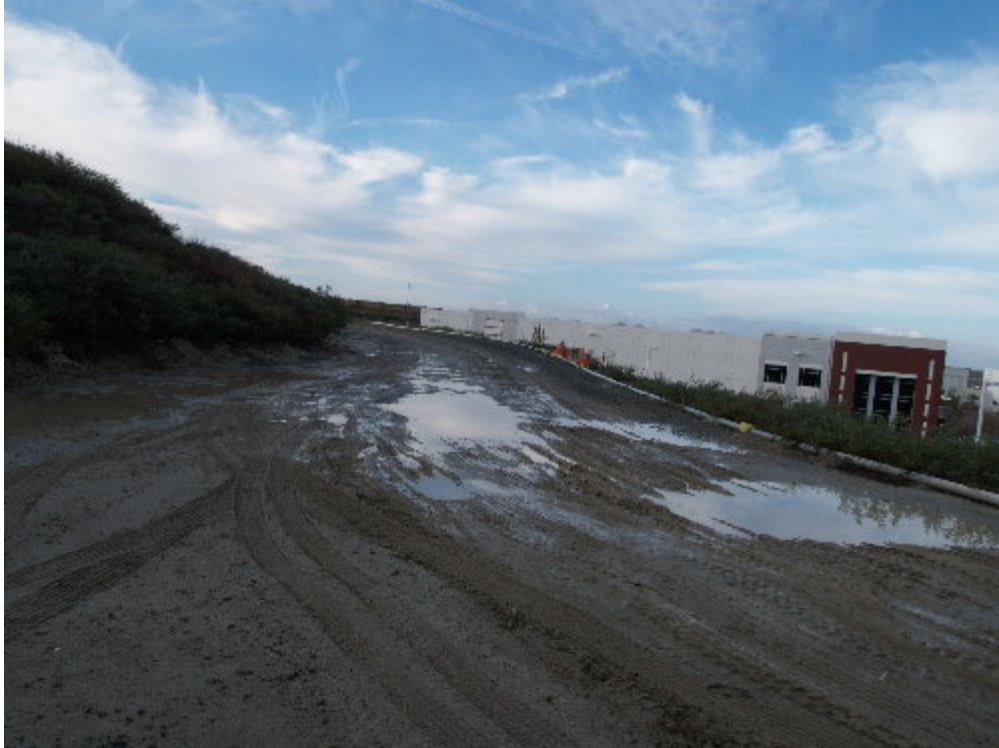
Figure 1 – The main road to the substation has been backfilled and was muddy during the site visit.

2. Straw wattles have been placed at the end of the driveway to prevent sediment from entering the public right-of-way and keep it away from storm drains during trenching for the water line. These Best Management Practices (BMPs) have been maintained prior to and after the recent rainfall. The main road was muddy at the time of the site visit due to rain over the weekend and on Monday (see Figure 1). SCE worked to minimize material tracked onto the public right-of-way and any dirt or mud on public roads was removed.

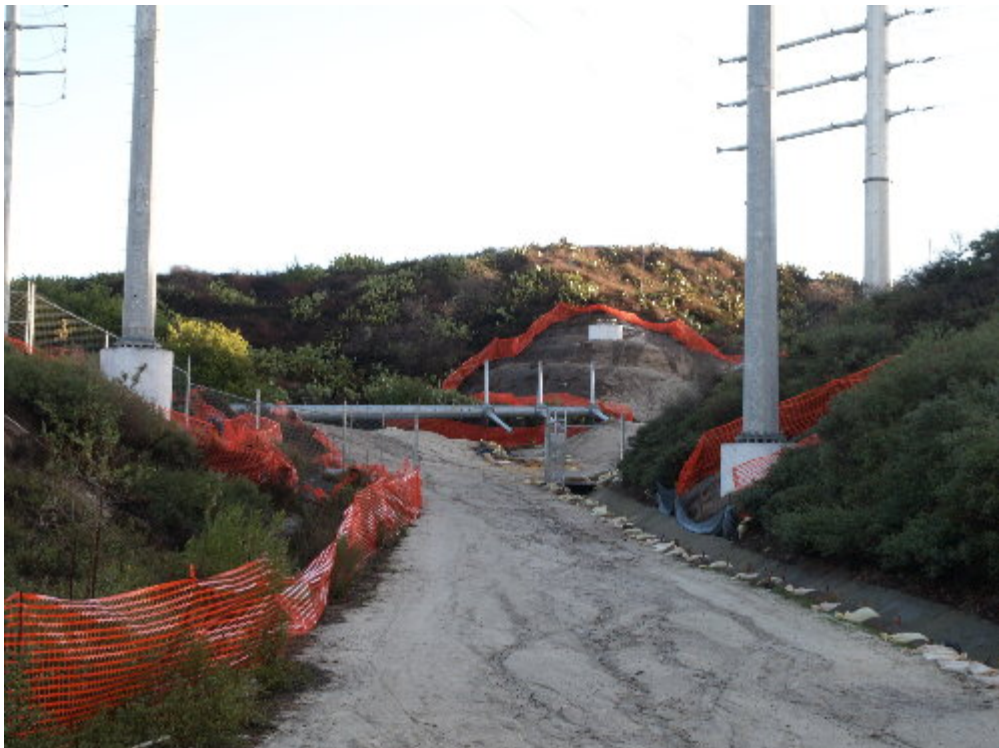
Figure 2 – The temporary steel pole adjacent to H-Structure 13 was lowered and will be removed.

1. SCE transmission line crews worked to pull the final sections of conductor at the Chiquita Substation during the subject week. The old 66 kV steel poles have been wrecked out to make room for the east arms on the H-Structures and the stringing of the eastern circuit. The temporary steel pole adjacent to H-Structure 13 has been lowered and will be removed from the project for reuse (see Figure 2). This pole was used to allow use of the substation during the completion of work on the transmission line.

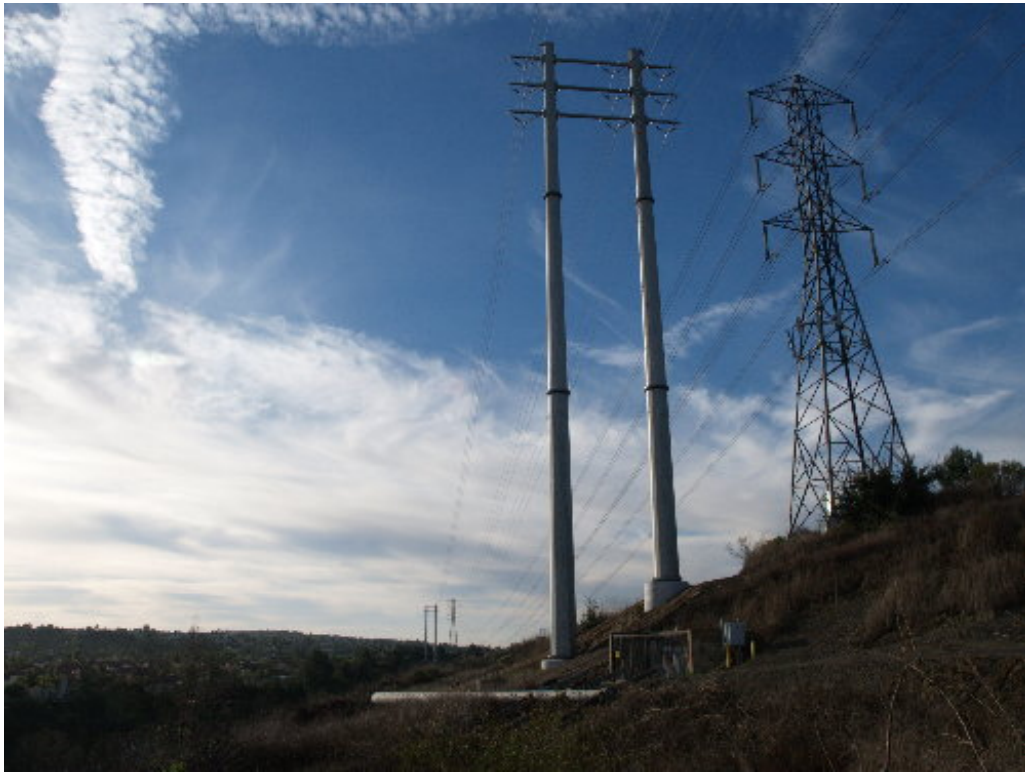
Figure 3 – The old steel poles have been lowered, but many are still on the right-of-way. These poles will be removed once the access roads dry out from the recent rains.

2. SCE has contracted a larger crane on-site for the removal of the old 66 kV steel poles that will require a greater reach to the pole site or have other complications that the previous crane could not address. Clean up and removal of the old 66 kV poles will involve cutting them into pieces and removing them off site. The steel poles that remain on the right-of-way will be removed once the right-of-way dries out enough to safely operate the crane and trucks (see Figure 3).
