## **PROJECT MEMORANDUM SCE – VIEJO SYSTEM PROJECT**

**To:** Jensen Uchida, CPUC  
**From:** Vida Strong, Aspen Project Manager  
**Date:** January 19, 2006  
**Subject:** Weekly Report #72, January 8 - January 14, 2006.  
**CPUC Environmental Monitor (EM):** Jenny Slaughter

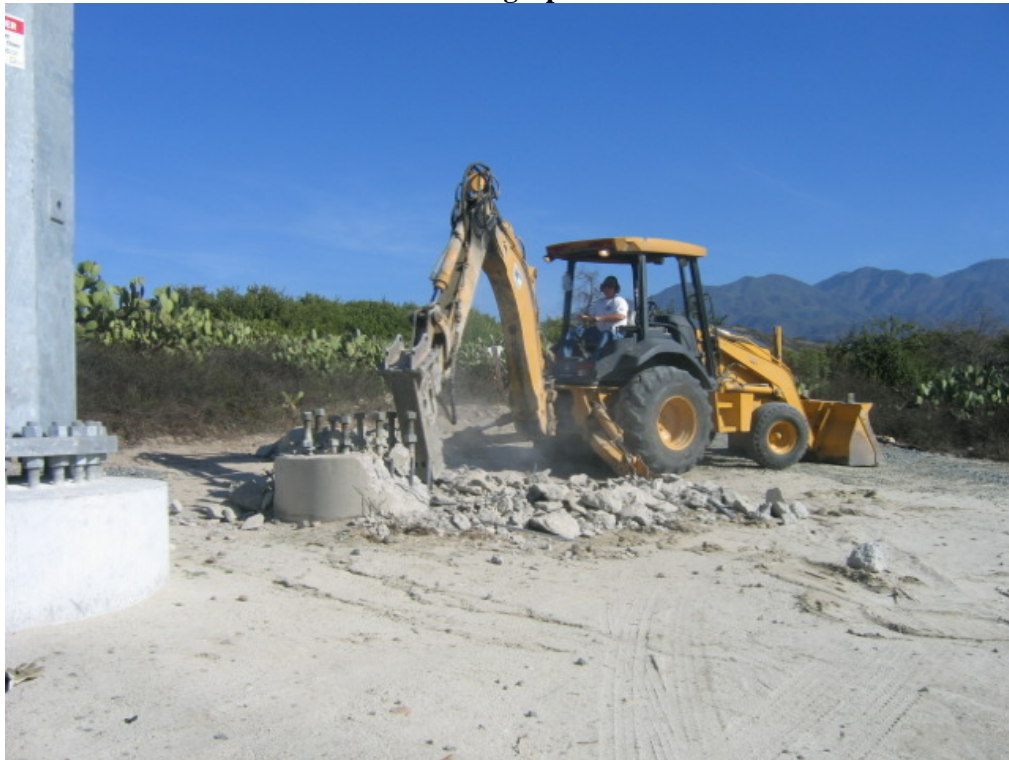
**Figure 1** – Arizona Pipeline crew dismantling a tower footing above the Viejo Substation during the site visit.

1. SCE crews installed fiber optic tabs on several of the towers during the site visit.
2. SCE subcontractor, Arizona Pipeline, has been onsite to remove the old tower footings (see Figure 1). Most of these footings are being removed using a backhoe, but some will require dismantling by hand because of the location of the footing.
3. SCE crews plan to restore the right-of-way by doing some minor grading and installing v-ditches. Work that remains to be done includes removing the dismantled poles and restoring access roads (see Figure 2).

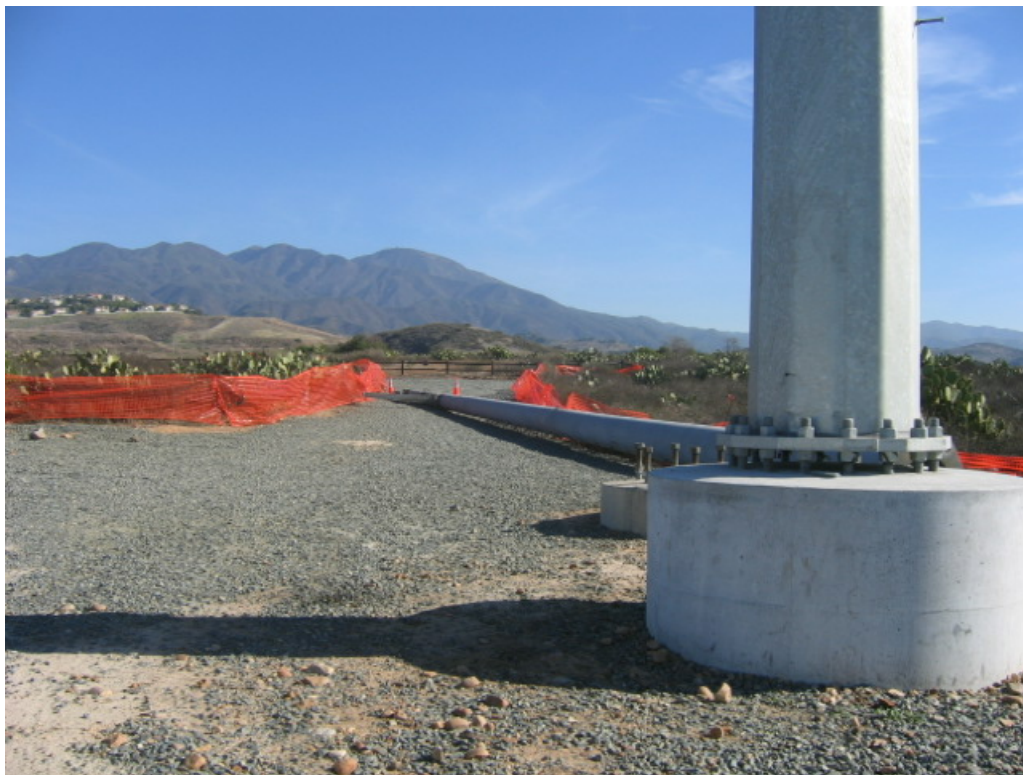
**Figure 2** – The old steel pole will be cut up and removed from the project area.
