PROJECT MEMORANDUM SCE – VIEJO SYSTEM PROJECT

To: Jensen Uchida, CPUC
From: Vida Strong, Aspen Project Manager
Date: February 3, 2006
Subject: Weekly Report #74, January 22 - January 28, 2006.
CPUC Environmental Monitor (EM): Jenny Slaughter

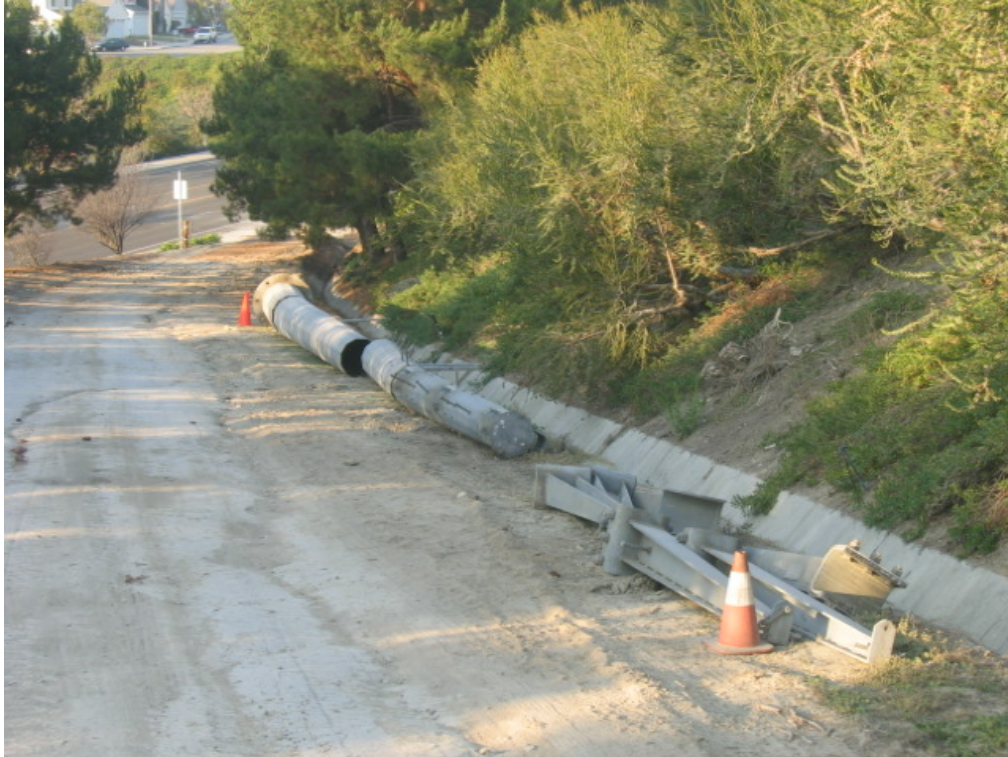
1. No Construction activities were observed during the site visit. Crews were taken off the Viejo Project in order to address emergency repairs in the area due to high winds. The CPUC EM toured the project route and inspected the right-of-way BMP's.
2. Several dismantled steel poles have been removed from the right-of-way (see Figure 1).
3. SCE subcontractor, Arizona Pipeline, continued work on dismantling old tower footings.
4. SCE crews plan to restore the right-of-way by doing some minor grading and installing v-ditches. Work that remains to be done includes removing the dismantled poles and restoring access roads.

Figure 1 – Dismantled steel poles are cut up and removed from the right-of-way.

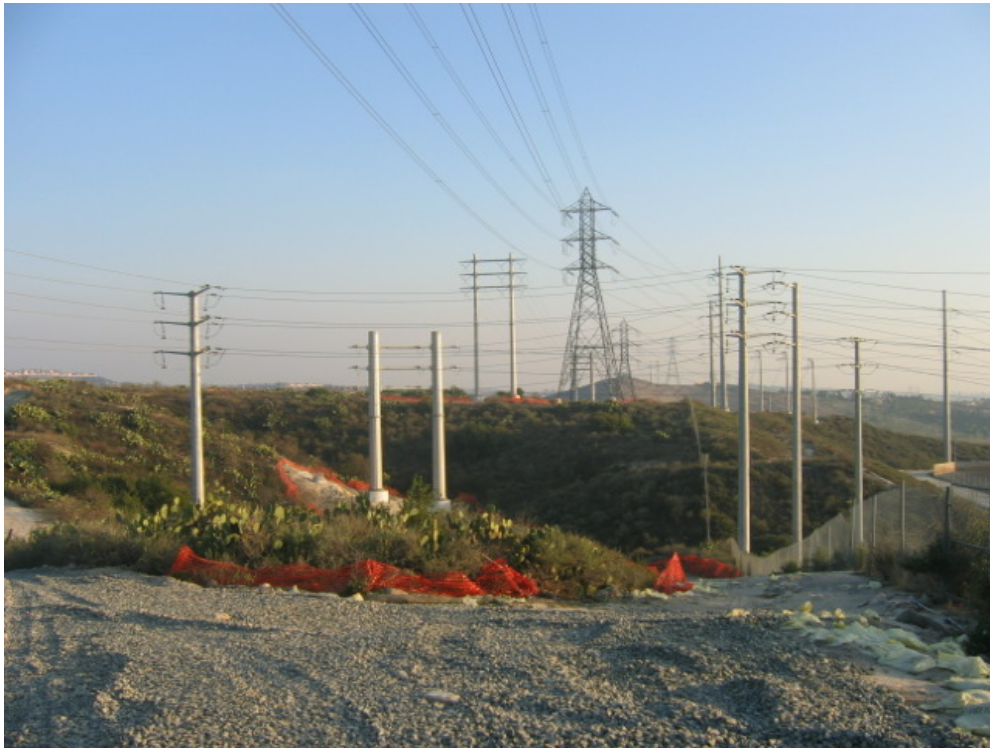
1. SCE personnel were reminded by the CPUC EM to leave the orange resource exclusion fencing in place until all project activities were completed in these areas. SCE may decide to remove the fencing in order to complete restoration activities and will have an Environmental Monitor present during work in the sensitive resource areas (see Figure 2).
2. All work observed on the 66 kV right-of-way during the site visit was in compliance with the mitigation measures adopted in the MND and other permitting requirements.
3. The slope below the pads above the Viejo Substation have been covered with jute netting in preparation for restoration and native vegetation has emerged through the netting. The non-native species should be removed before they produce seed.

Figure 2 – Orange exclusion fencing around sensitive habitat near the new Substation.
