PROJECT MEMORANDUM SCE – VIEJO SYSTEM PROJECT

To: Jensen Uchida, CPUC
From: Vida Strong, Aspen Project Manager
Date: February 10, 2006
Subject: Weekly Report #75, January 29 – February 4, 2006.
CPUC Environmental Monitor (EM): Jenny Slaughter

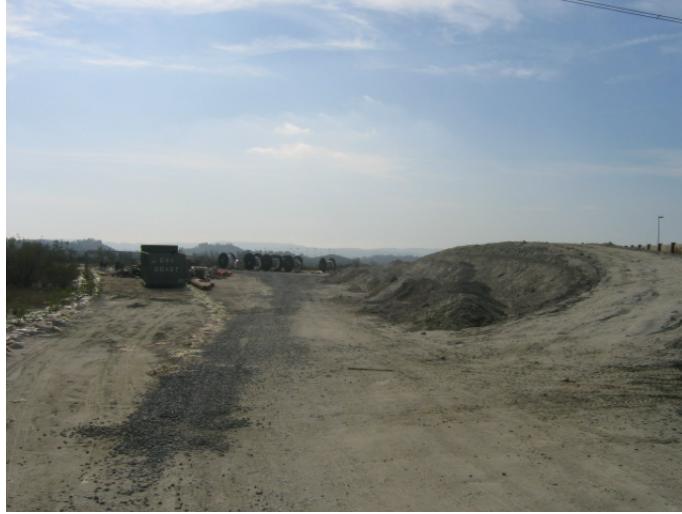
1. All operations observed by the CPUC EM were in compliance with mitigation measures adopted in the MND and other permitting requirements. The large spoils pile behind the Viejo Substation still needs to be removed or stabilized (see Figure 1). The CPUC EM previously recommended removal of the spoils in dry conditions to avoid tracking of mud or dripping of muddy water onto the public right-of-way. The CPUC EM will be following up with SCE regarding their plans for removal of the spoils pile.

Figure 1 – The spoils pile behind the Viejo Substation will be removed or stabilized.

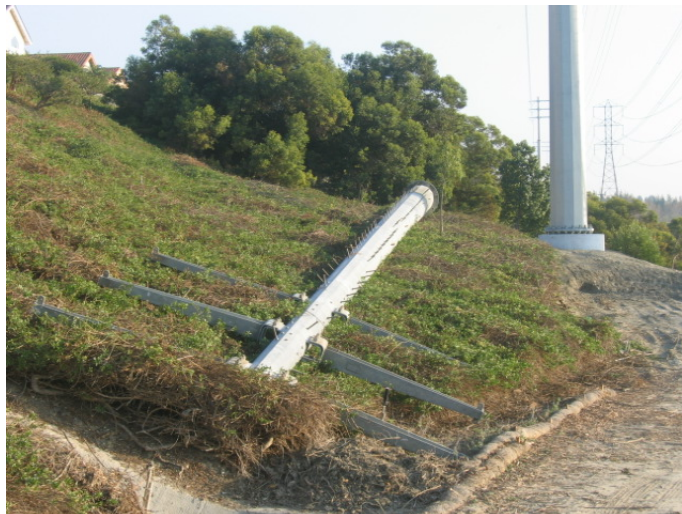
1. No construction activities were observed during the site visit. The CPUC EM toured the project route and inspected the right-of-way clean up activities and project Best Management Practices (BMP's).
2. Several dismantled steel poles have been removed from the right-of-way (see Figure 2).
3. SCE subcontractor, Arizona Pipeline, continued work on dismantling old tower footings.
4. SCE has created a punch list of items for final project restoration. Items remaining include minor grading, sidewalk repair, dismantled pole removal, and installing v-ditches.
5. Crews plan to install the communication line into the Chiquita Substation later in the week.

Figure 2 – Dismantled steel poles are cut up and removed from the right-of-way.
