PROJECT MEMORANDUM SCE – VIEJO SYSTEM PROJECT

To: Jensen Uchida, CPUC
From: Vida Strong, Aspen Project Manager
Date: March 8, 2006
Subject: Weekly Report #77, February 19 – March 4, 2006.
CPUC Environmental Monitor (EM): Jenny Slaughter

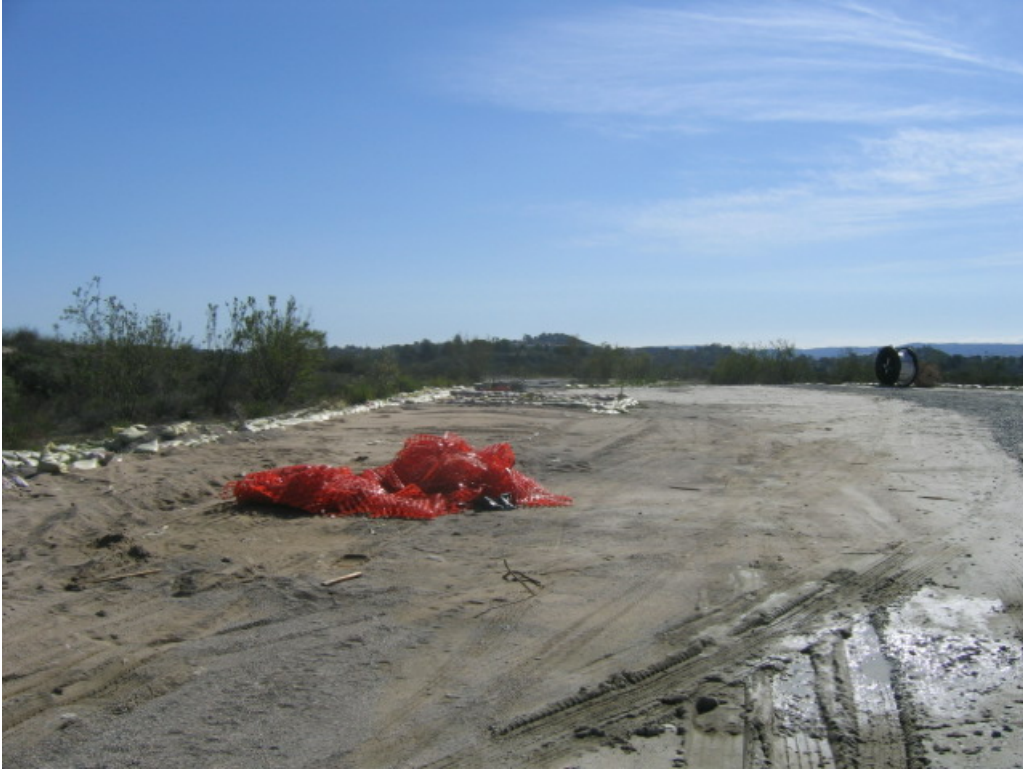
1. All operations observed by the CPUC EM were in compliance with mitigation measures adopted in the MND and other permitting requirements. The large spoils pile behind the Viejo Substation is in the process of removal. The CPUC Lead EM reviewed the information and approvals required if SCE decided to spread the spoil pile over the temporary work space and then stabilizing the spoils and restoring the area. SCE elected to remove the excess spoils as originally proposed. The clean-up of other items in the staging area is underway (see Figure 1).

Figure 1 – Area behind the Viejo Substation used for staging materials. Most project materials have been removed.

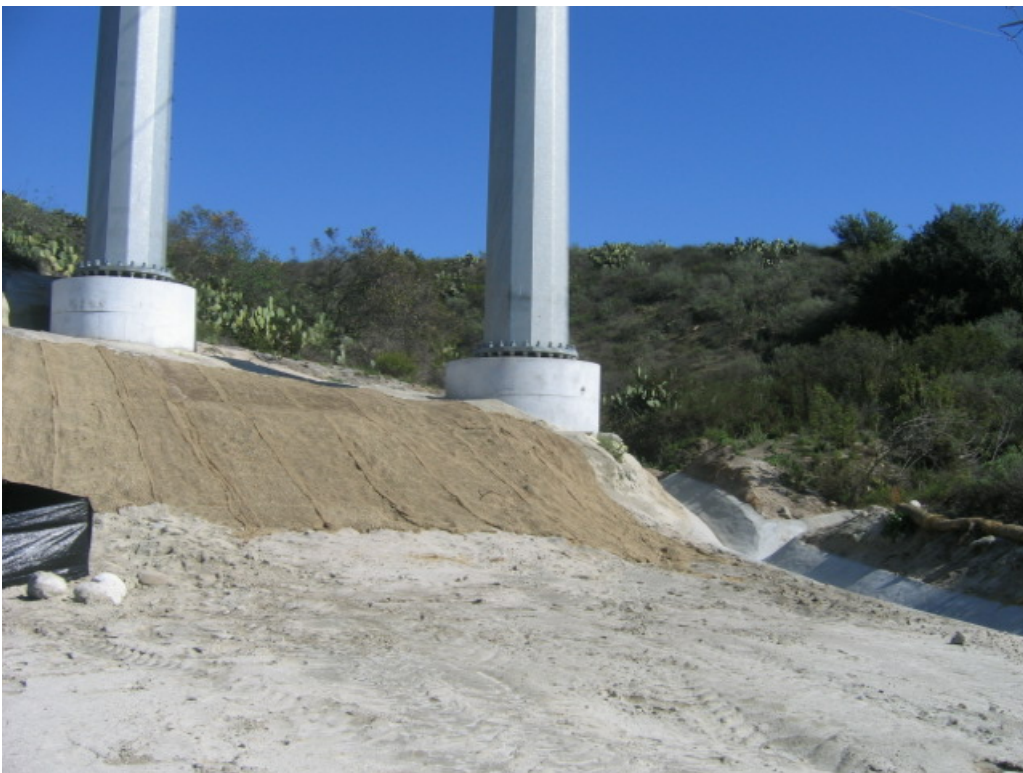
1. All dismantled steel poles have been removed from the right-of-way.
2. SCE subcontractor, Arizona Pipeline, has been working on a punch list of items for final project restoration. Items include minor grading for tower pads, sidewalk repair, dismantled pole removal, and installing v-ditches (see Figure 2).
3. The orange exclusion fencing has been removed from the project right-of-way and the access roads and tower pads have been restored (see Figure 3).

Figure 2 – Restoration of a tower pad under H structure near Viejo Substation. Note the new v-ditches and erosion netting.

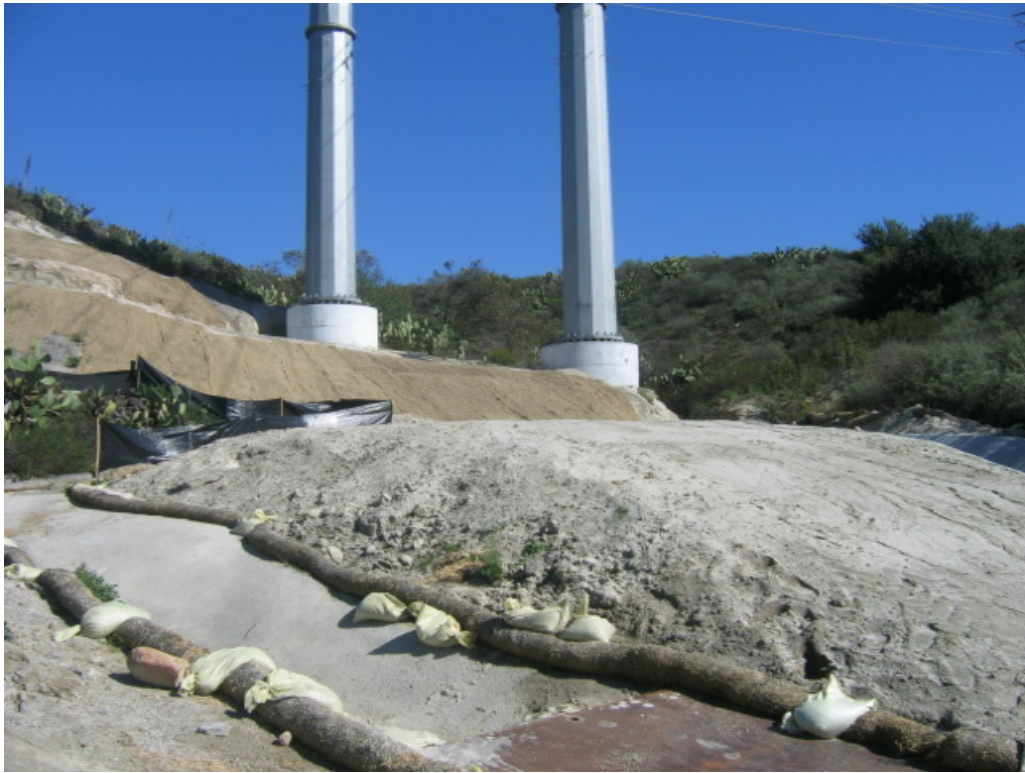
Figure 3 – Restored area near Viejo Substation.
SCE crews routinely check the right-of-way for erosion and BMP repair.
