# Environmental Minor Project Refinement Form

Project Name: West of Devers Upgrade Project Request Prepared By: Sylvia Granados

Date Approval Required: 5/29/2018 Variance Request No.: 14

Specify Source (e.g., Mitigation Measure B.5): Modification to NTP #3 Subtransmission Work Area Mapping.

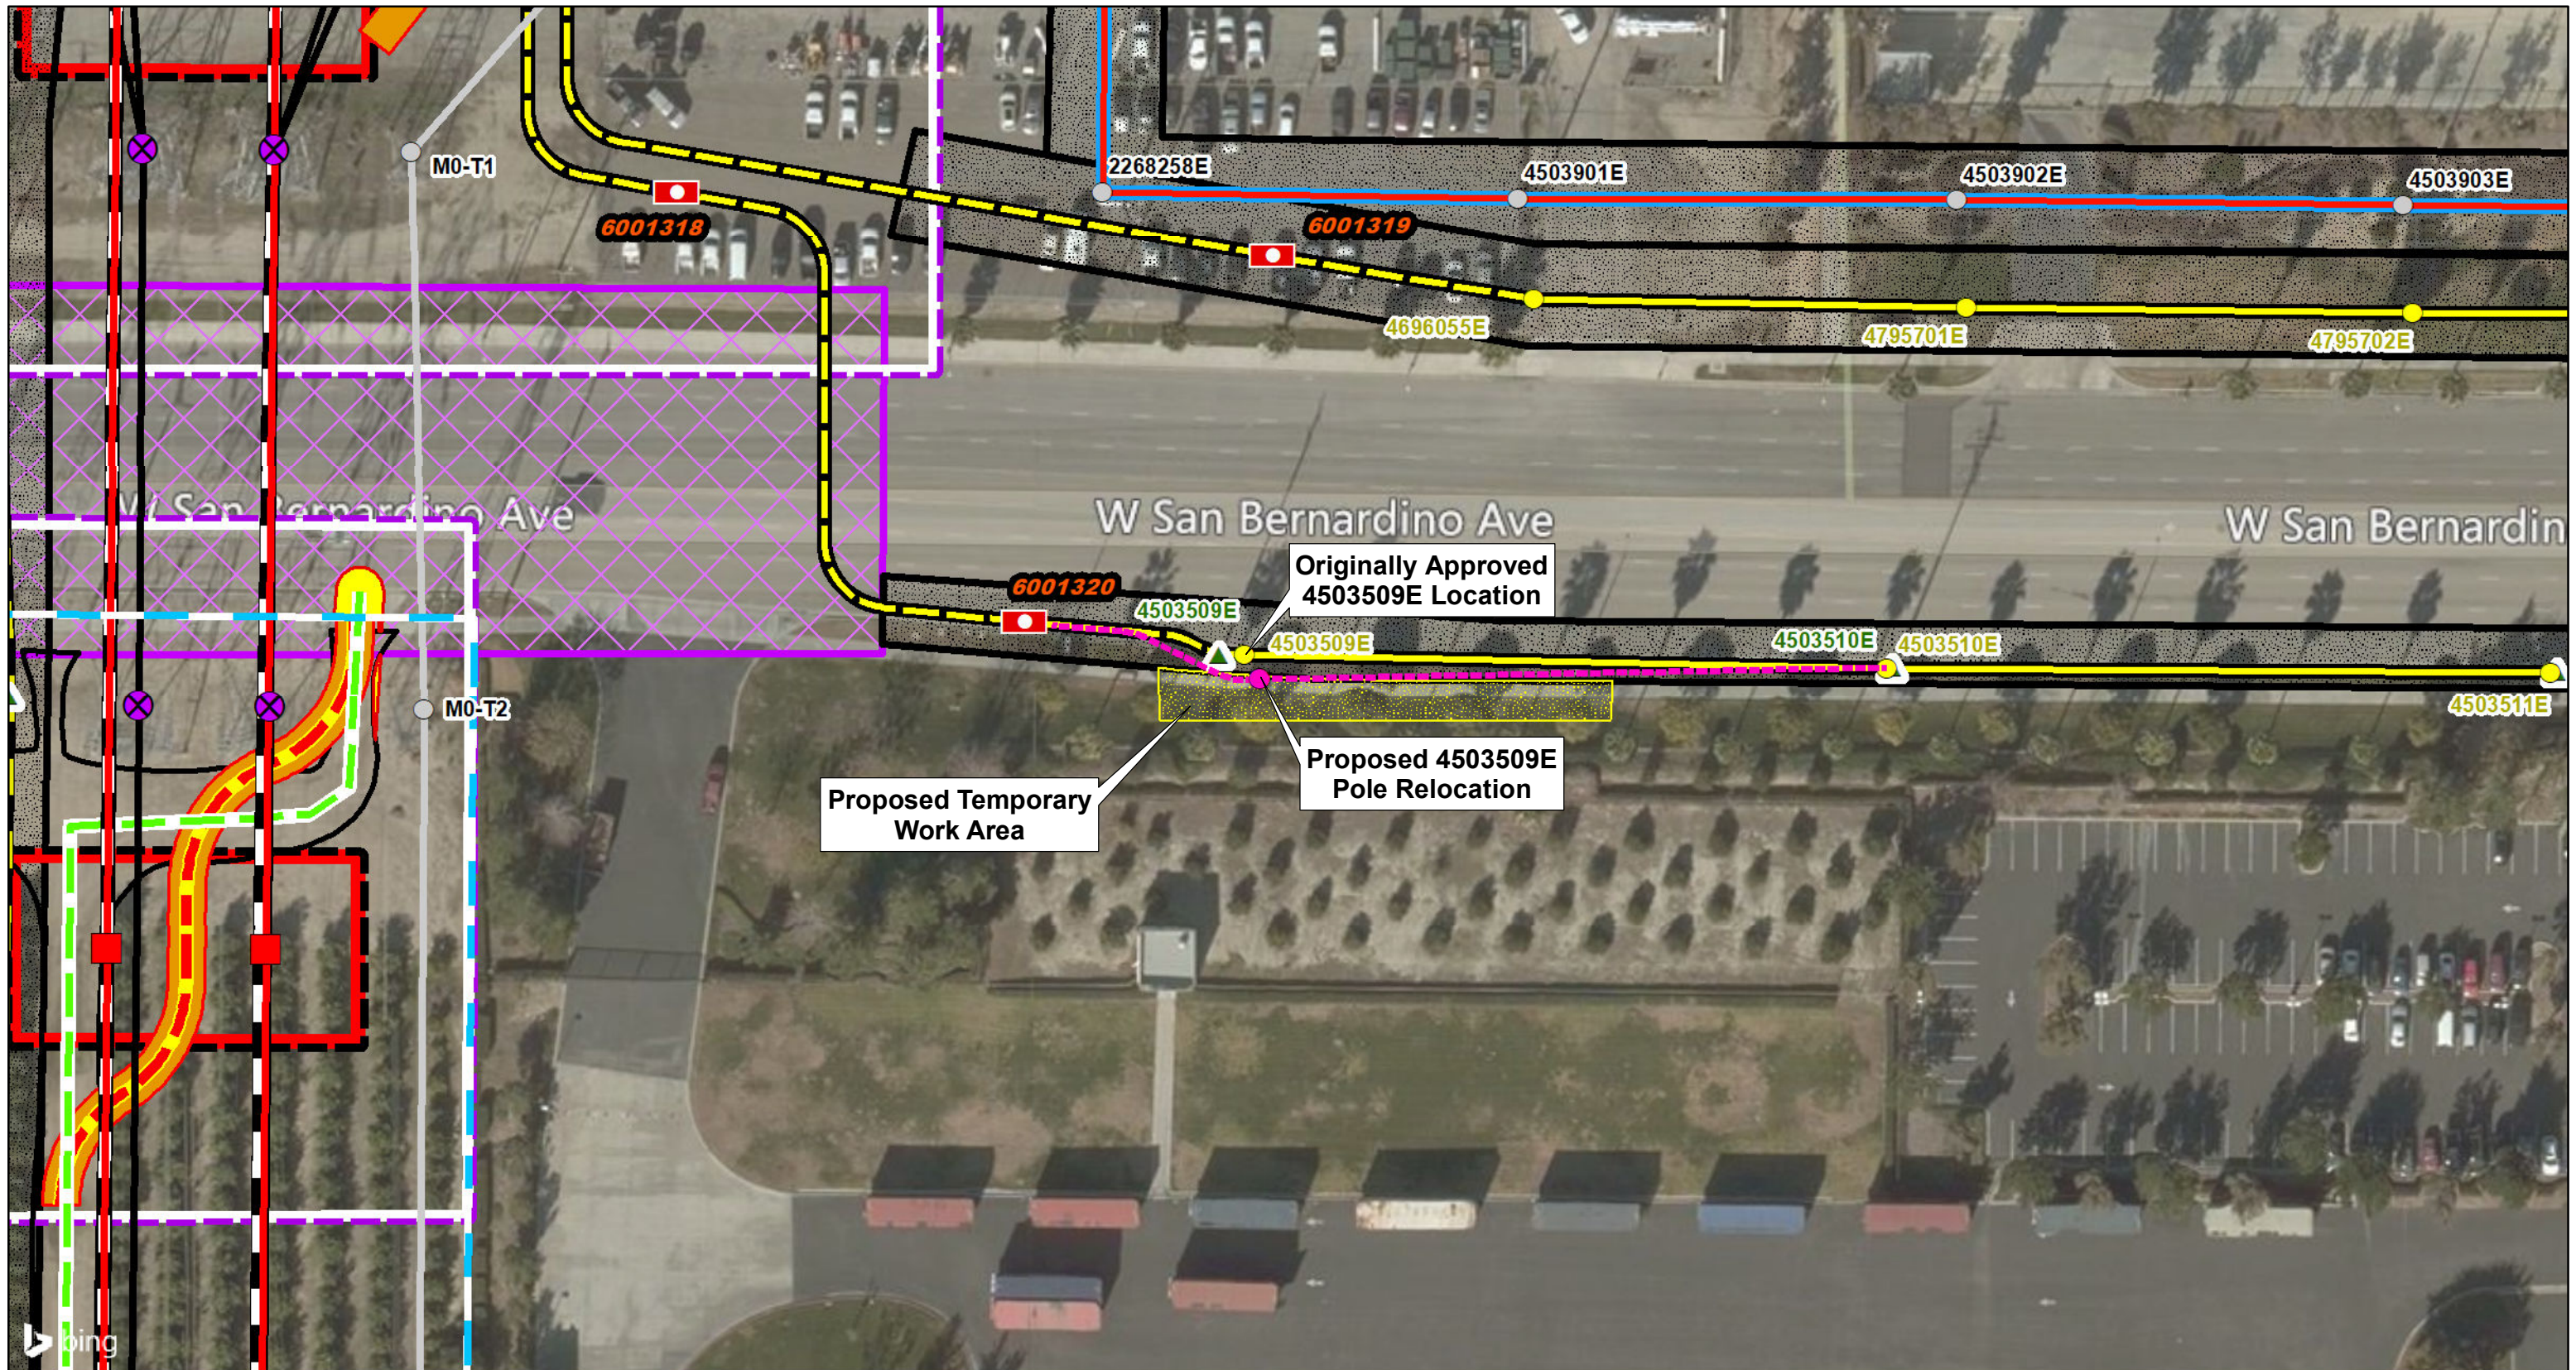
FIGURE 1

Due to underground utility conflicts encountered in the approved work area, the location of TSP 4503509E, along the San Bernardino–Redlands–Timoteo 66-kV subtransmission line, requires adjustment to the south, as shown in Figure 1.

The temporary impacts to developed/disturbed land associated with the redesign are 0.06 acre.

*Southern California Edison*  
 West of Devers Upgrade Project  
 San Bernardino Ave (West)  
 MPR #14  
 Subtransmission Changes

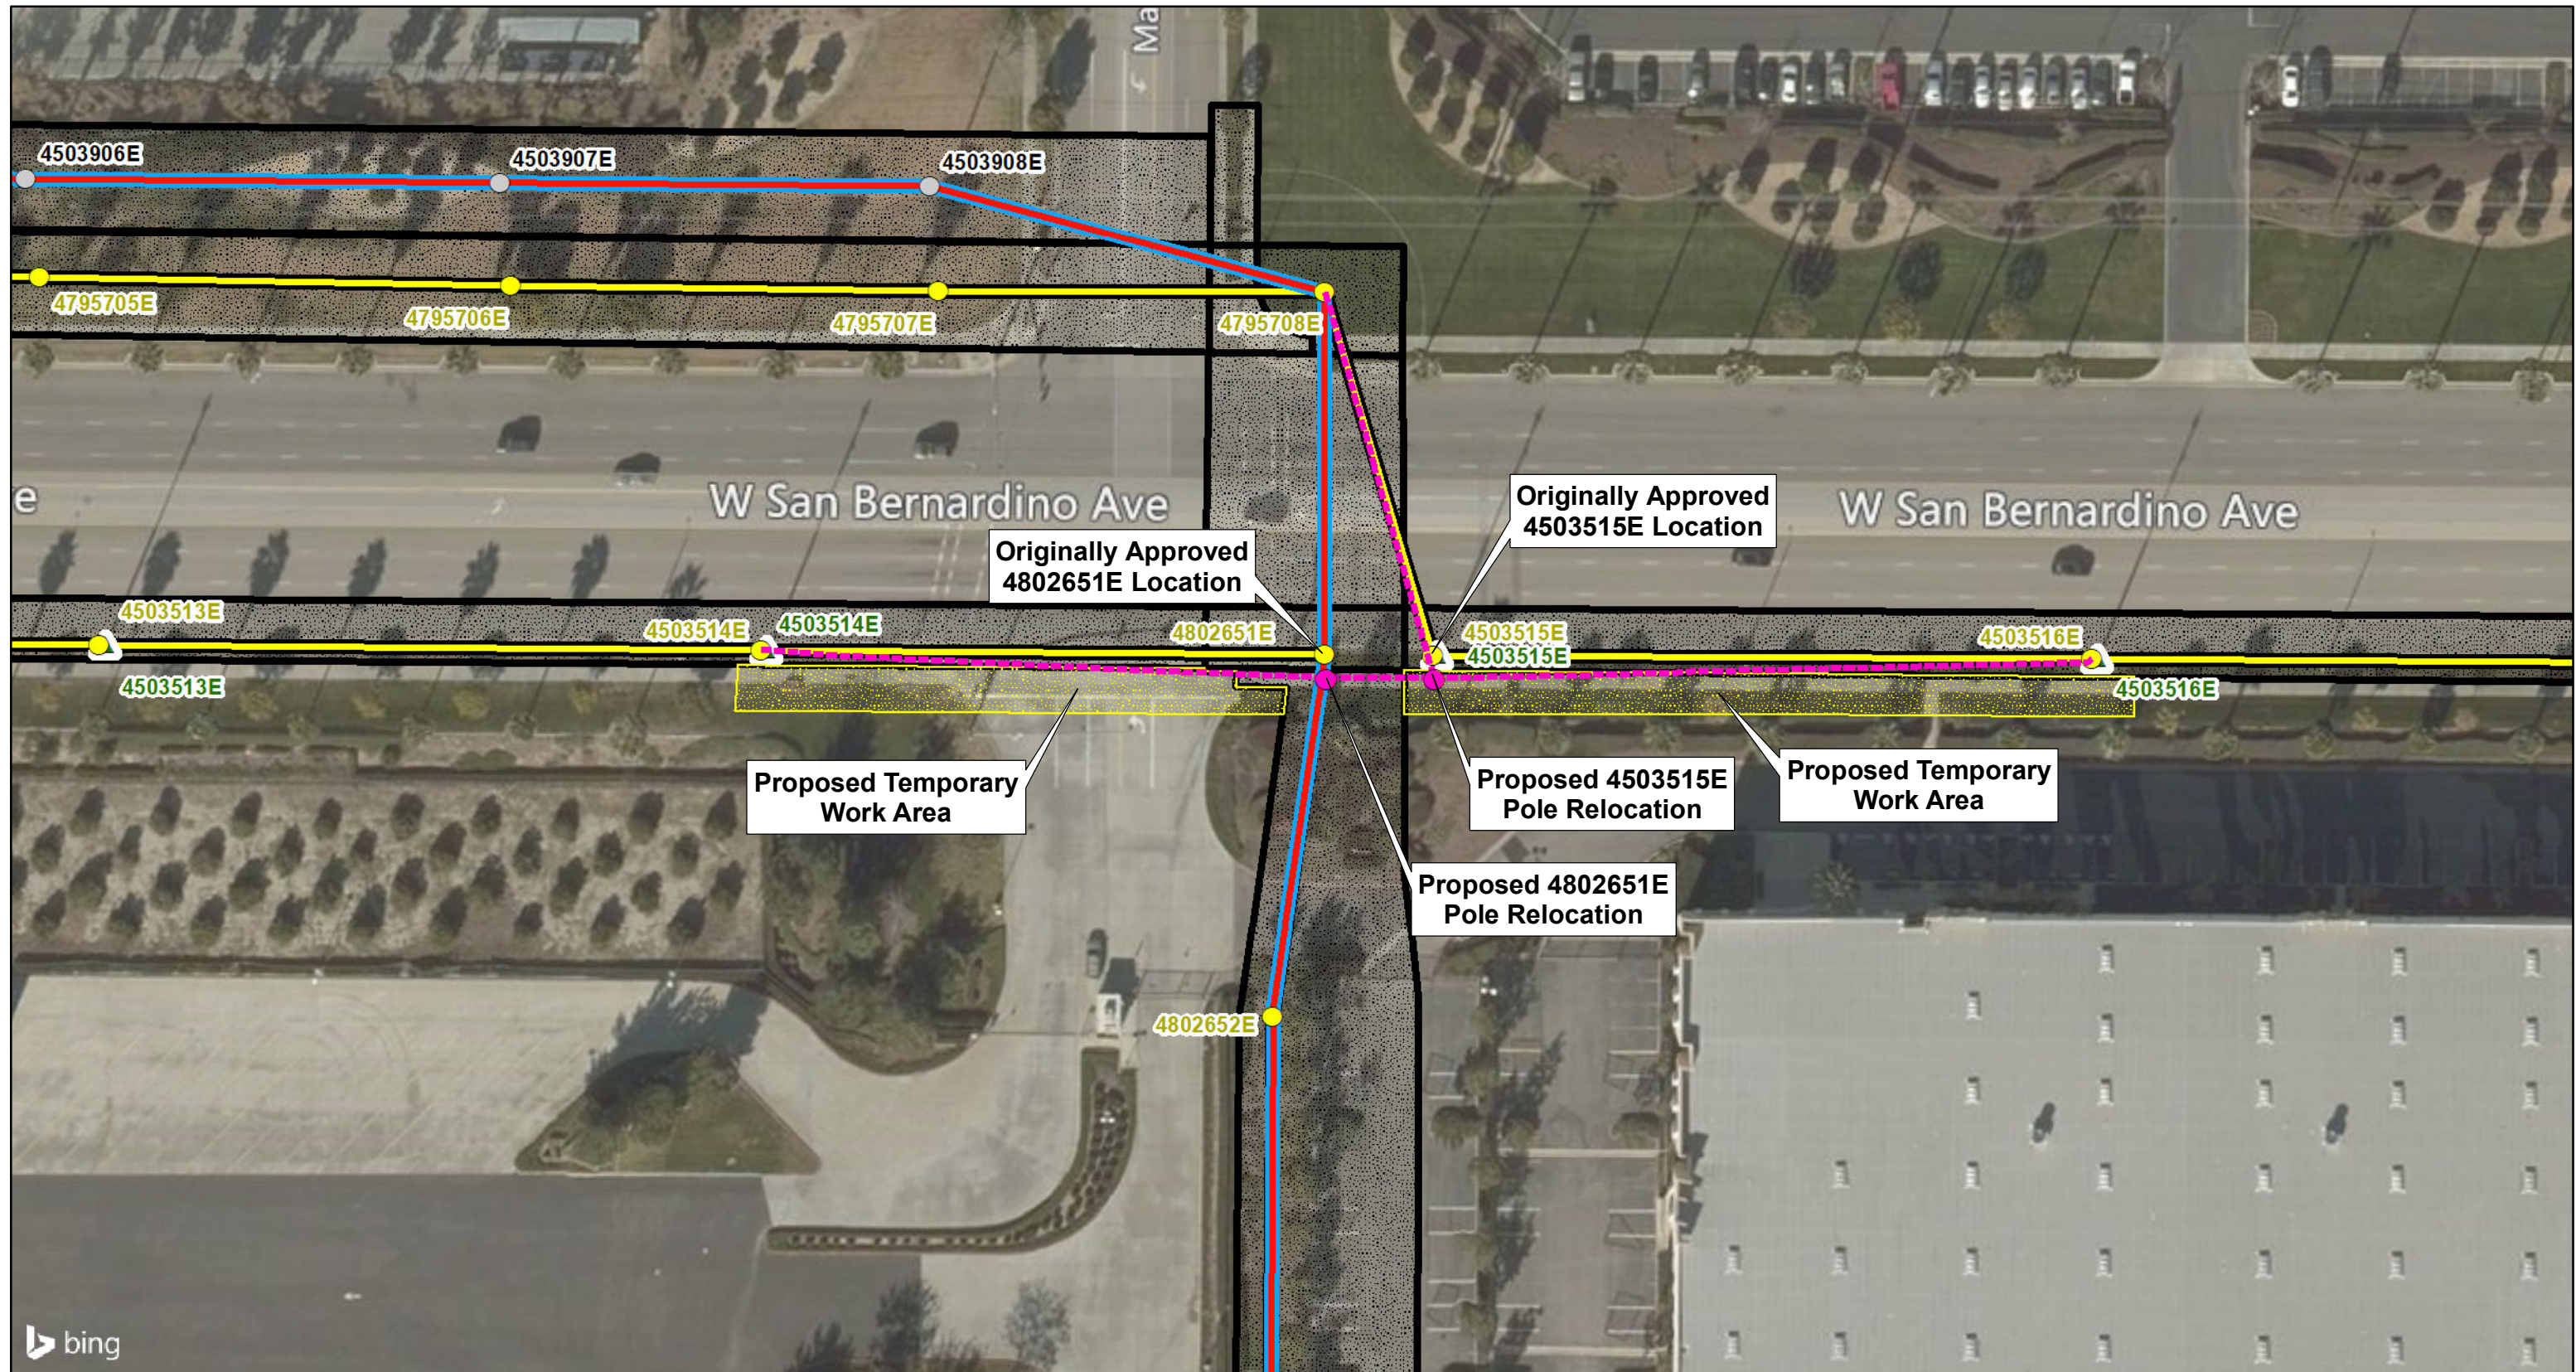
FIGURE 2

Due to underground utility conflicts encountered in the approved work area, the locations of TSP 4802651E, along the San Bernardino–Redlands–Timoteo 66-kV subtransmission line, and TSP 4503515E, along the San Bernardino–Redlands–Tennessee 66-kV subtransmission line, require adjustment to the south, as shown in Figure 2.

The temporary impacts to developed/disturbed land associated with the redesign are 0.18 acre.

*Southern California Edison*  
*West of Devers Upgrade Project*  
 San Bernardino Ave (East)  
**MPR #14**  
**Subtransmission Changes**

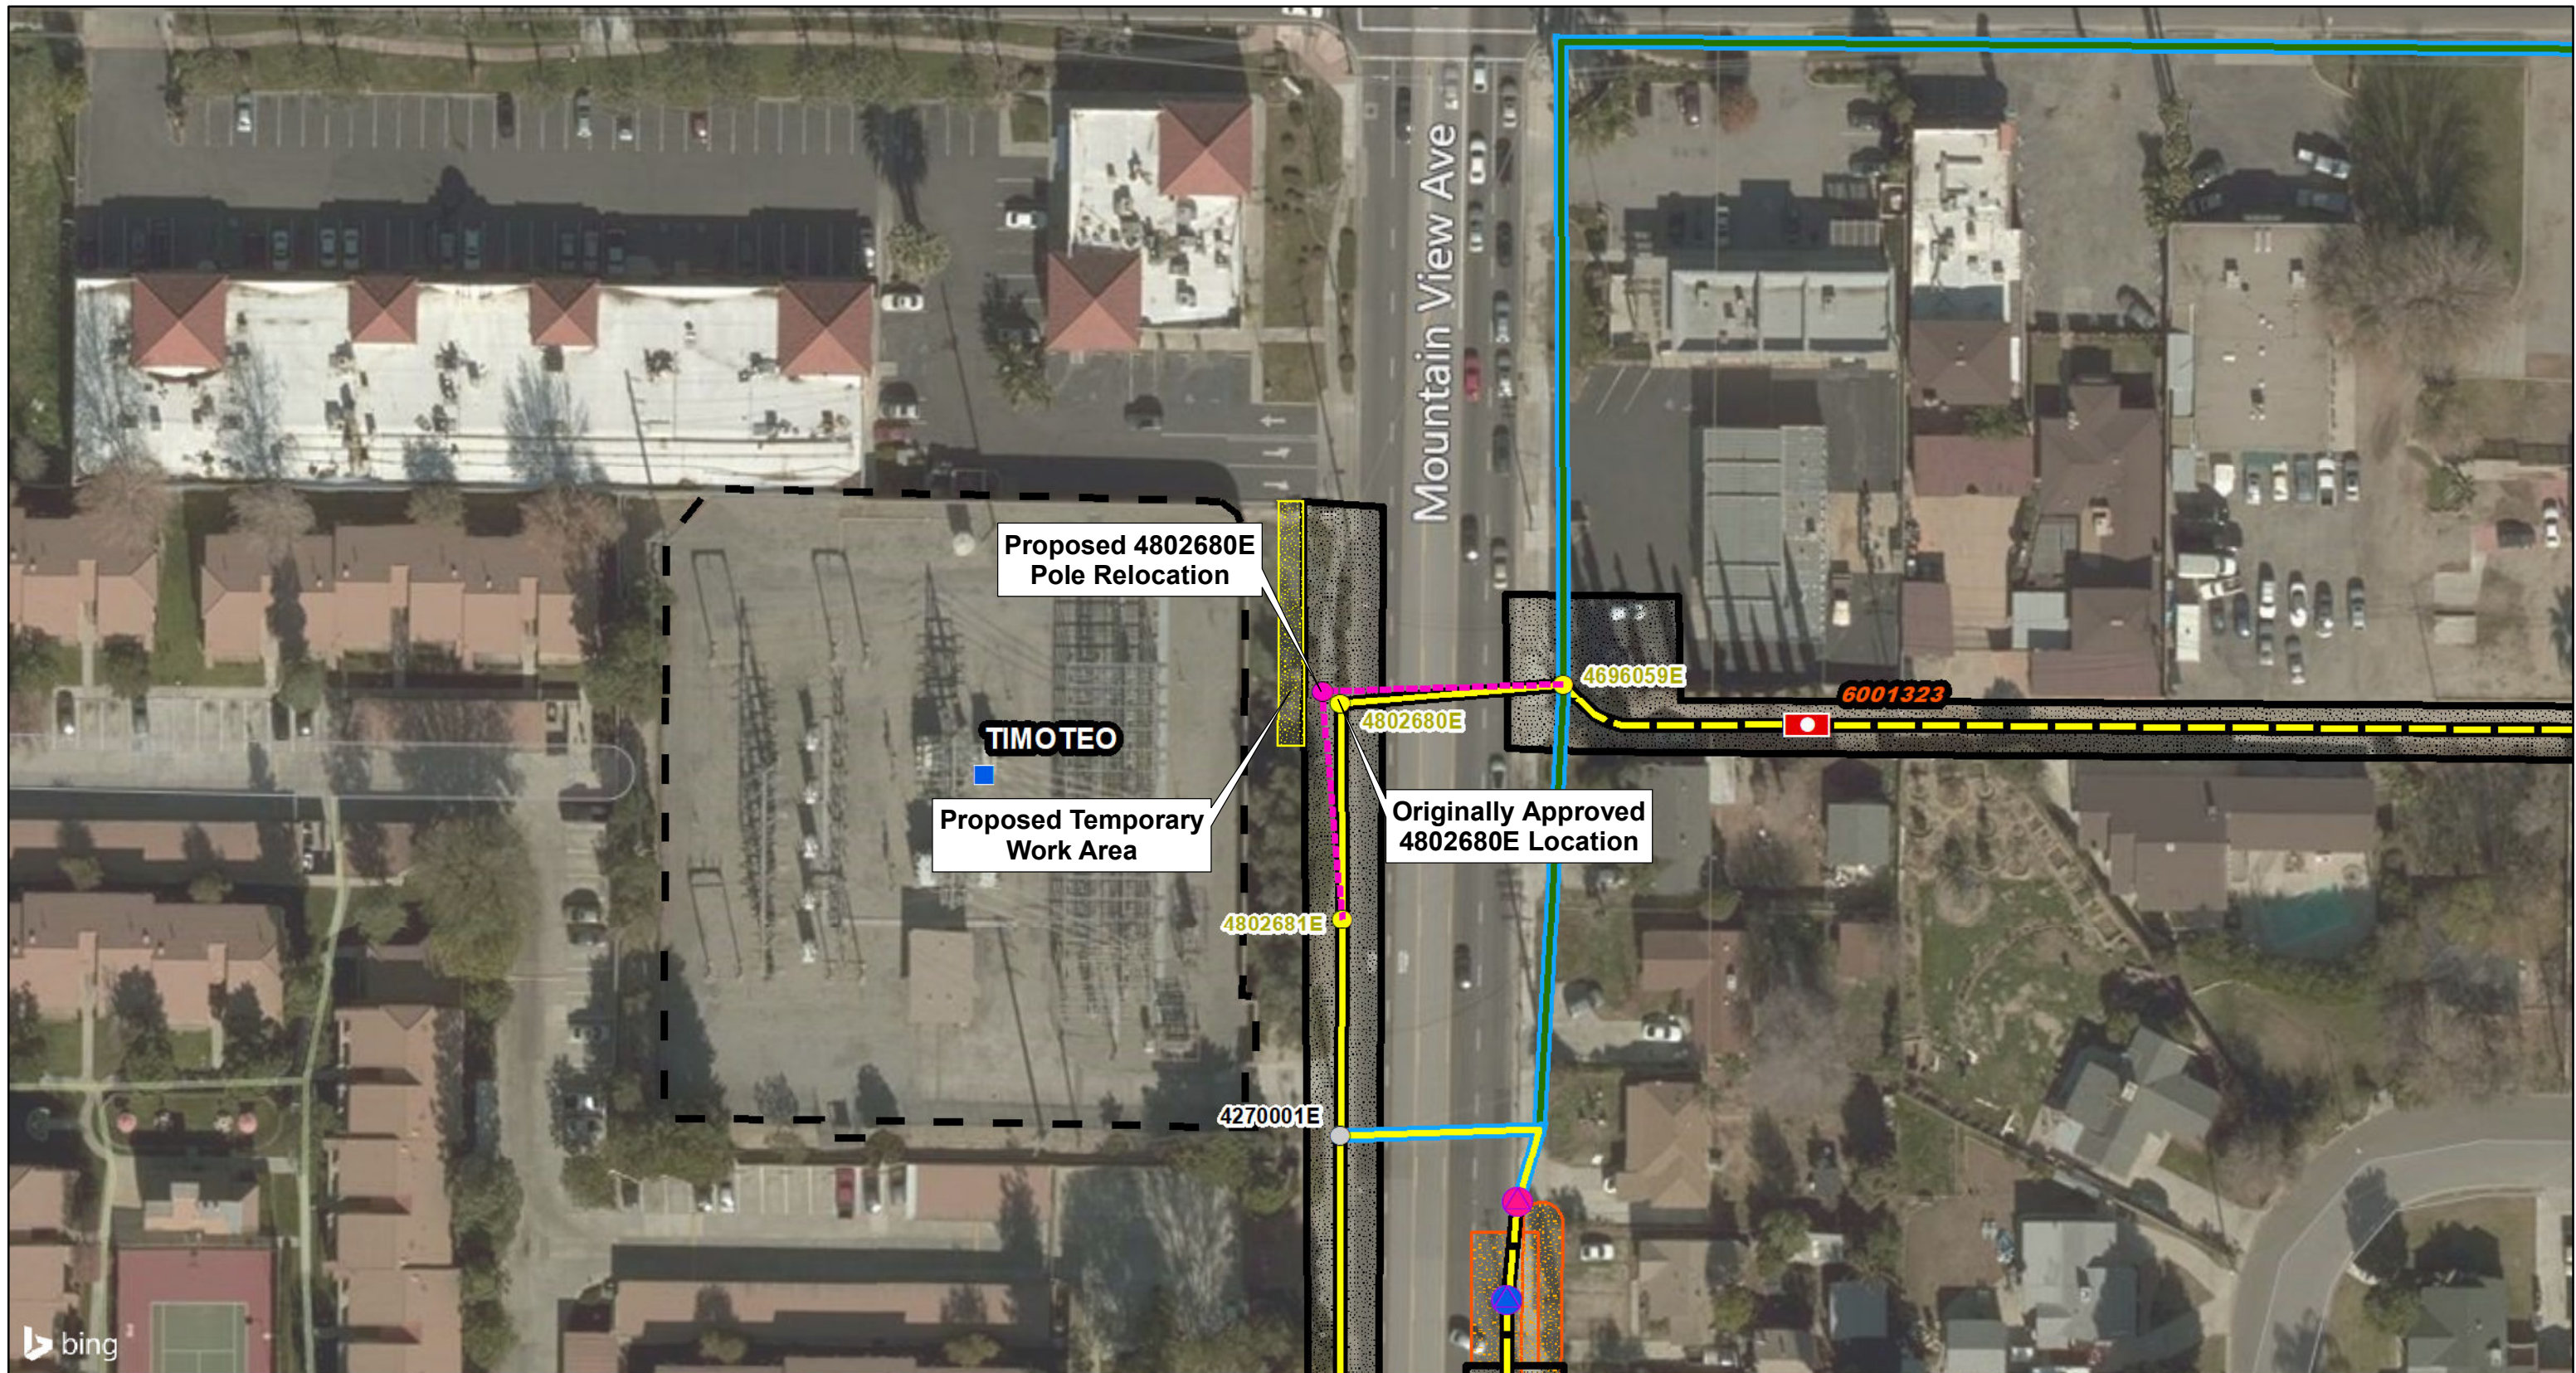
FIGURE 3

Due to underground utility conflicts encountered in the approved work area, the location of TSP 4802680E on Mountain View Avenue, along the San Bernardino–Redlands–Timoteo 66-kV subtransmission line, requires adjustment to the west, as shown in Figure 3.

The temporary impacts to developed/disturbed land associated with the redesign are 0.02 acre.

Mountain View Ave  
**MPR #14**  
**Subtransmission Changes**

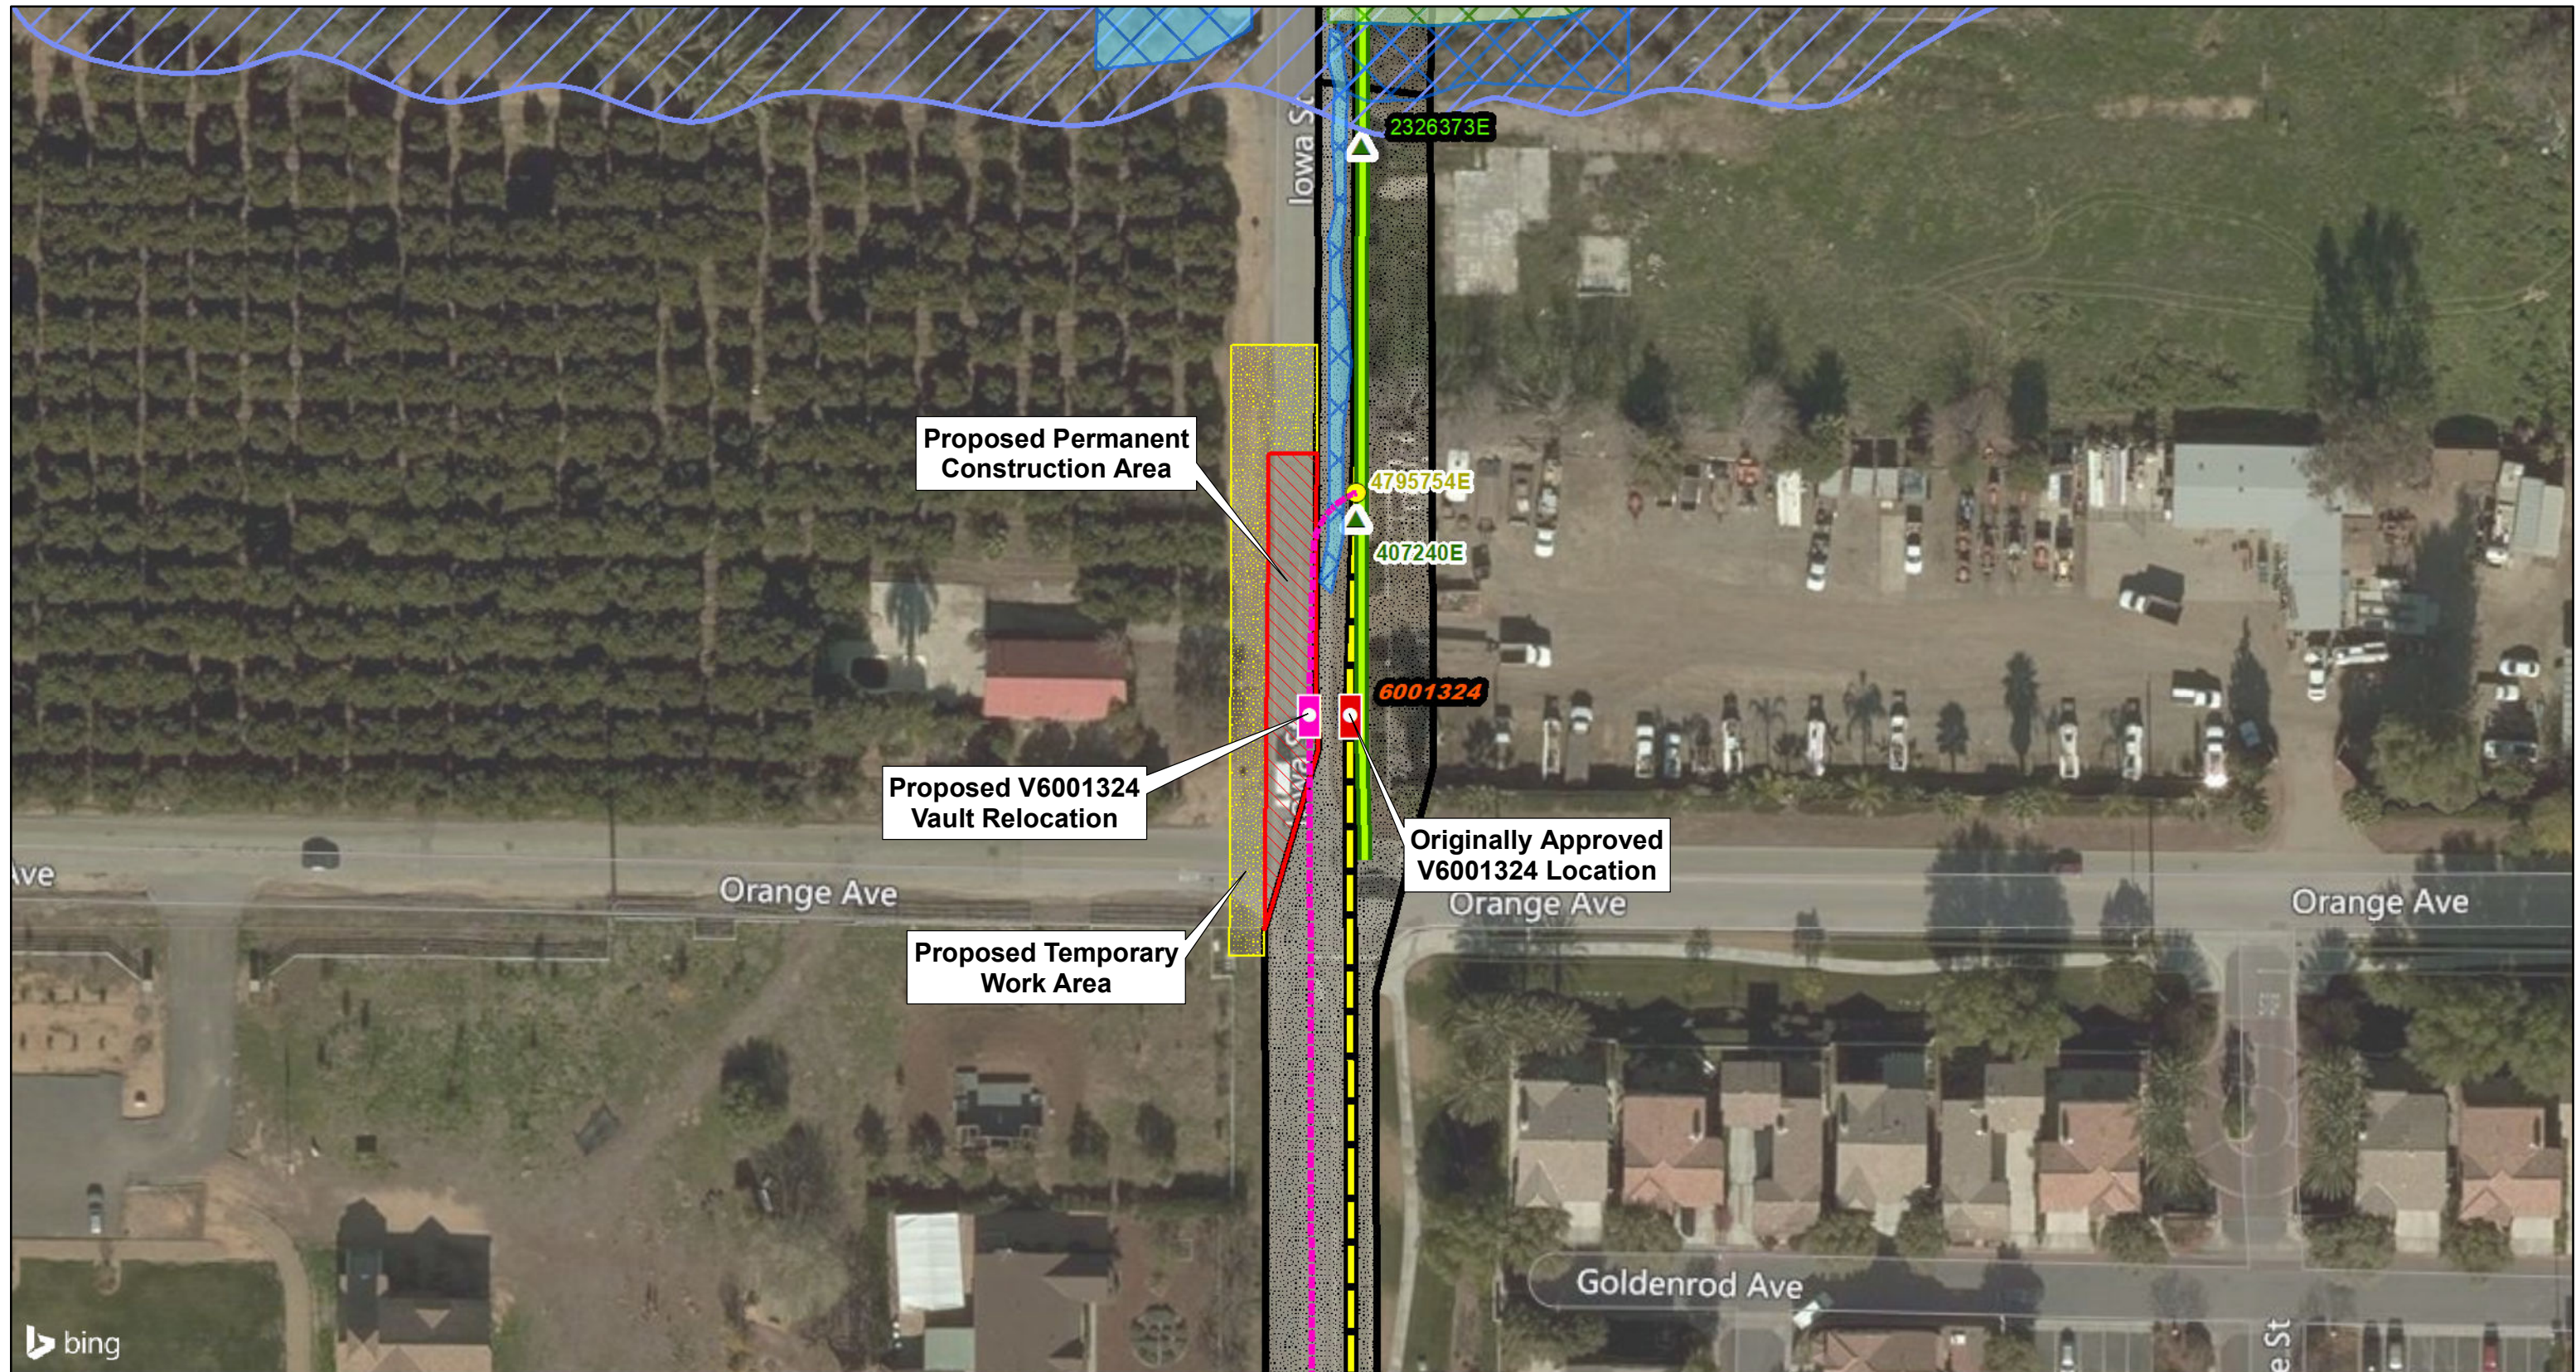
FIGURE 4

Due to underground utility conflicts encountered in the approved work area, a portion of the San Bernardino–Redlands–Tennessee subtransmission line and vault V6001324 require adjustment to the center of the road north of the intersection of Iowa Street and Orange Avenue, in the City of Redlands, as shown in Figure 4.

The temporary impacts to developed/disturbed land associated with the redesign are .15 acre.

Jurisdictional Waters – A jurisdictional feature is located north of Orange Avenue between structures 436540E and 2326373E. The jurisdictional feature, which intersects the work area, will be conspicuously staked for avoidance during construction activities.

Listed Riparian Birds – The work area along Iowa Street includes suitable habitats for riparian birds. Changes proposed in this MPR are located within 500 feet of a riparian habitat patch along Iowa Street, between Citrus and Orange. Beginning April 10, 2018, least Bell's vireo biologists John Green and Stephen J. Myers began least Bell's vireo protocol survey visits at this location. Both biologists are also authorized to survey for southwestern willow flycatcher under the authority of recovery permits TE054011-7 (Green) and TE804203-11 (Myers). Flycatcher surveys began after May 15 according to the protocol. No least Bell's vireo have been observed. Willow flycatchers have been observed in the habitat patch. However, migrant willow flycatchers of several subspecies are relatively common in passage in many southern California habitats. Migrants of that kind have been detected in the subject patch in the past. None stayed and none were considered the "southwestern" willow flycatcher subspecies. Due to the low and degrading quality of the habitat, lack of historic occurrences, and lack of presence over multiple years of project surveys, southwestern willow flycatchers are not expected.

Southern California Edison  
 West of Devers Upgrade Project  
 Iowa St & Orange Ave  
**MPR #14**  
**Subtransmission Changes**
