Environmental Minor Project Refinement Form

Project Name: West of Devers Upgrade Request Prepared By: Sylvia Granados

Maraschino Tap - Existing Underground Cable Removal

Devers Tap - Existing Overhead Cable Removal

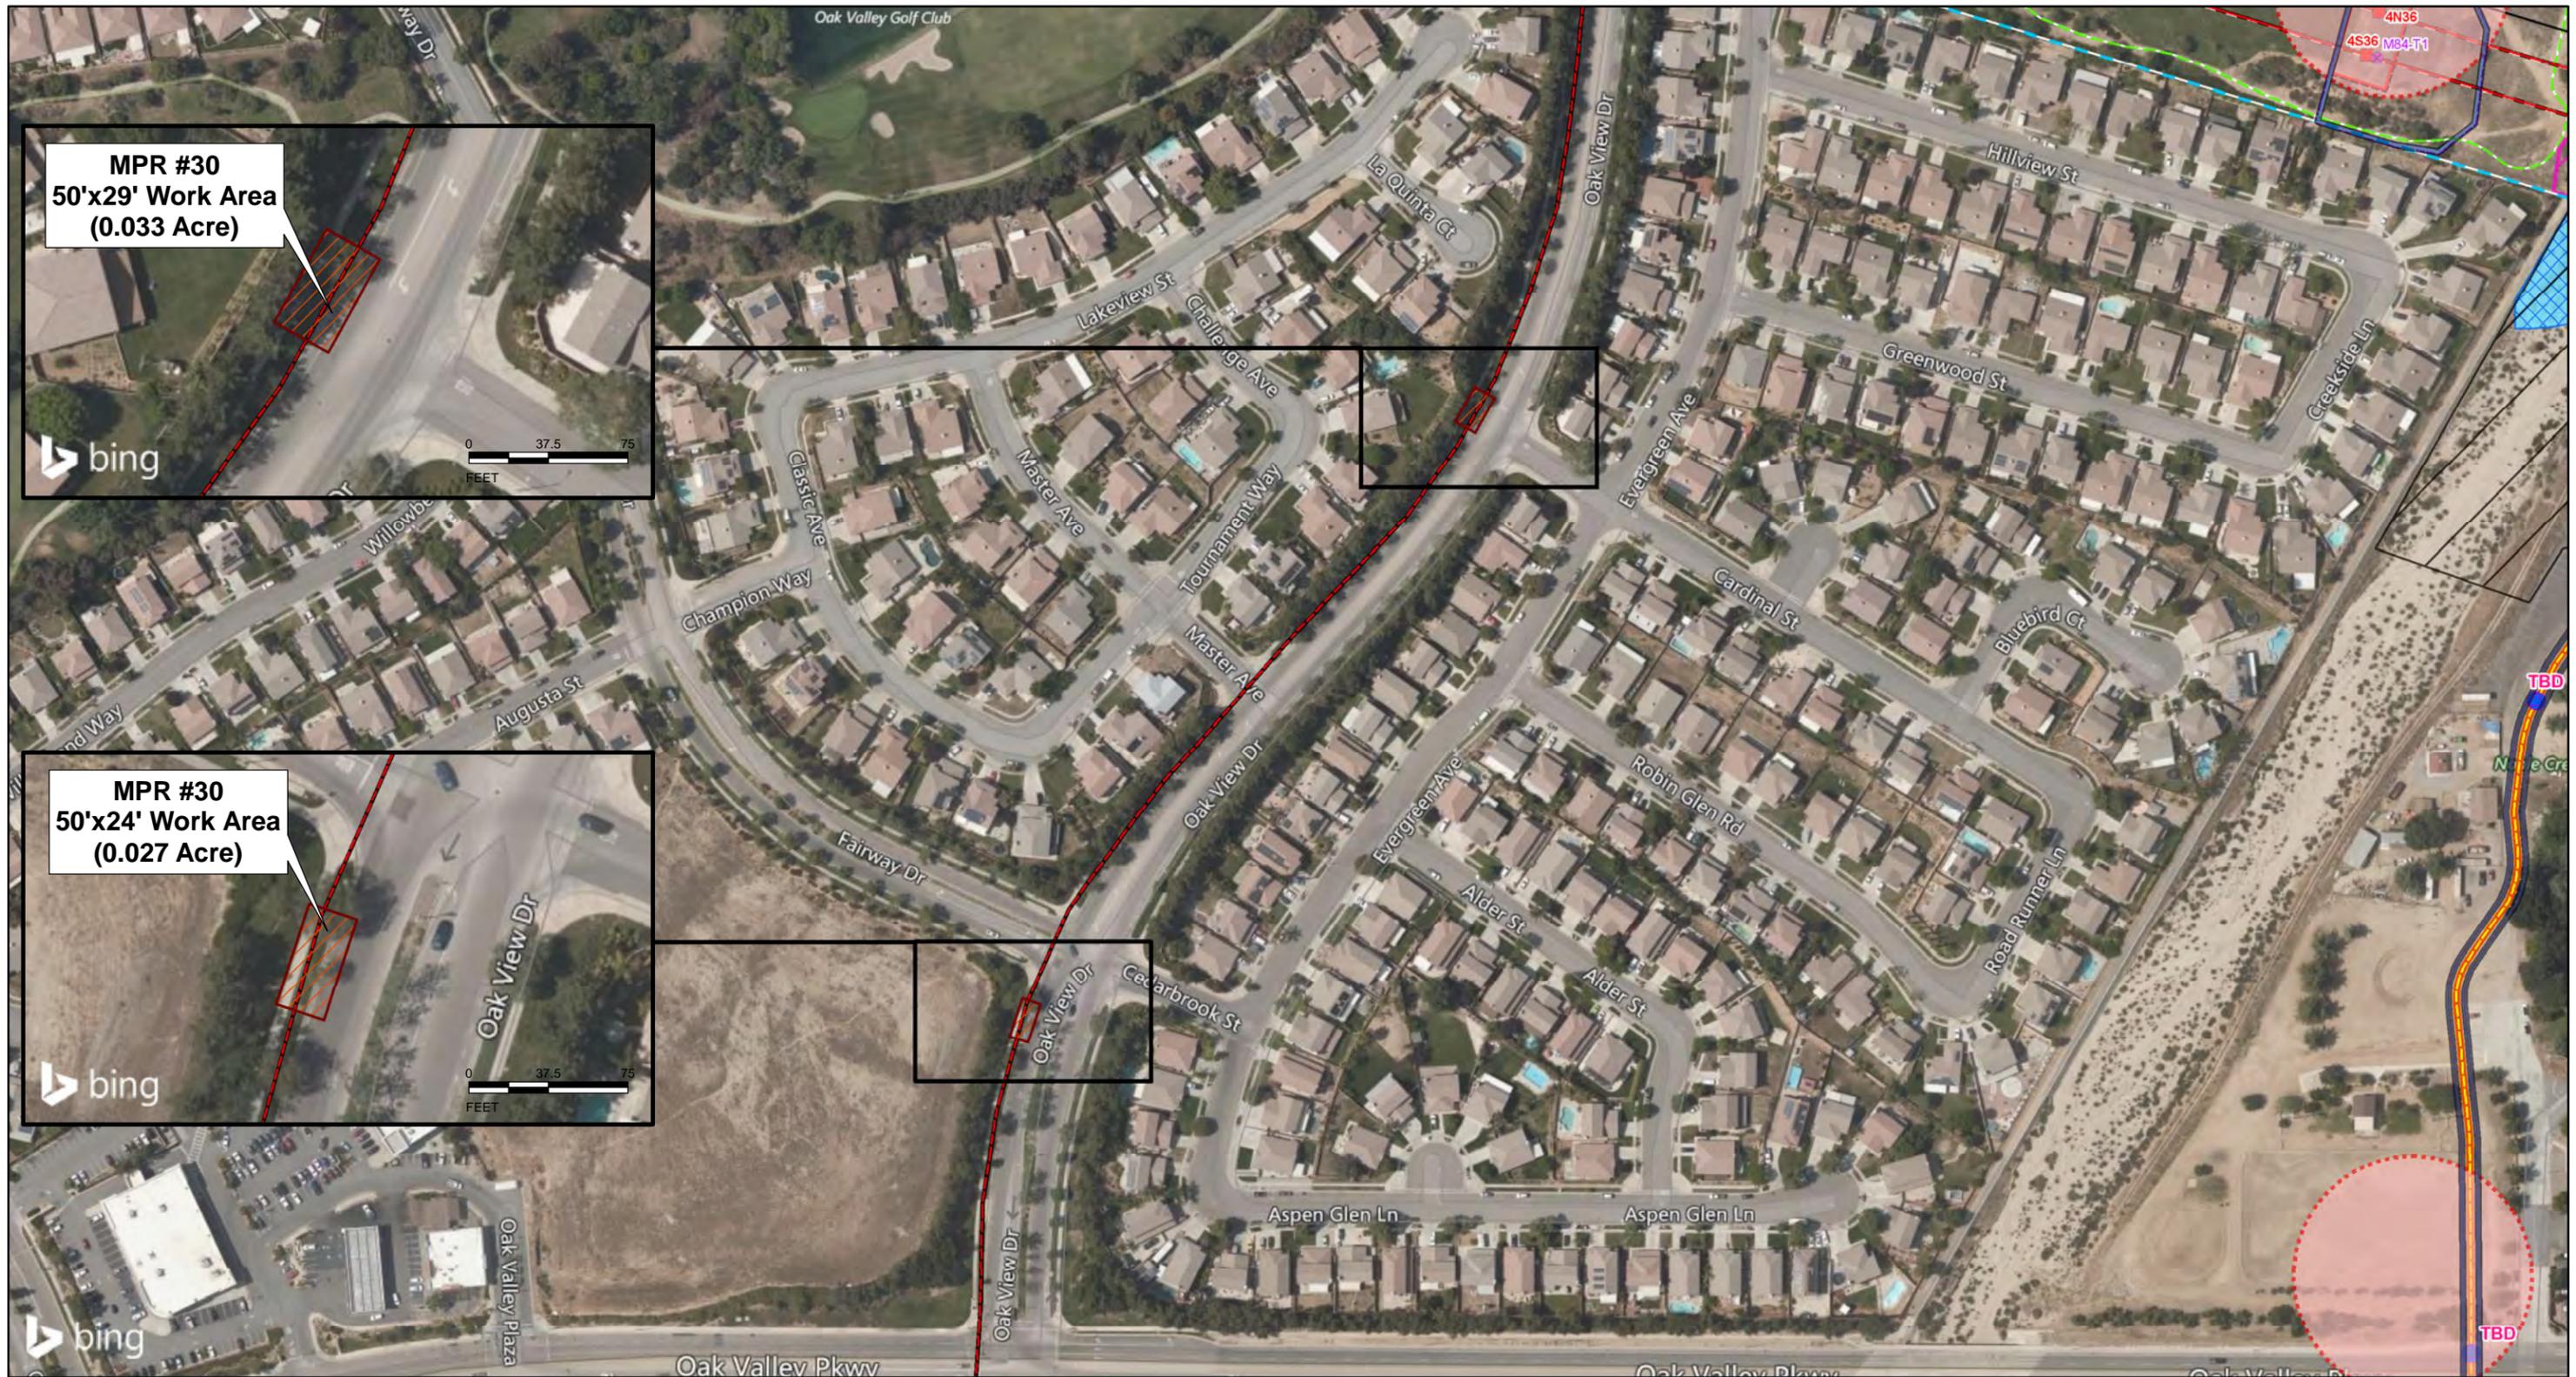
FIGURE 1

Two temporary work areas are required on the west side of Oak View Drive, north of Oak Valley Parkway and south of Fairview Drive in Beaumont, to facilitate the removal of existing underground telecommunication cable from two existing manhole locations, as shown in Figure 1. The new work areas will be used to park construction vehicles along the concrete curb on the paved street and stage material and equipment adjacent to the existing manhole locations on the sidewalk and remove existing cable. No ground disturbance is required in the new work areas.

The temporary work areas each consist of approximately 0.03 acre of developed/disturbed land located in the public right of way in Beaumont, Riverside County.

Southern California Edison
West of Devers Upgrade Project
Maraschino Tap Work Areas
MPR #30

The Oak View Drive work areas (Figure 1) are not located within the range of the DETO; therefore, no impacts to DETO are anticipated at those locations.

The Oak View Drive work areas (Figure 1) are not suitable habitat for special-status small mammals; therefore, no impacts are anticipated at those locations.

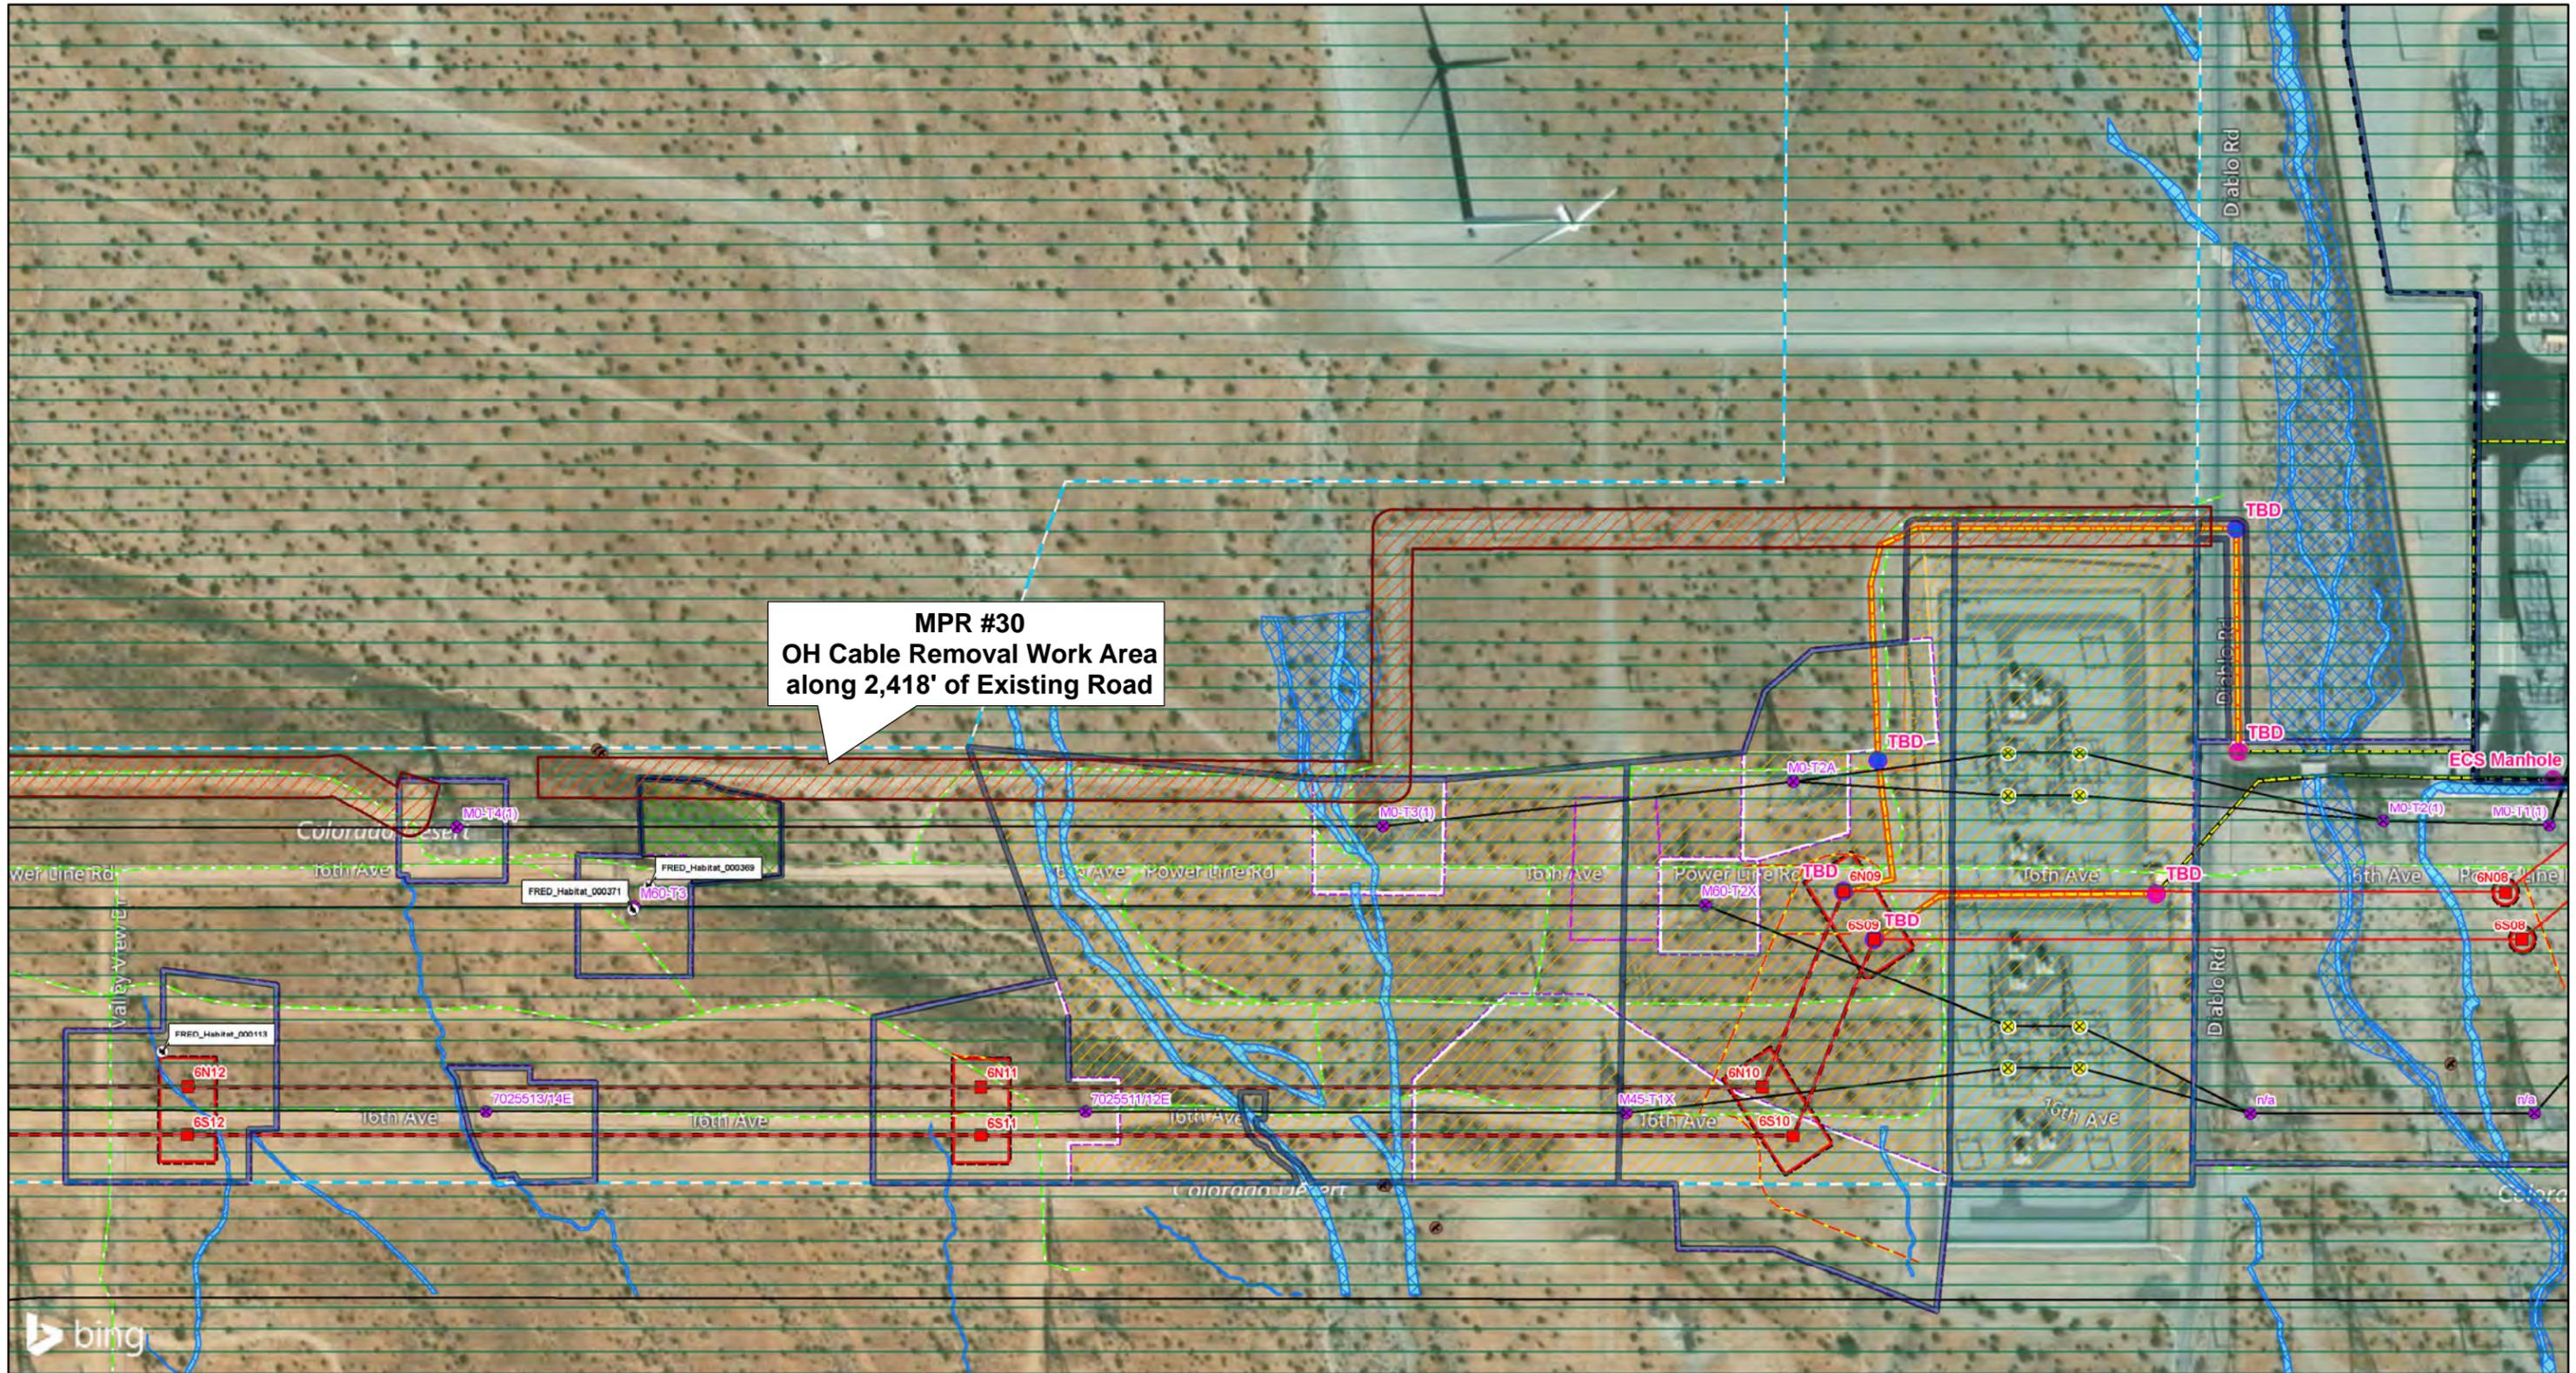
FIGURE 3
Page 2

The existing access road from tower M1T1 east to Diablo Road is required to remove existing overhead telecommunication cable from existing poles along the access road, as shown in Figure 2. The new work area will be used to stage construction vehicles, material, and equipment along the existing access road, adjacent to the existing distribution poles and remove the overhead cable. No ground disturbance is required to improve the existing access road in the new work locations.

The work area associated with the cable removal consists of approximately 5,380 linear feet of developed/disturbed access road. The land is located within the existing SCE transmission line right-of-way in Riverside County.

**MPR #30
OH Cable Removal Work Area
along 2,418' of Existing Road**

Southern California Edison
West of Devers Upgrade Project
M1-T1 to Diablo Road Work Area
MPR #30

Desert Tortoise (DETO) – The new work area along the Segment 6 access road associated with the Devers Tap overhead cable removal is located within desert tortoise modeled habitat.
