Environmental Minor Project Refinement Form

Project Name: West of Devers Upgrade Project **Request Prepared By:** Sylvia Granados

Southern California Edison
West of Devers Upgrade Project
Proposed Work Areas

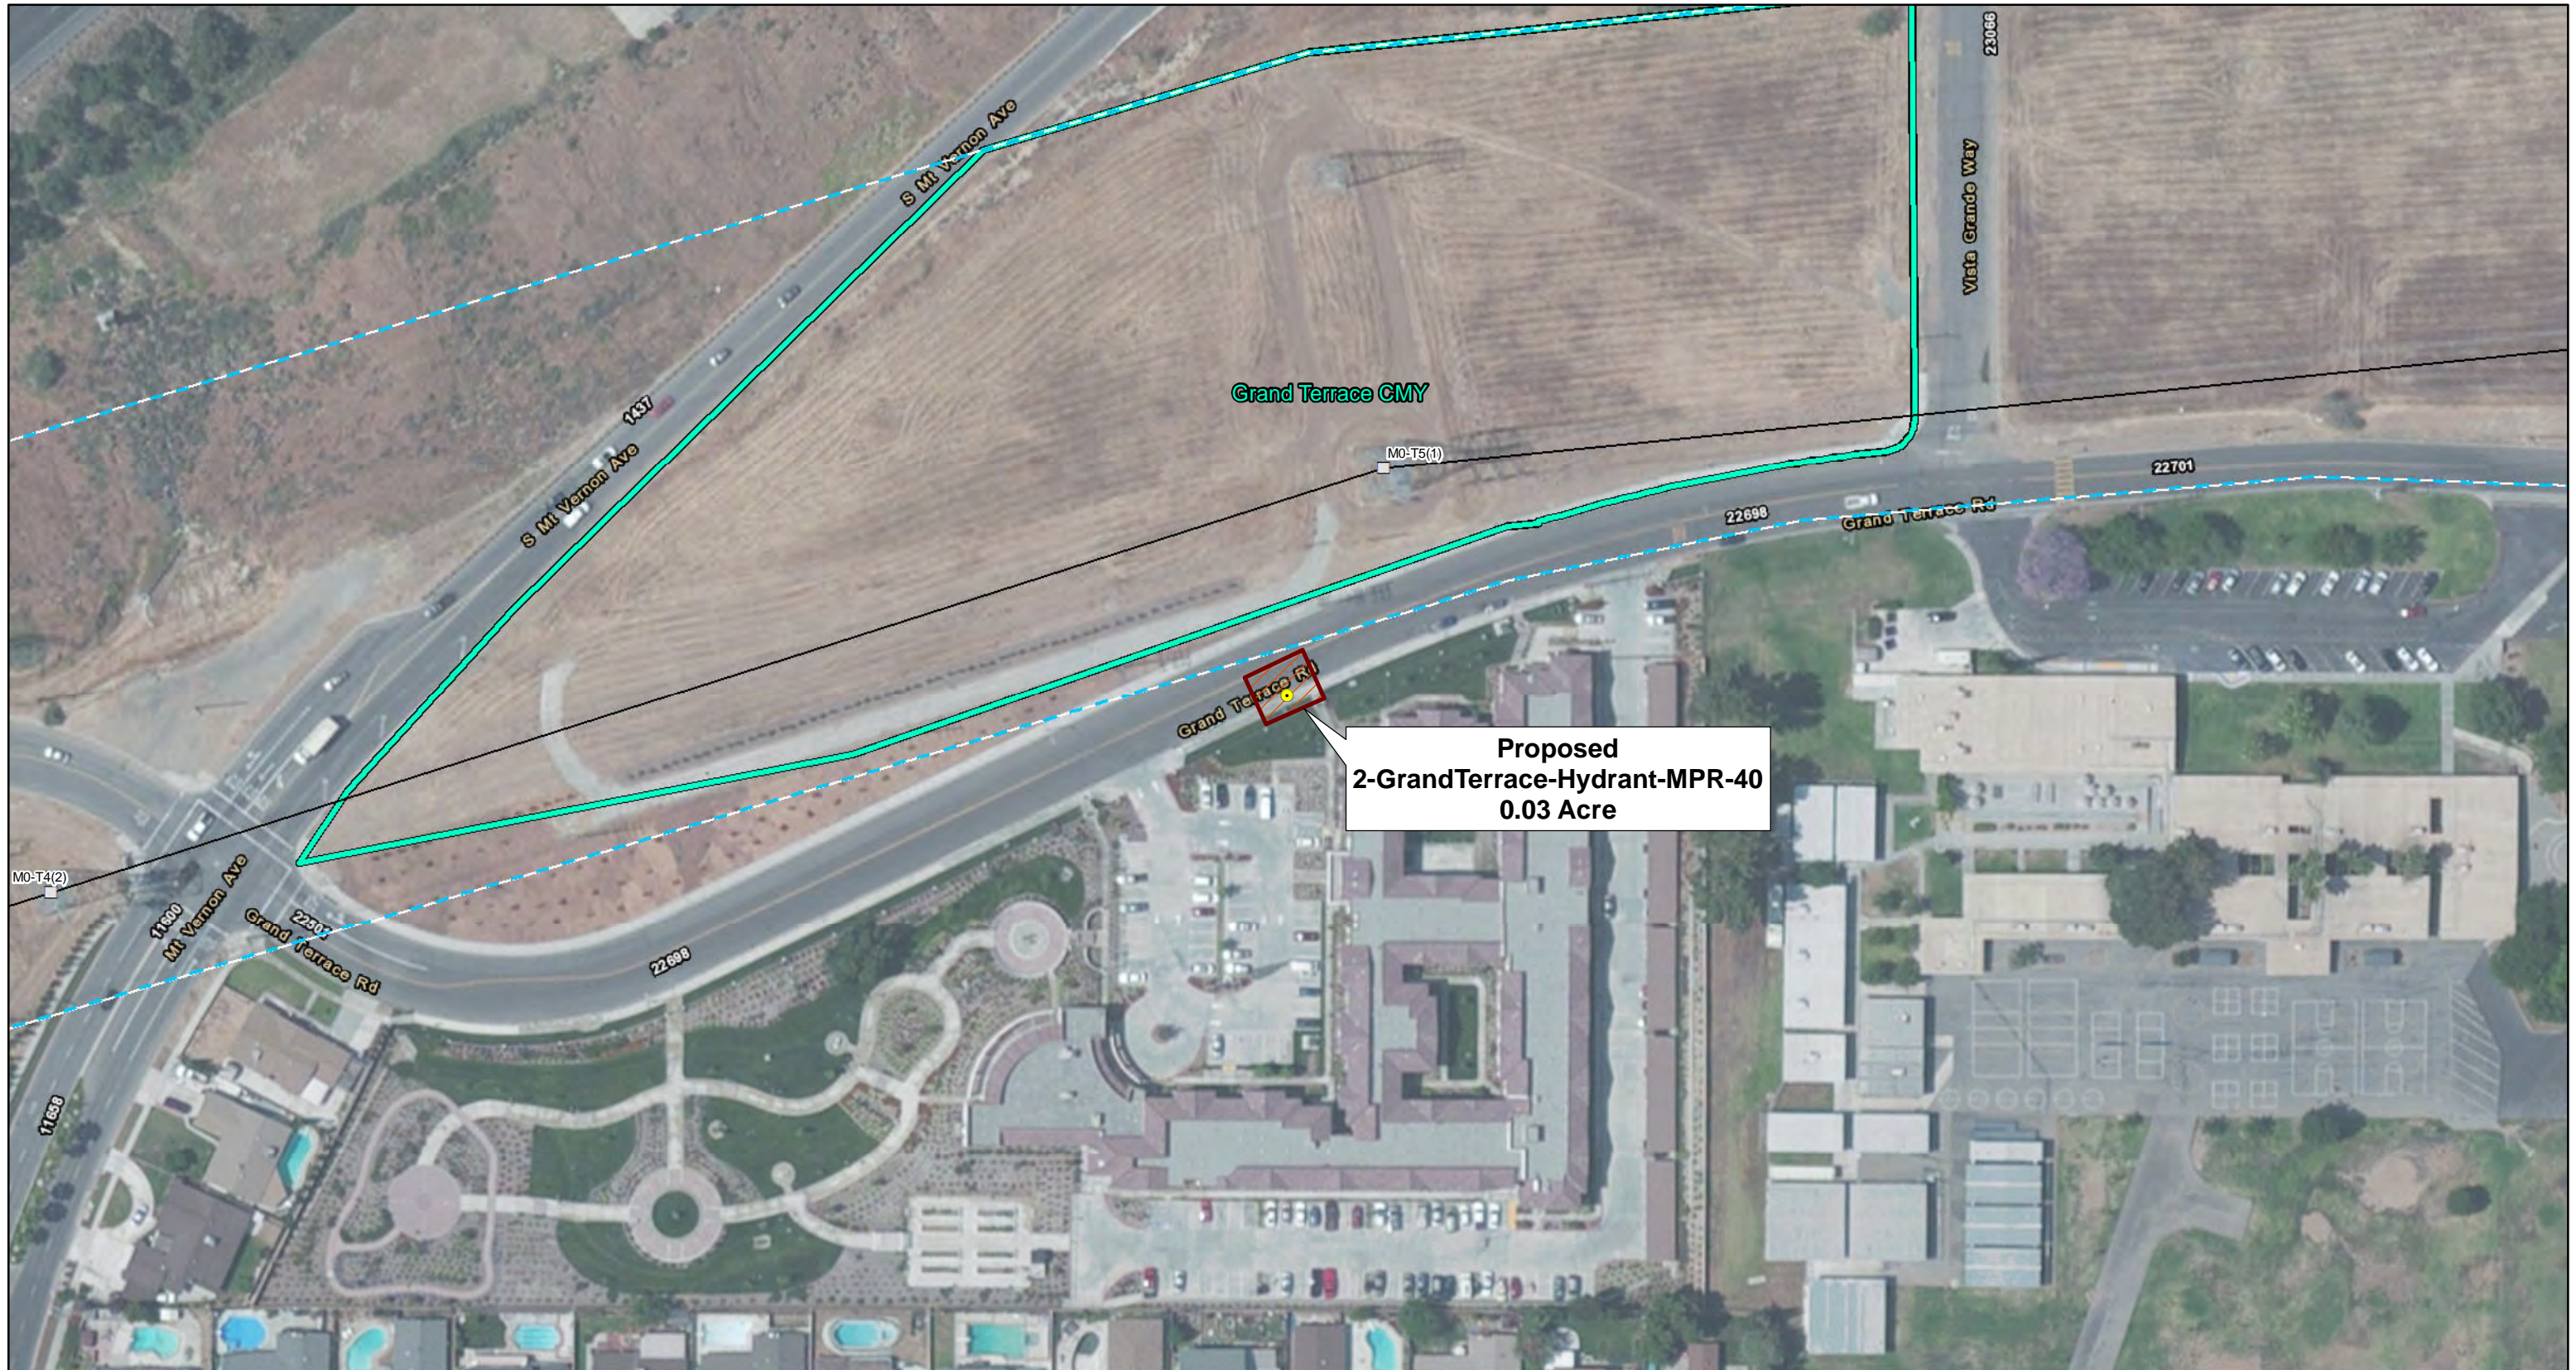
2-GrandTerrace-Hydrant-MPR-40 (Figure 1, page 1)

Rubber tired water trucks will park along the concrete curb of the paved, public road immediately south of the Grand Terrace Material Yard to access the potable water hydrant shown on Figure 1, page 1. Only occasional short-term filling of water trucks will occur at the location, while allowing continued access to local land uses. No ground disturbance will occur at the water source location. All Water Districts/Agencies listed in the FEIR were contacted to determine the availability of non-potable water as an alternative water source, however no non-potable water service exists in this vicinity of Segment 2.

The total temporary disturbance area associated with the new work area, previously approved for use in TEWS #27, consists of approximately .03-acre of previously disturbed/developed street/sidewalk and the hydrant owned and operated by the Riverside Highland Water Company in City of Grand Terrace.

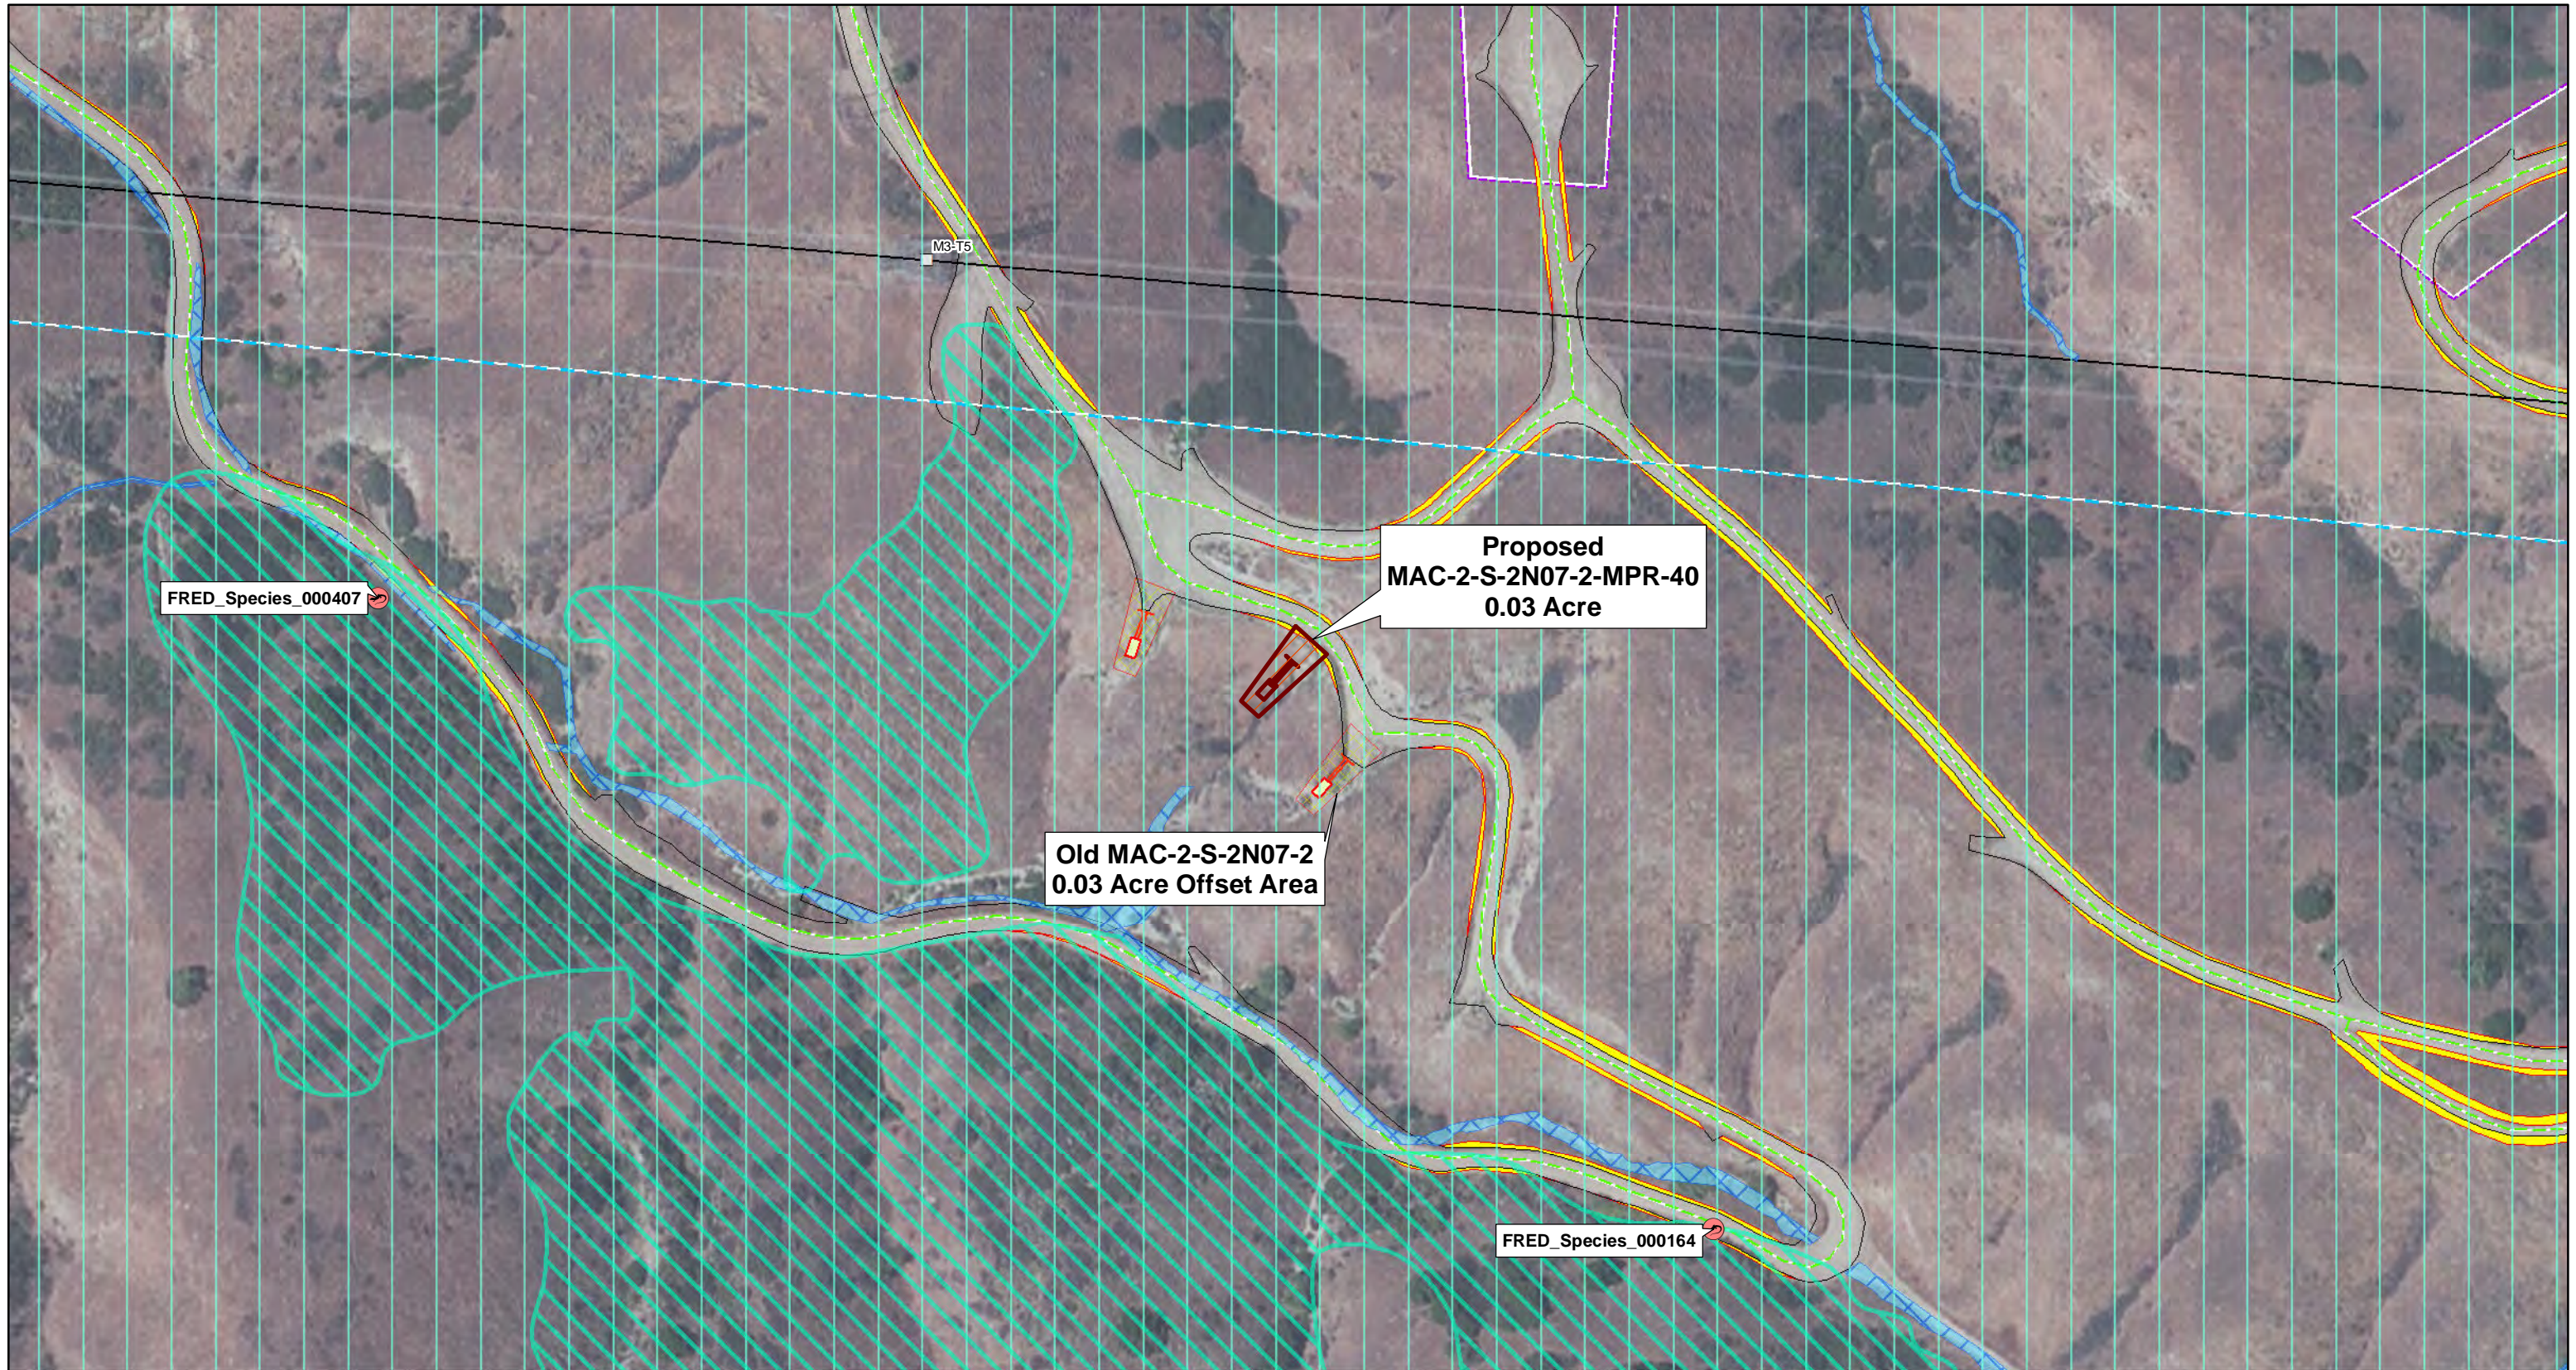
MAC-2-S-2N07-2-MPR-40 (Figure 1, page 3)

The location of MAC-2-S-2N07-2 has been redesigned and relocated to the west, as shown in Figure 1, page 3, to better capture and divert rain flow off the access road and discharge flows downstream to uplands. The relocation of the McCarthy drain will not result in additional project impacts, because the original location will not be constructed, and will therefore offset disturbance impacts for the new McCarthy drain location, as shown on Figure 1, page 3.

The new McCarthy drain location is located along an approved utility access road in the City of Loma Linda, in San Bernardino County, and consists of approximately 0.01-acre of developed/disturbed land and 0.02-acre of grassland/forbland.

Coastal California Gnatcatcher [CAGN] – MAC-2-SE-2N12-1-MPR-40 and MAC-2-S-2N07-2-MPR-40 are located within USFWS-designated Critical Habitat for coastal California gnatcatcher. See Figure 1, pages 2 and 3. Suitable CAGN habitat is located approximately 150 feet west and southwest of MAC-2-S-2N07-2-MPR-40. Focused surveys for CAGN were conducted in March and April 2018. No CAGN were detected in Segment 2. Due to a history of subsequently negative CAGN survey results in the area, no impacts to CAGN are anticipated.

To offset additional impacts to Critical Habitat subject to mitigation, the originally planned McCarthy drain locations (totaling 0.06-acre) will not be constructed and will therefore offset the new McCarthy drain locations (totaling 0.05-acre), as shown on Figure 1, pages 2 and 3. The original McCarthy drain locations will be removed from the project data upon approval of this MPR.
