Southern California Edison  
West of Devers Upgrade Project  
2012 and 2013 Drainage Assessment Results

*Proponent's Environmental Assessment  
West of Devers Upgrade Project*

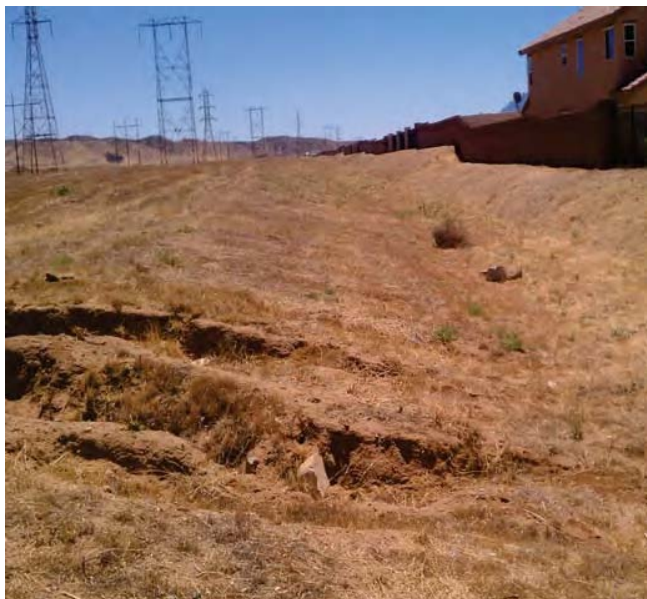
Erosion rills are formed by overland water flows that erode the soil surface during rain events and rills may deepen into gullies. Both are typically formed on valley sides and floors where no well-defined channel previously existed. If these features lack a connection with a drainage they are called rills and are not jurisdictional.

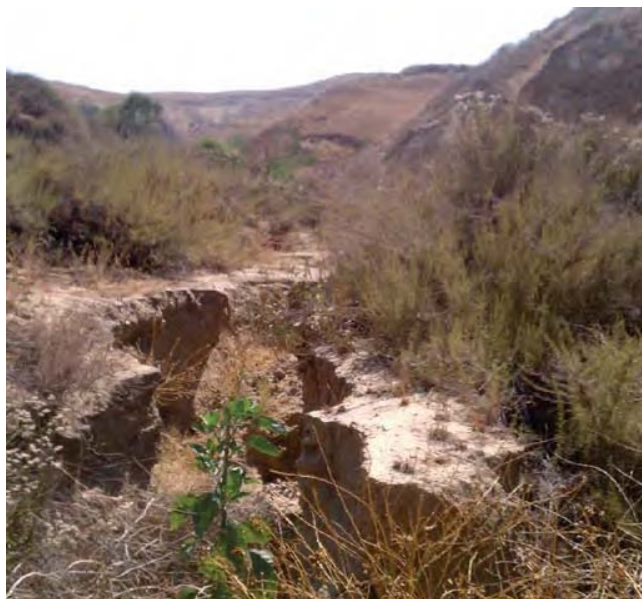
A rill/gully is typically formed on valley sides and floors where no well-defined channel previously existed. If these features lack a connection with a drainage they are called rills/gullies and are not jurisdictional.

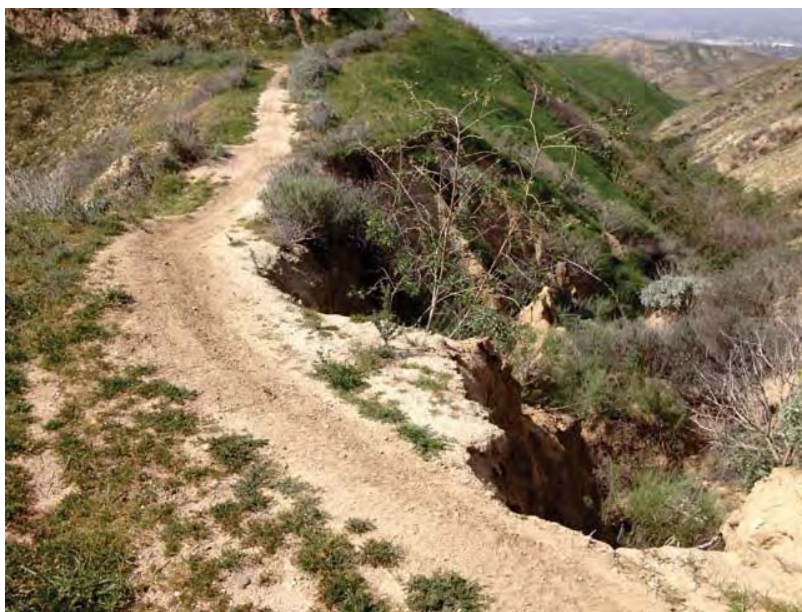
Potential access road in the San Timoteo Badlands showing erosion rills. Many rills are created by surface water flowing off of roads or trails, and over time these rills can erode said passageways. If these features lack a connection with a drainage they are called rills and are not jurisdictional.

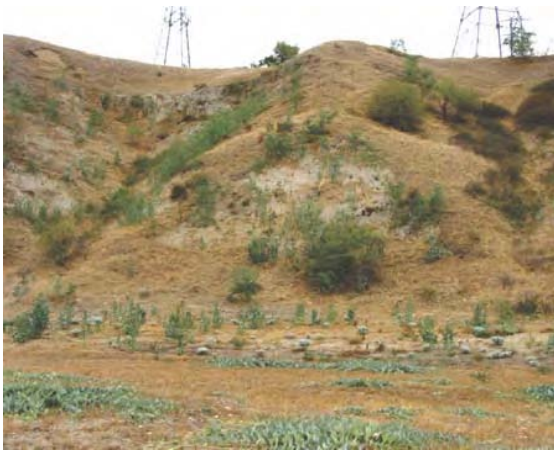
Swales on rolling hills near the Vista Substation lack evidence of an OHWM and any occasional flows daylight into the flat field below.

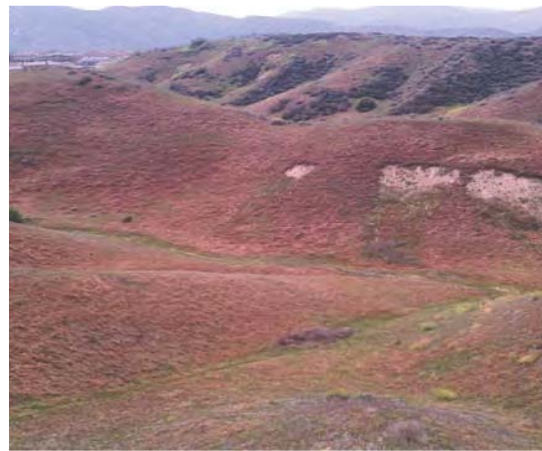
Swales on rolling hills of the San Timoteo Badlands lack evidence of an OHWM and a connection to the potentially jurisdictional drainage below.

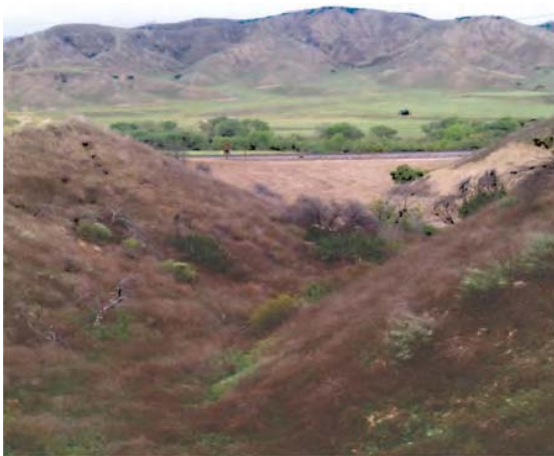
A swale at the bottom of rolling hills with no evidence of an OHWM.

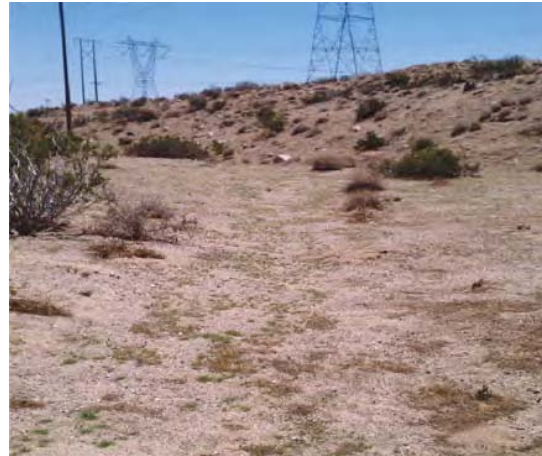
A desert swale with no clearly defined evidence of a measurable OHWM.

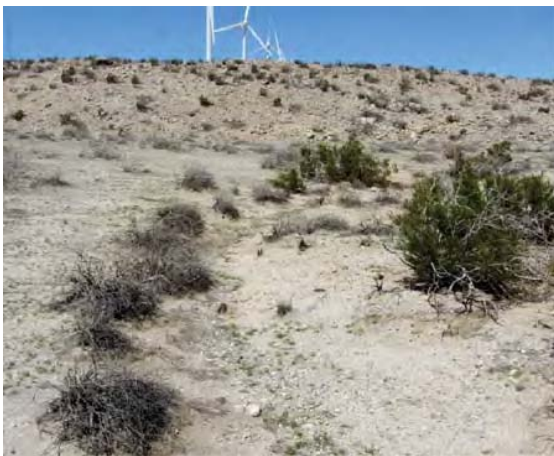
Swale showing slight evidence of change in particle size distribution, but not enough to measure a distinct OHWM line.

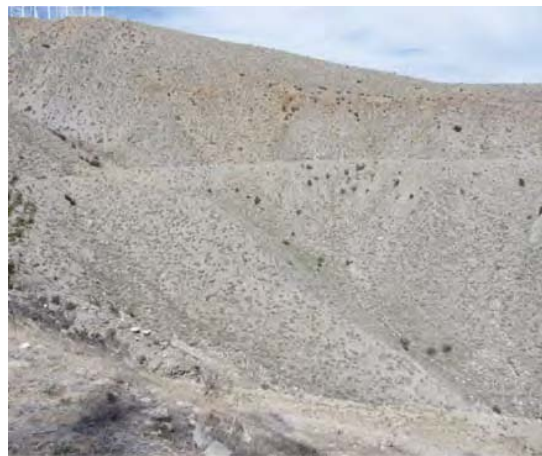
Swales on steep, rolling hills west of Whitewater River lack evidence of an OHWM in the sandy substrate.

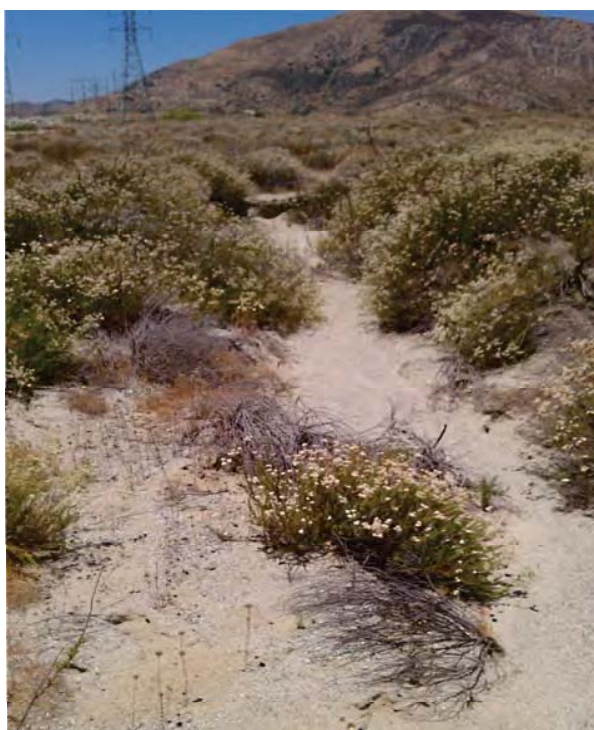
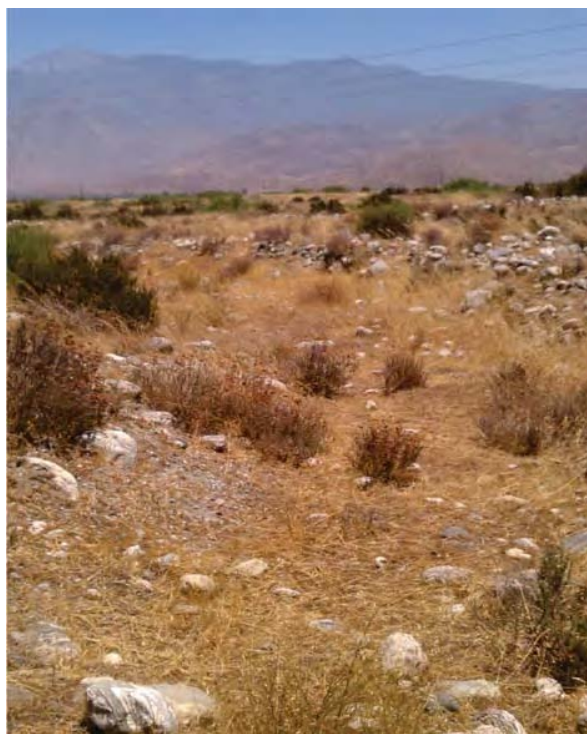
FIGURE 3  
Sheet 3 of 8

Paleo channels in the low terrace portion of the floodplain at west edge of the Morongo Reservation. These features are now abandoned by water flows, but still have a channel-like formation.

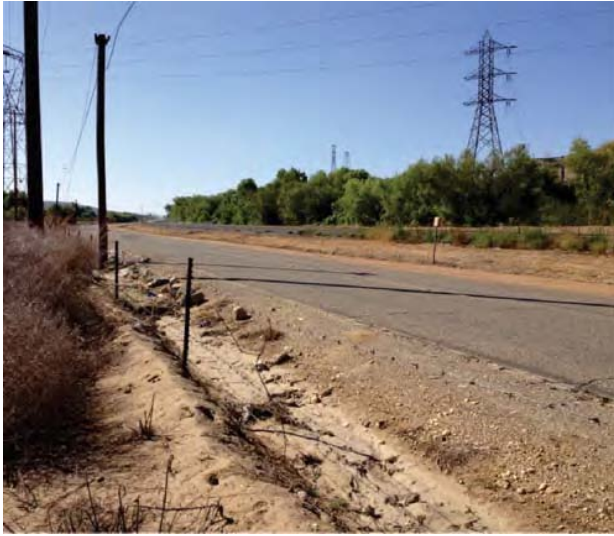
Roadside ditch near San Timoteo Creek that occasionally conveys flows and appears to have a connection to a drainage. This area is potentially CDFG, and Corps jurisdictional, but there is no riparian vegetation.

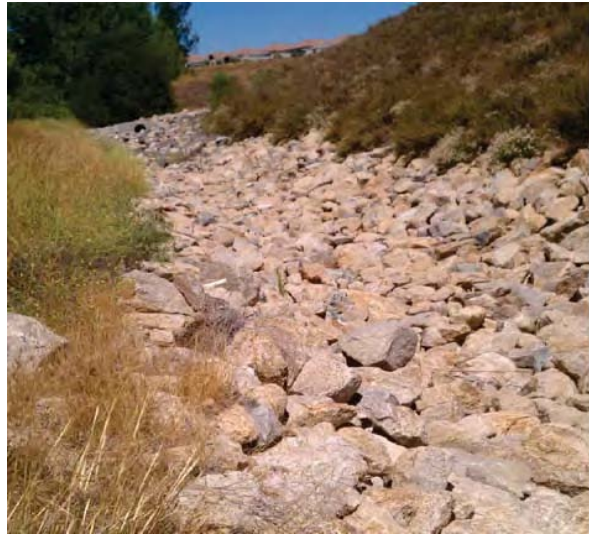
A rip rap channel in upland habitat lacking riparian vegetation is CDFG jurisdictional, but may potentially be Corps jurisdictional if there is a connection to a drainage with a nexus to a traditional navigable water.

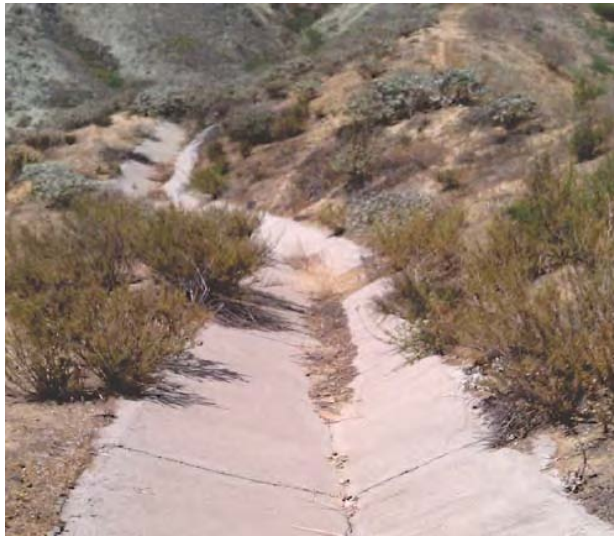
Concrete v-ditch. These areas are often erosion control features excavated on dry land, with no value for fish and wildlife resources. As such they are usually not Corps or CDFG jurisdictional. If they replace a natural drainage or convey flow from one natural drainage to another they are likely CDFG jurisdictional and, Corps jurisdictional, if they connect to a drainage with a connection to a traditional navigable water.

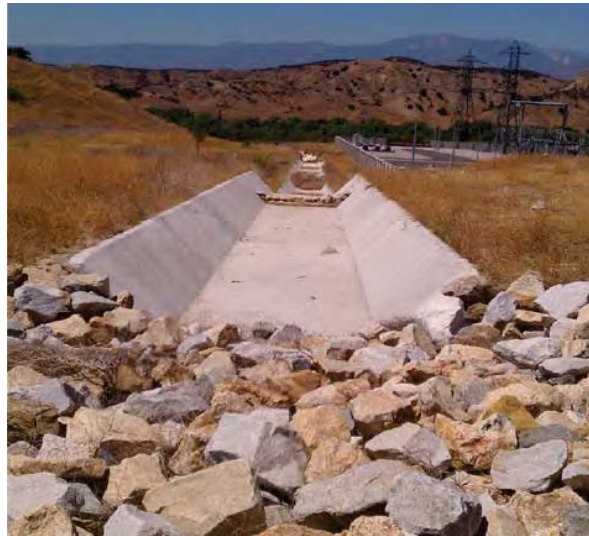
Concrete and rip rap channel. These areas may have Corps jurisdiction if they replace an historical drainage and if they connect to a drainage with a connection to a traditional navigable water.

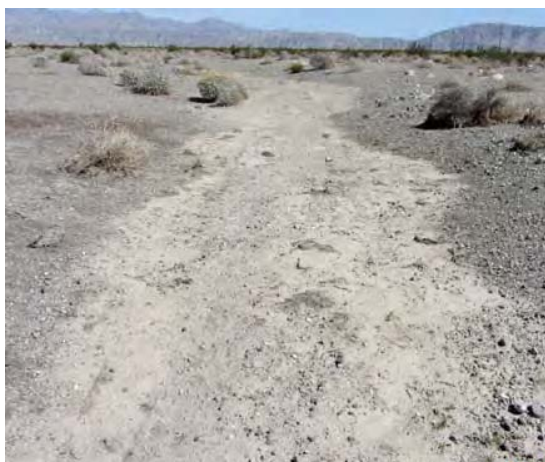
A desert drainage showing change in particle size distribution indicating the channel width and clear edge of the OHWM.

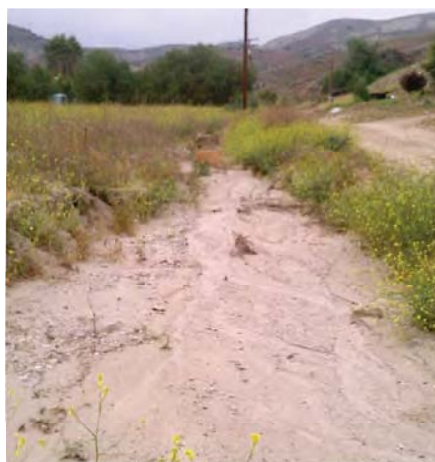
Roadside wash that conveys flows with evidence of gravel sheets (sand ridges) below the OHWM.

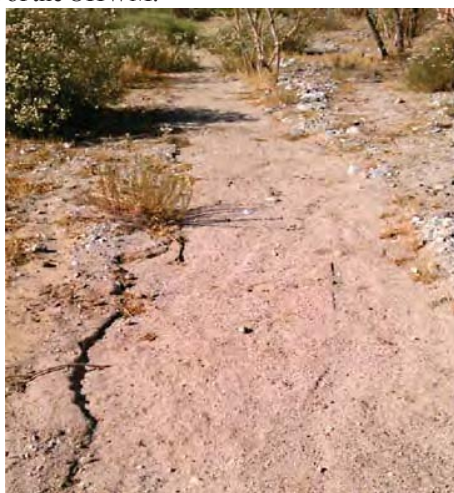
A typical ephemeral low-flow channel showing the upper limits of sand-sized particles near/at the OHWM.

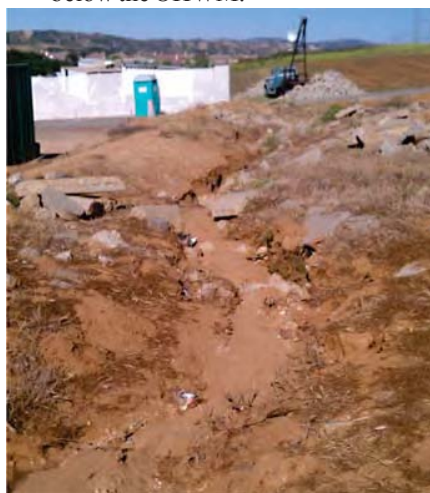
Ephemeral channel showing change in particle size and lack of vegetation at/below the OHWM.

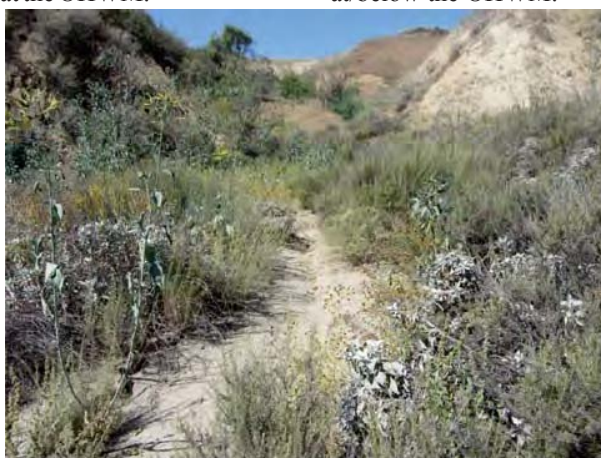
FIGURE 3  
Sheet 5 of 8

Ephemeral active channel shows lack of vegetation at/below the OHWM. There was evidence of a low-flow channel in the bottom.

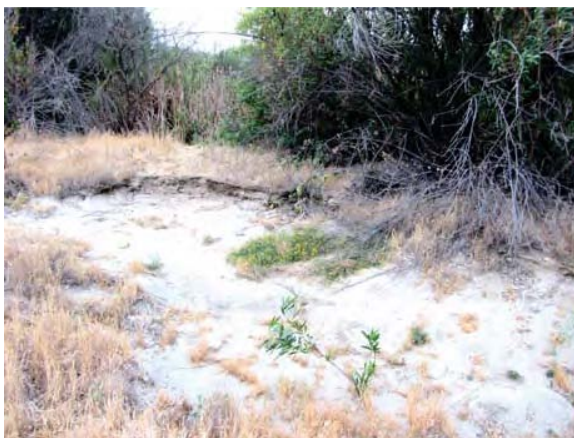
Ephemeral high-flow channel shows lack of vegetation at/below the OWHM.

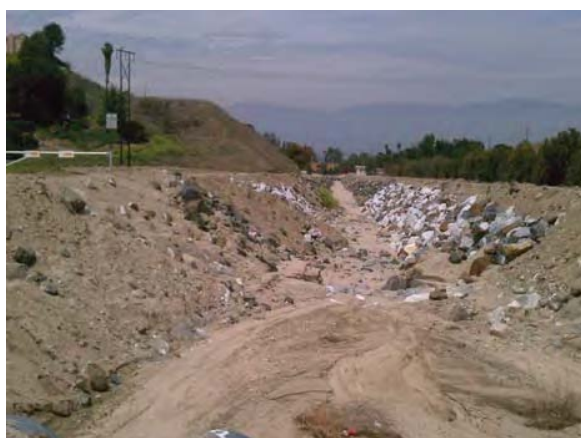
Reche Canyon, a trapezoidal earthen and rip rap channel east of the City of Grand Terrace that is potentially jurisdictional for CDFG and Corps.

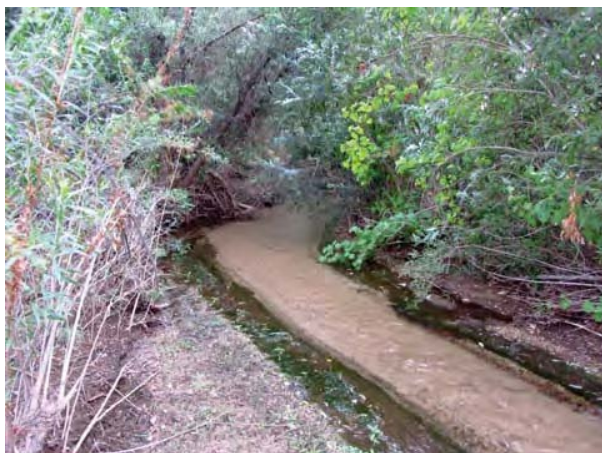
San Timoteo Creek flows perennially northwest. This channel is both potentially a CDFG and Corps jurisdictional wetland.

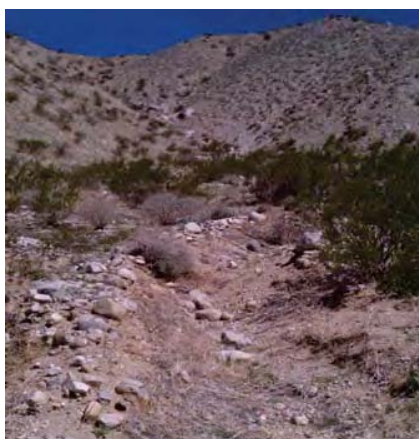
Ephemeral channel showing change in particle size and benches above the OWHM in the hills west of Whitewater Canyon.

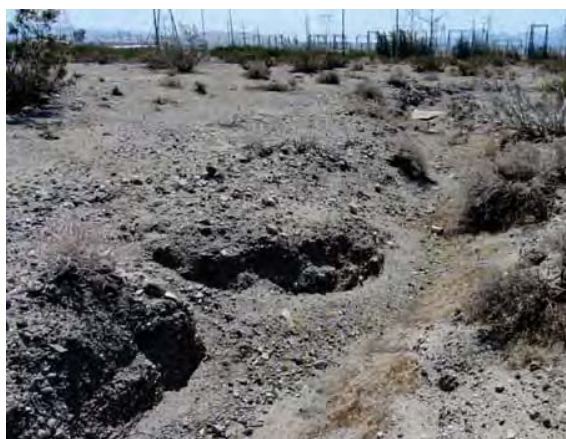
Ephemeral channel showing change in particle size near the OWHM and benches above the OWHM.

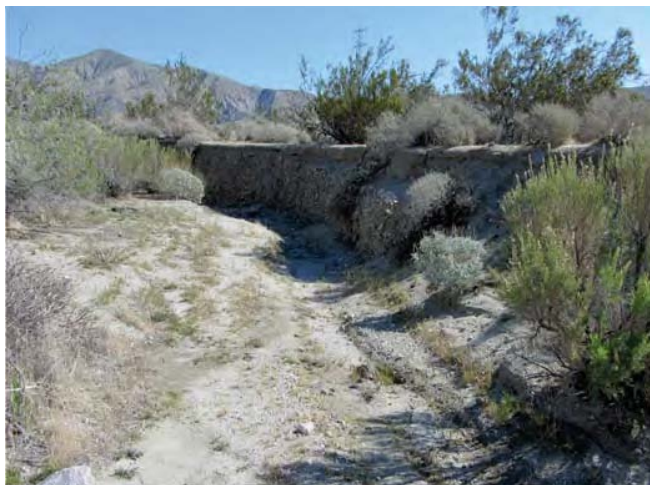
Ephemeral channel with clear evidence of change in particle size distribution, benches, and exposed roots. This drainage is both potentially CDFG and Corps jurisdictional.

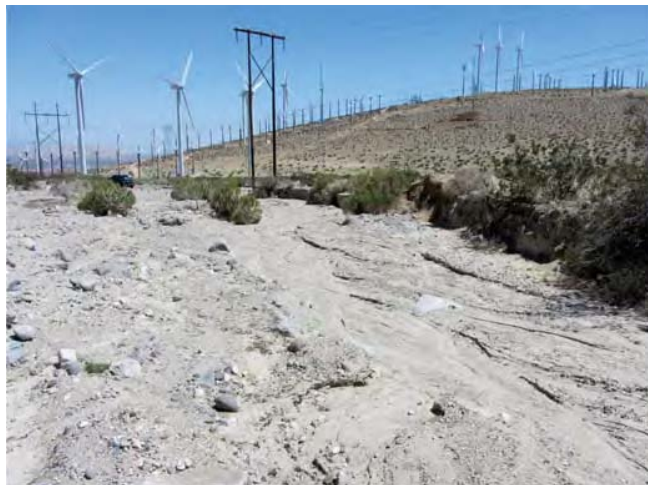
Super Creek shows evidence of change in particle size distribution, benches, and exposed roots. This drainage is both potentially CDFG and Corps jurisdictional.

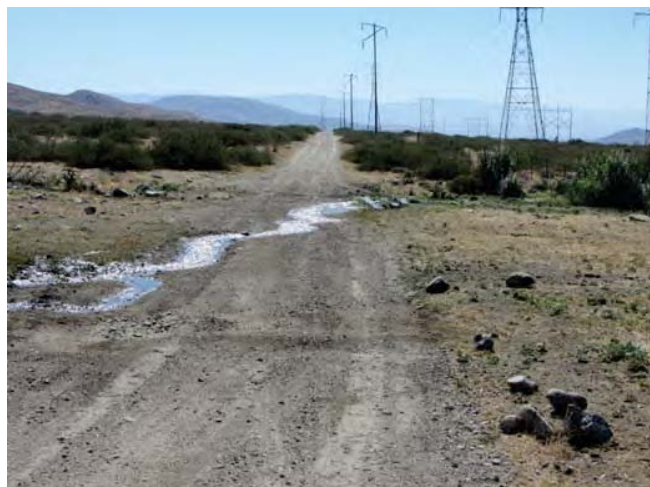
Perennial spring on Morongo Reservation flowing across road. This channel is potentially subject to CDFG jurisdiction and daylights into the desert floor.

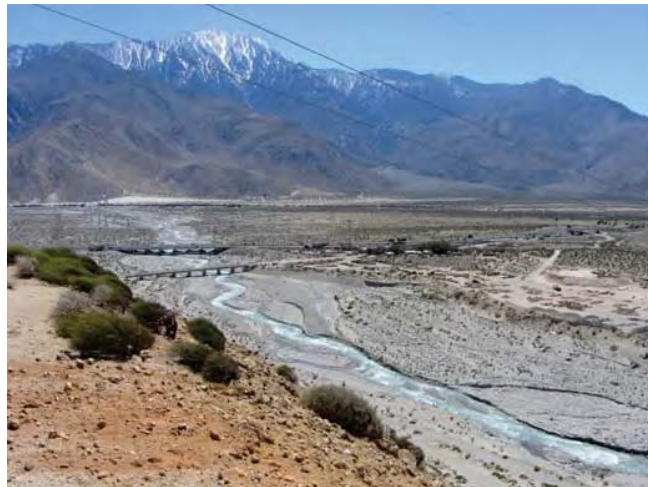
Whitewater River with San Jacinto Mountain in the background. This channel is potentially CDFG and Corps jurisdictional and is ultimately tributary to the Salton Sea.

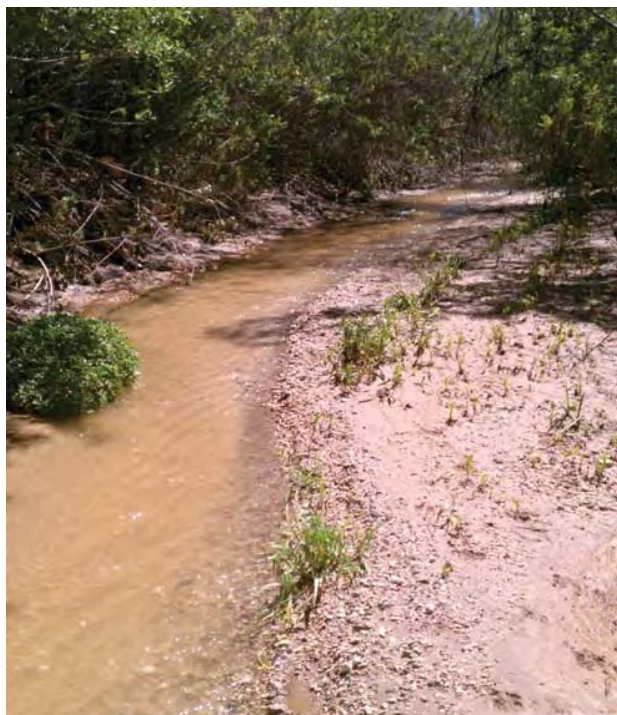
Riparian vegetation associated with San Timoteo Creek generally determines the maximum potential CDFG jurisdictional area.

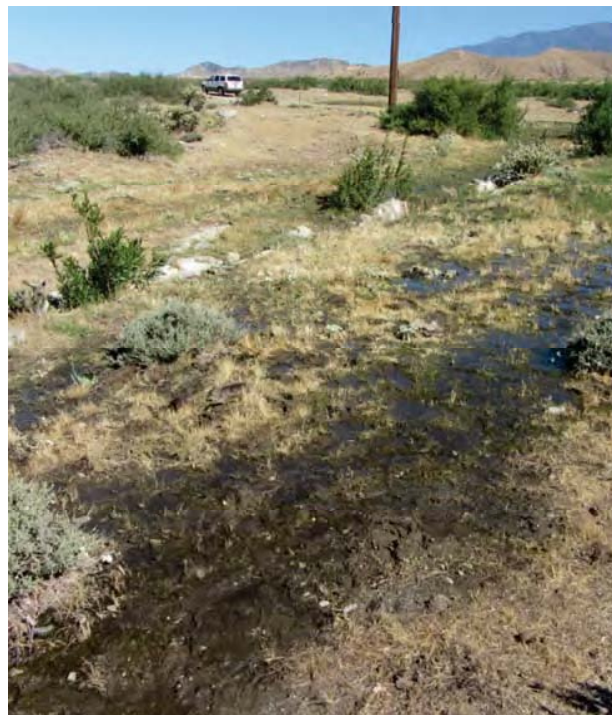
Spring on Morongo Reservation has some associated riparian vegetation.

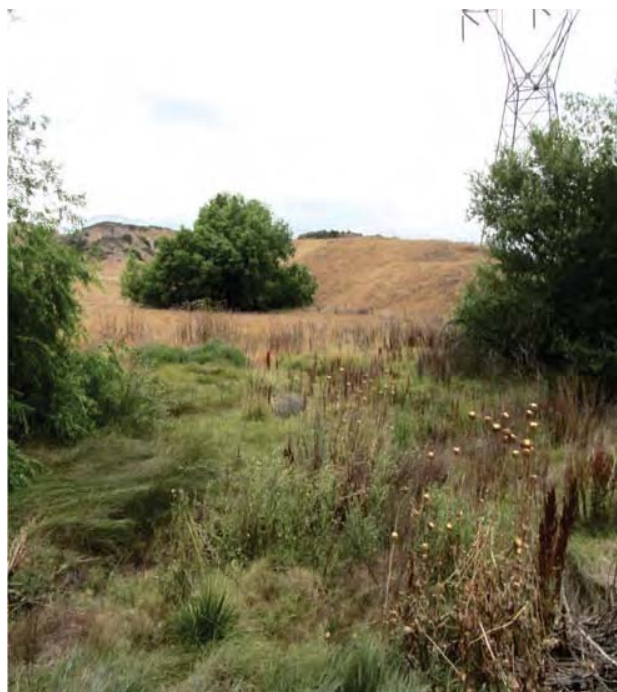
Representative riparian vegetation showing willows, blue elderberry (formerly Mexican elderberry), and annual riparian species (*Juncus* sp., *Rumex* sp., rabbitfoot grass).

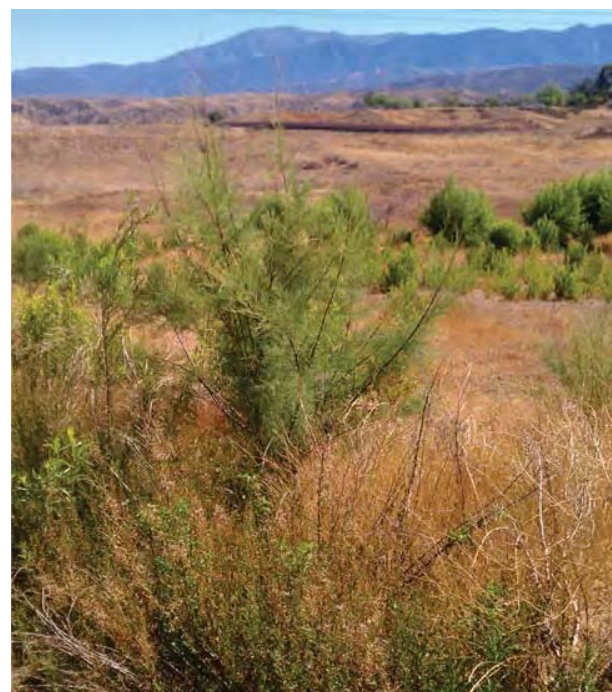
Emergent riparian vegetation (*Tamarix* sp., willow, mulefat) in a basin in the City of Calimesa.
