PROJECT MEMORANDUM
SCE WEST OF DEVERS (WOD) UPGRADE PROJECT

To: Billie Blanchard, Project Manager, CPUC
From: Vida Strong, Aspen Project Manager
Date: June 13, 2018
Subject: Monitoring Report #19: May 28 to June 10, 2018

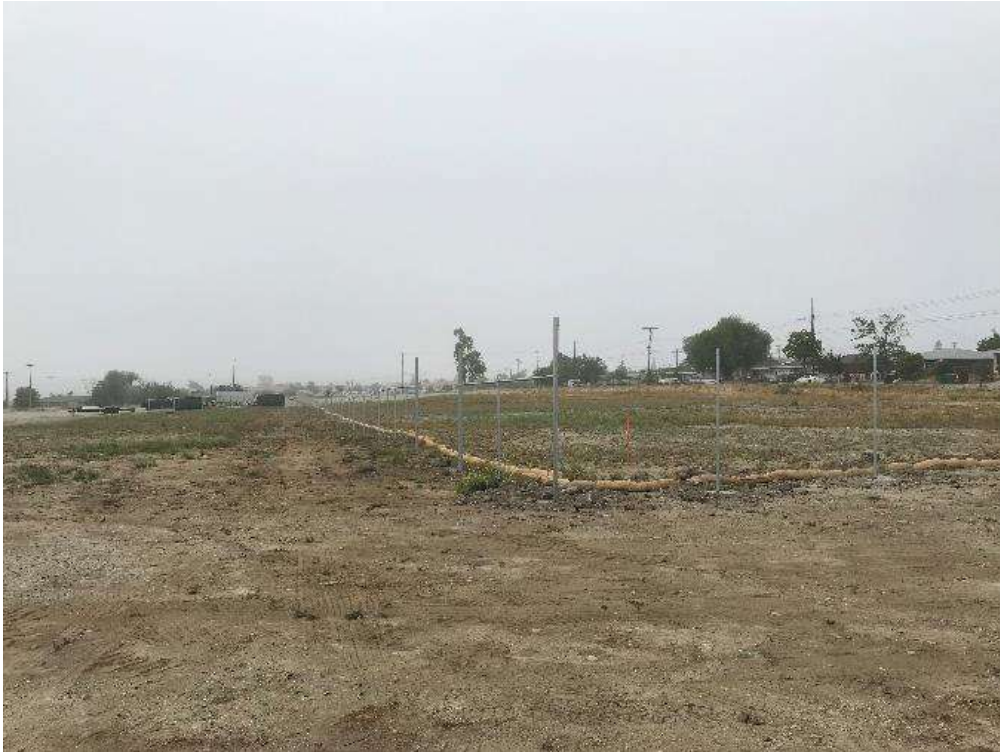
Photo 1 – Installing poles for perimeter chain link fencing at Match MY (May 30, 2018).

5. The Match MY is being utilized by Barnard Construction primarily for tubular steel pole (TSP) storage. Work associated with the Match MY included chain link fence installation (see Photo 1).

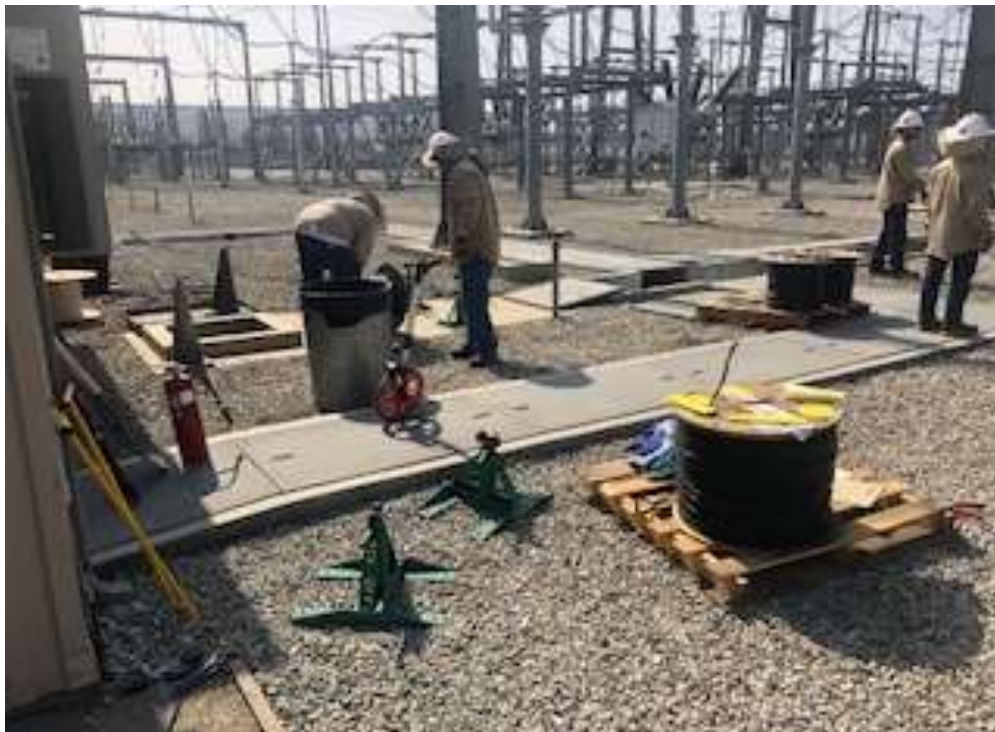
Photo 2 Installing cable at the San Bernardino Substation (photo courtesy of SCE FRED) (June 8, 2018).

1. Work associated with the San Bernardino Substation upgrades included trenching for conduit, setting forms, and installing cable connecting with the MEER building (see Photo 2).
2. Work associated with the El Casco Substation upgrades is currently postponed due to active nests located within bus positions. Work is scheduled to resume once the nests have fledged.

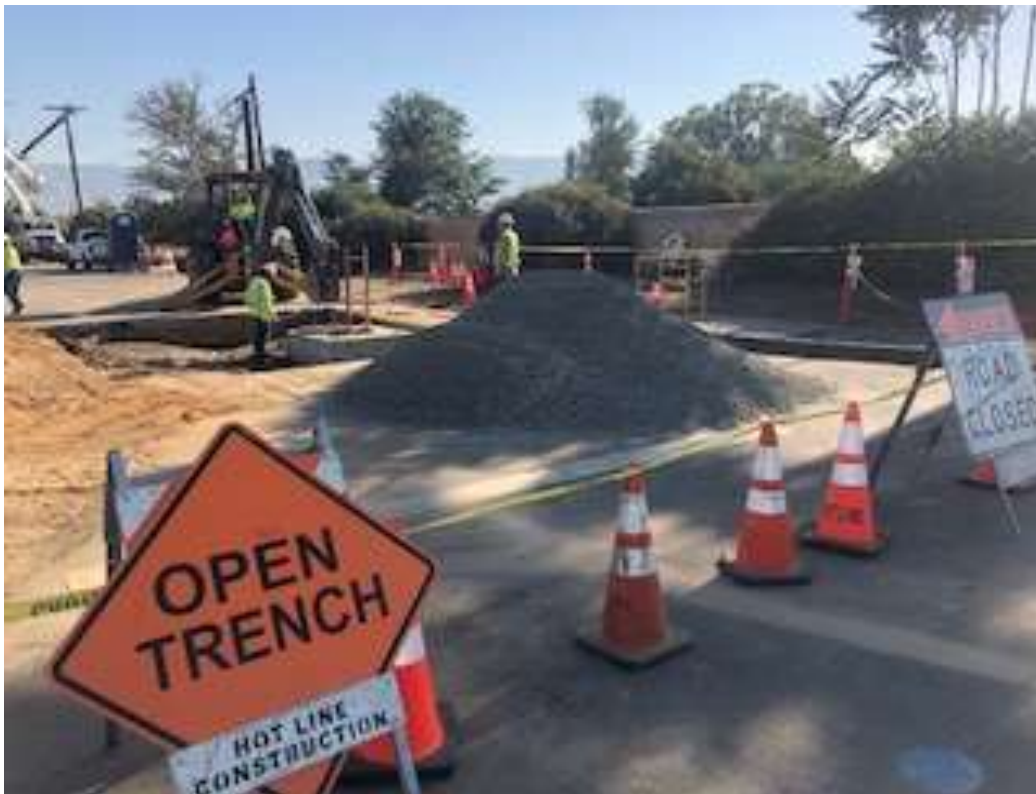
Photo 3 – Vault installation occurring along Iowa Street for the Tennessee Relocation (photo courtesy of SCE FRED) (May 30, 2018).

3. Work associated with the Tennessee Relocation subtransmission improvements included, potholing for existing utilities, installation of underground vaults, trenching and installation of underground conduit, and foundation excavation and installation of LWTSPs and TSPs (see Photo 3).

2. On June 4, SCE submitted authorization from the City of Redlands regarding after-hours work scheduled for June 7 associated with vault installation along Iowa Street for the Tennessee Relocation.

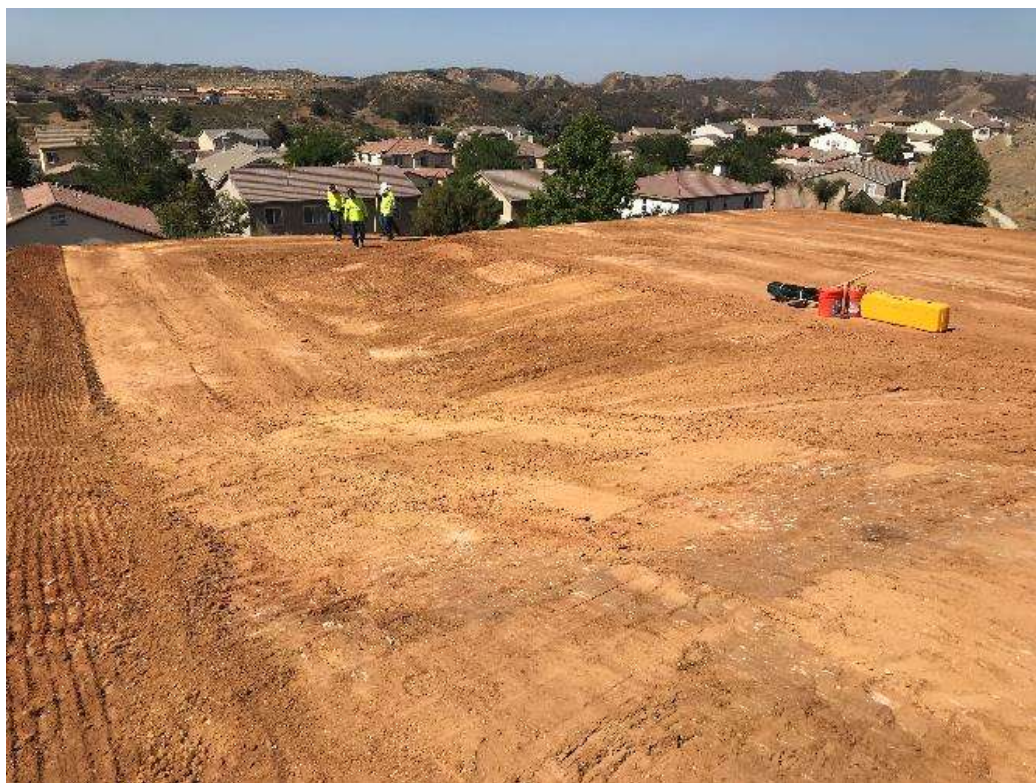
Photo 4 – Grading activities completed at Tower Site 4X53 (June 8, 2018).

1. For the currently approved transmission components, Power Grade Incorporated is conducting access road maintenance/stabilization, BMP installation, vegetation removal, and site grading.
2. Work associated with Segment 4 included access road maintenance. BMP installation was conducted at Tower Sites 4X47, 4X53, and 4X54. Vegetation removal was conducted at Tower Site 4X48. Site grading occurred at Tower Sites 4X51, 4X53, 4X54, and 4X55 (see Photo 4).

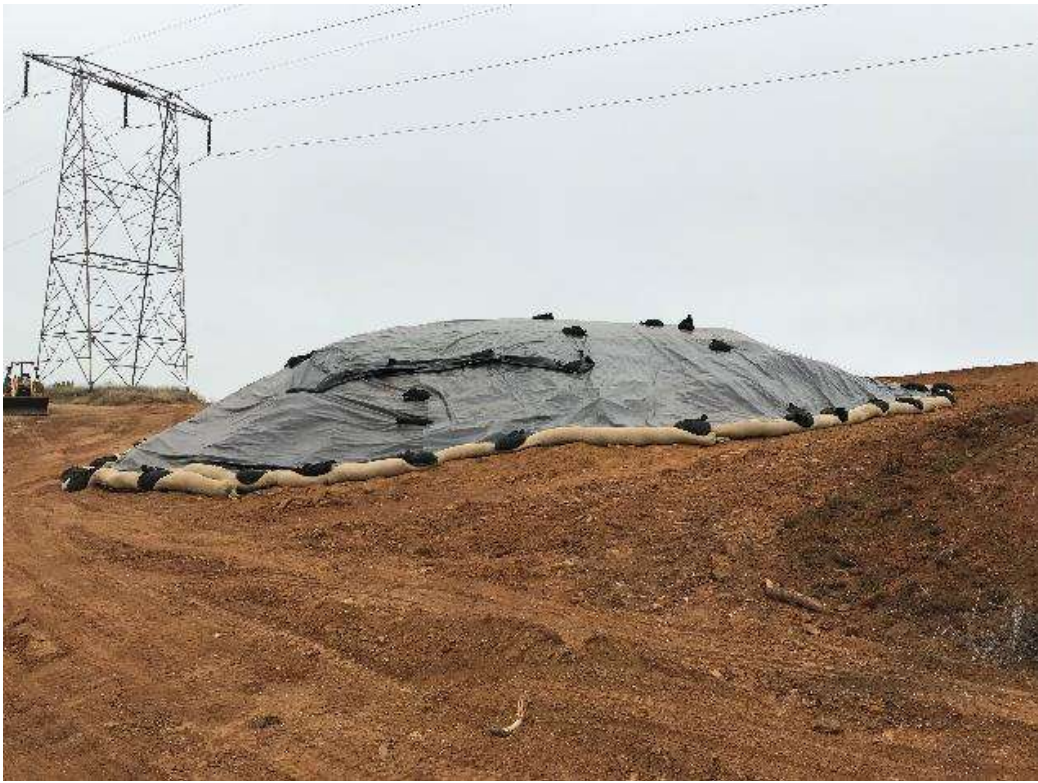
Photo 5 – Soil stockpile properly contained at Tower Site 4X51 (May 30, 2018).

1. All construction activities associated with NTP #4 were in compliance with Project mitigation measures, permit conditions, and plan requirements throughout the monitoring period (see Photos 5 and 6).

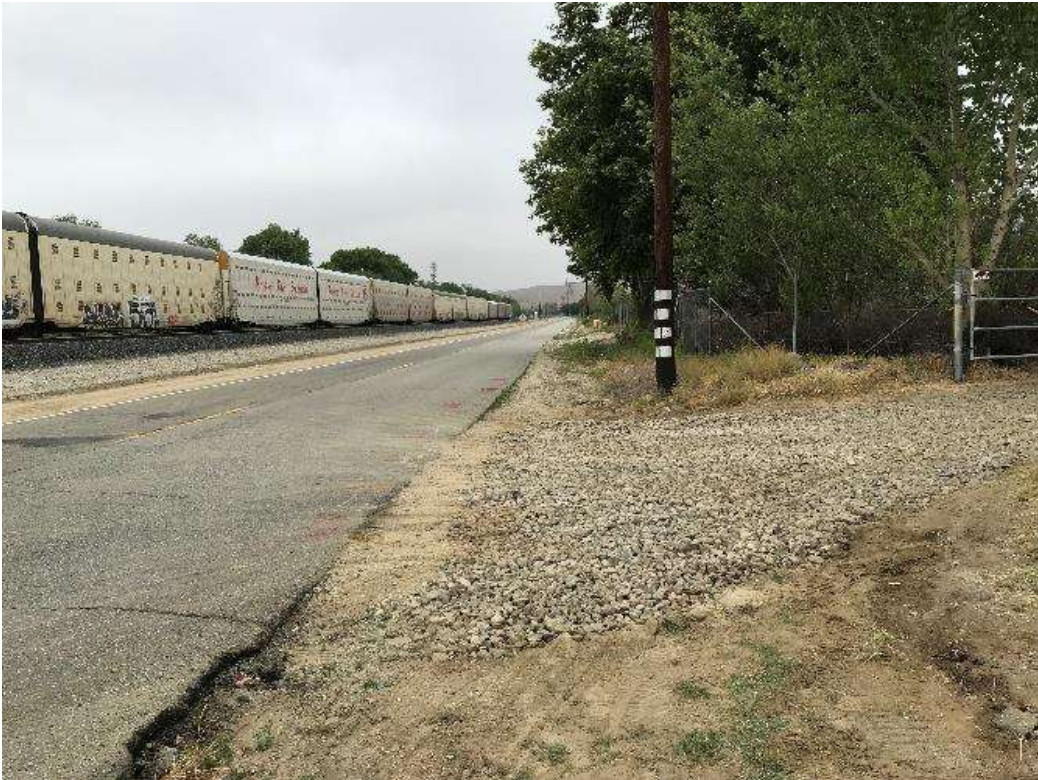
Photo 6 – Adequate entrance stabilization and trackout control along San Timoteo Canyon Road (May 30, 2018).
