PROJECT MEMORANDUM
SCE WEST OF DEVERS (WOD) UPGRADE PROJECT

To: Billie Blanchard, Project Manager, CPUC
From: Vida Strong, Aspen Project Manager
Date: August 3, 2018
Subject: Monitoring Report #26: July 23 to 29, 2018

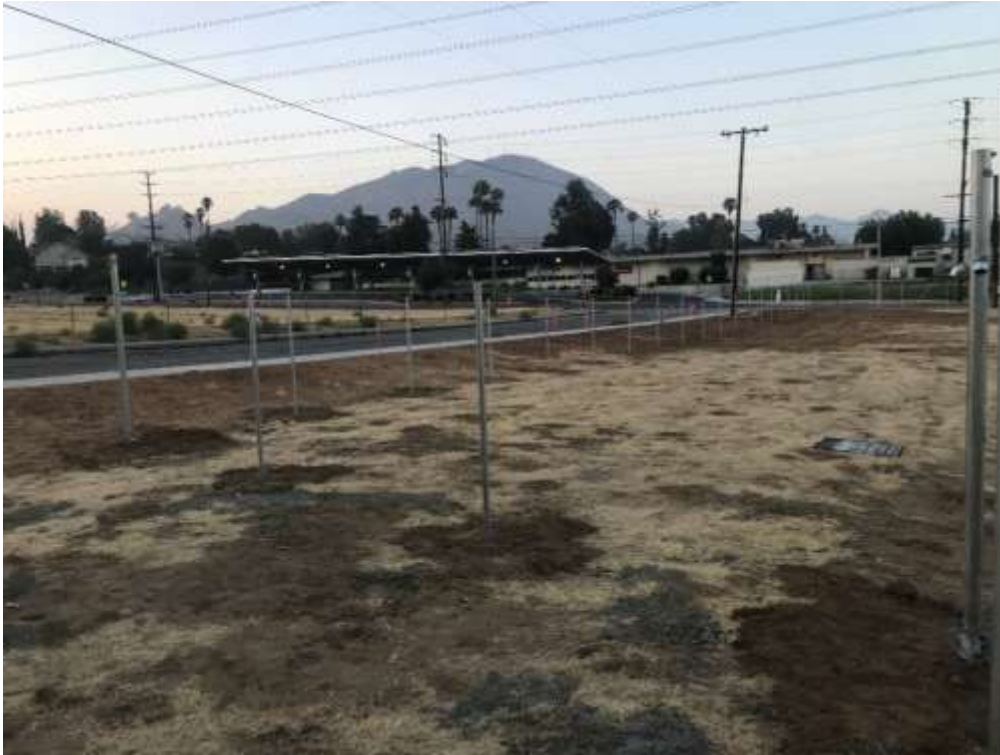
6. The Grand Terrace MY is being used primarily as a show-up location for project construction crews. Work associated with the Grand Terrace MY during the reporting period included the installation of chain link perimeter fencing (see Photo 1).

Photo 1 – Installation of fence posts at the Grand Terrace MY (photo courtesy of SCE, July 27, 2018).

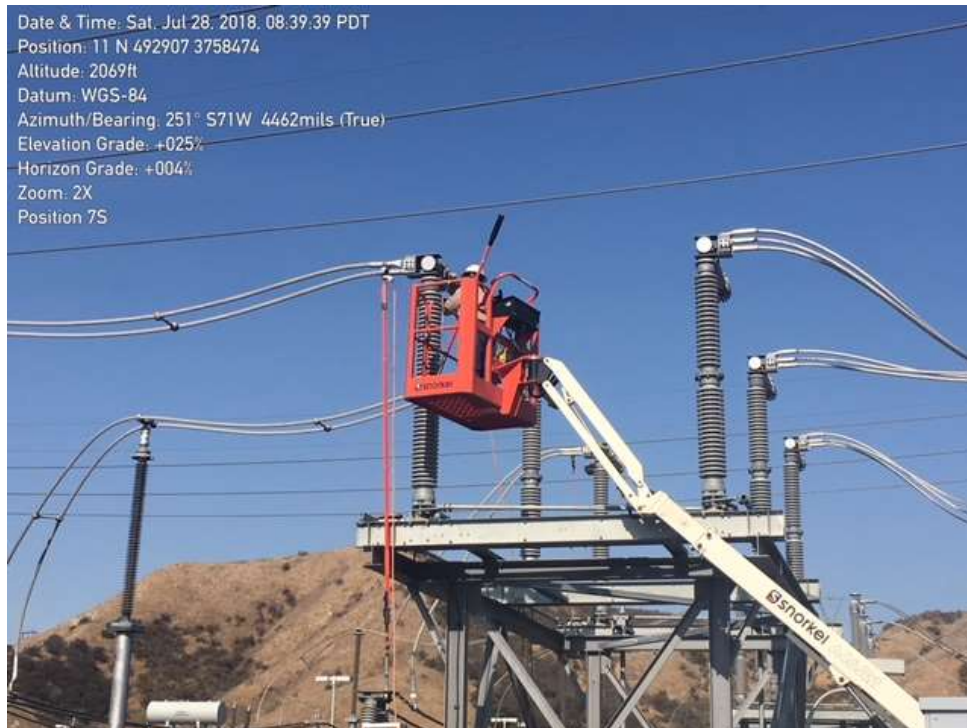
Photo 2 – SCE crew opening switch and conducting nest removal at El Casco Substation (photo courtesy of SCE, July 28, 2018).

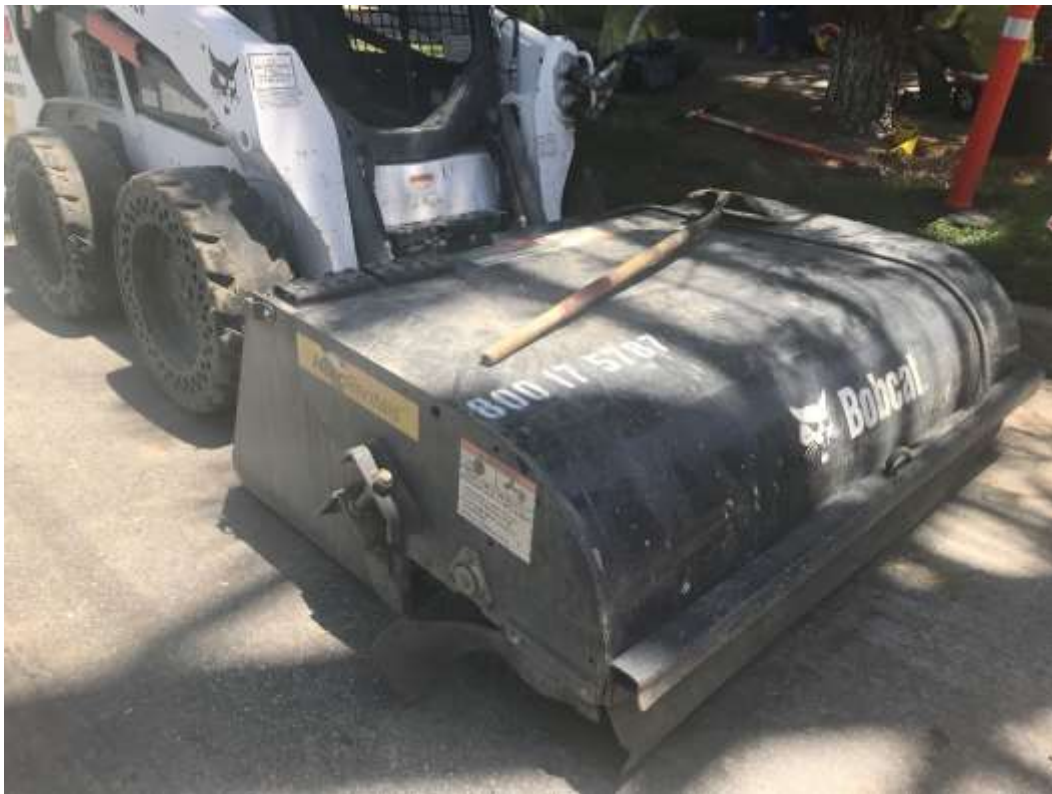
1. The CPUC EM observed a sweeper attachment in use by subtransmission crews (see Photo 3). The sweeper was not consistent with the type identified in the SWPPP and the Project QSP was notified. SCE ultimately provided an approval for use of this type of sweeper attachment, and updated information was added to the SWPPP.

Photo 3 – Hotline crew using sweeper attachment which was inconsistent with what was proposed in the SWPPP (July 24, 2018).

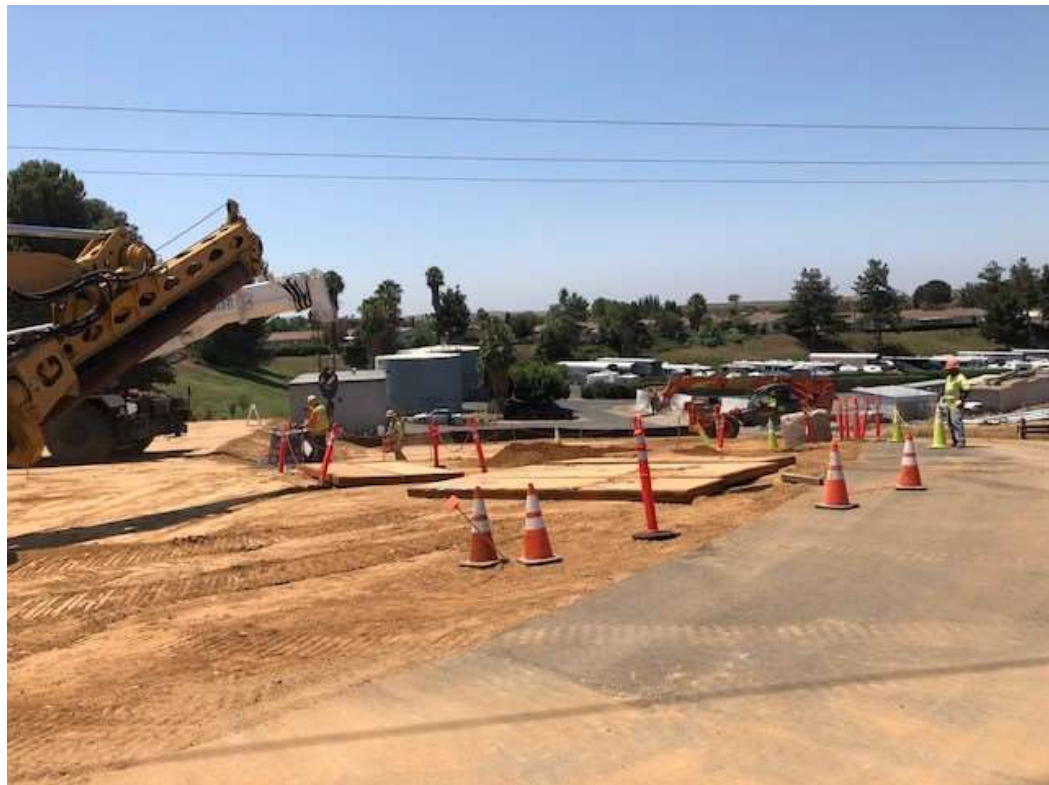
1. For the currently approved transmission components, Power Grade Incorporated is conducting access road maintenance/stabilization, BMP installation, vegetation removal, and site grading. CJ drilling is performing foundation drilling and concrete pouring.
2. Work associated with Segment 3 included access road maintenance and installing BMPs at Tower Sites 3X22, 3X24, 3X25, 3X26, 3X40, 3X41, and 3X42. Vegetation removal was conducted at Tower Site 3X21. Grading activities were conducted at Tower Sites 3X22 and 3X23.
3. Work associated with Segment 4 included installing BMPs at Tower Sites 4X46 and 4N63. Vegetation removal occurred at Tower Site 4X45, 4X46, and 4N62. Grading activities were conducted at Tower Sites 4X45, 4X46, and 4N62. Foundation drilling and concrete pouring occurred at Tower Sites 4X47 and 4X48 (see Photo 4).

Photo 4 – Foundation activities occurring at Tower Site 4X47 (July 26, 2018).

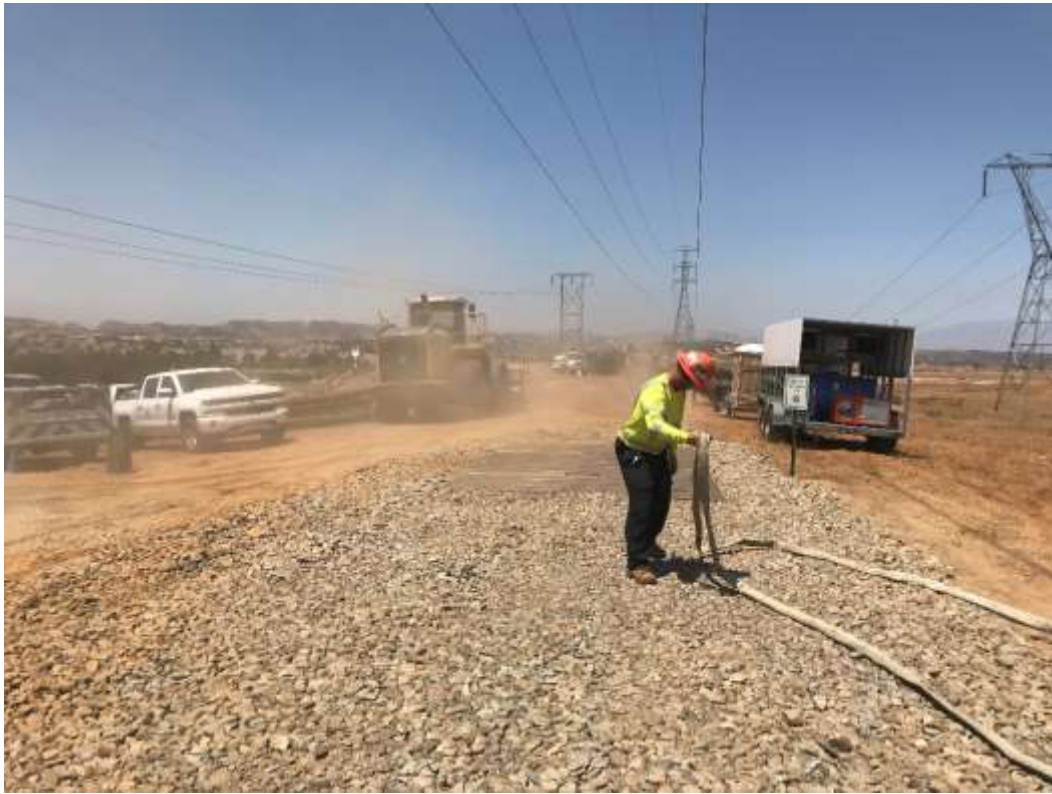
1. The CPUC EMs noted that dust suppression was ineffective at Tower 4X47 during foundation drilling activities. Fugitive dust was observed to be leaving the site (see Photo 5).

Photo 5 – Fugitive dust during foundation activities at Tower Site 4X47 (July 26, 2018).
