PROJECT MEMORANDUM
SCE WEST OF DEVERS (WOD) UPGRADE PROJECT

To: Billie Blanchard, Project Manager, CPUC
From: Vida Strong, Aspen Project Manager
Date: August 21, 2018
Subject: Monitoring Report #28: August 6 to 19, 2018

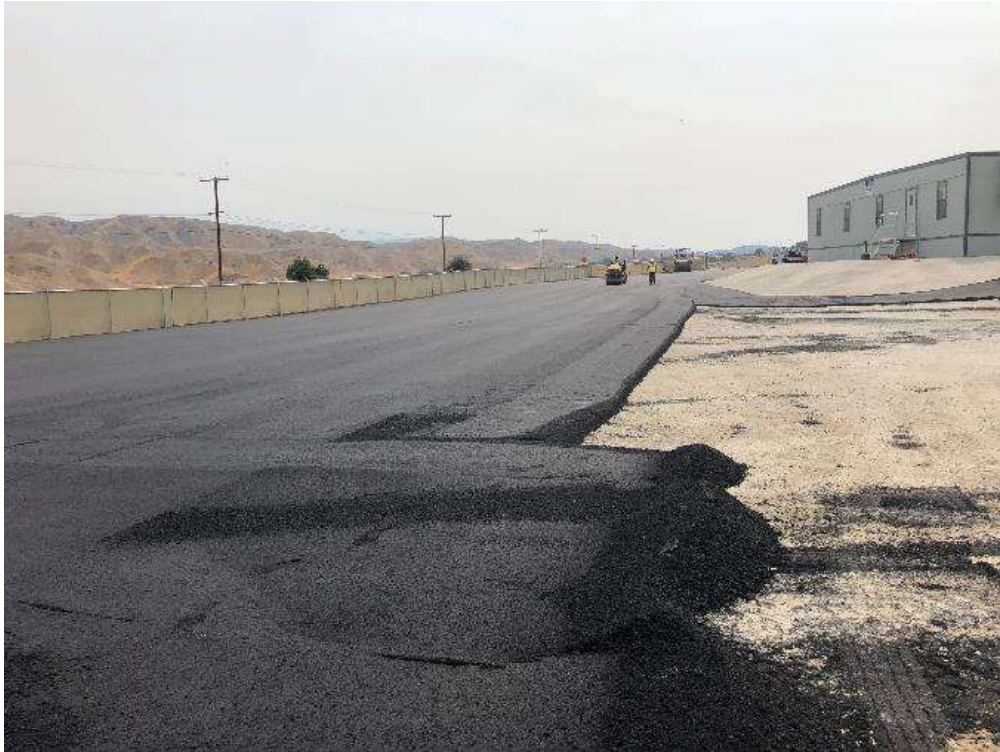
Photo 1 – New pavement being applied at Poultry MY (August 10, 2018).

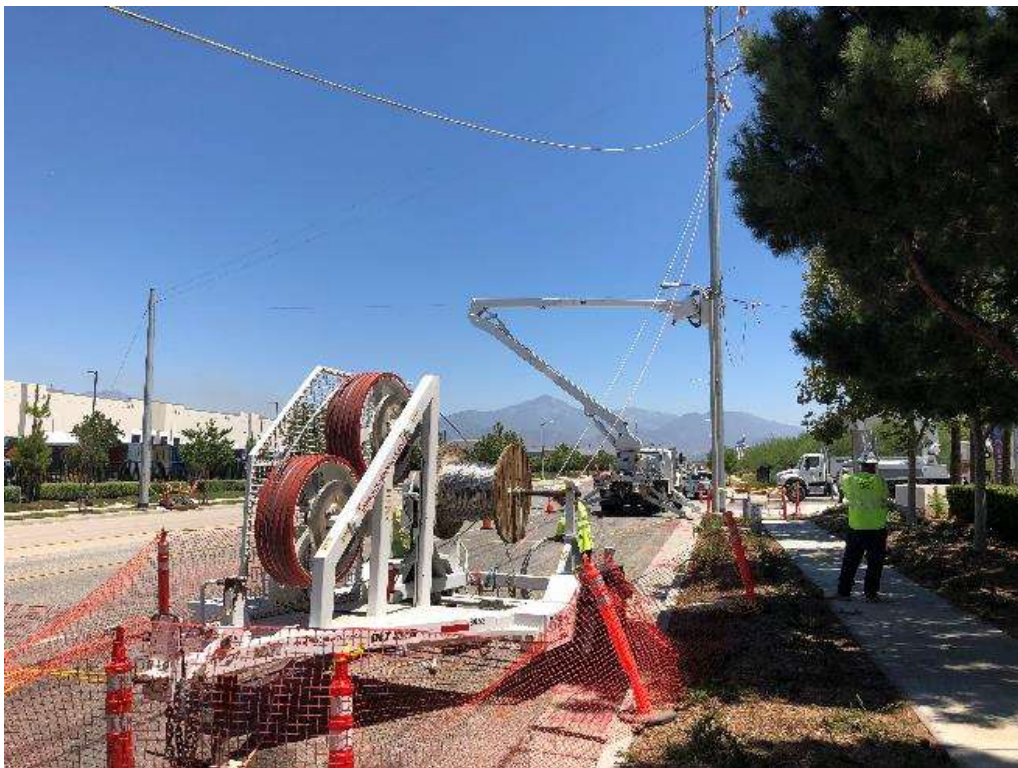
3. Work associated with the Timoteo Relocation subtransmission improvements included potholing for existing utilities, tree trimming, trenching for underground alignment, installation of underground conduit and conductor wire, erection of lightweight tubular steel poles (LWTSPs) and tubular steel poles (TSPs), installation of overhead conductor wire, repaving roads, repairing curbs and gutters, replacing a cinder block wall, and general clean-up (see Photo 2).

Photo 2 – Installing overhead conductor wire along Lugonia Avenue for the Timoteo Relocation (August 6, 2018).

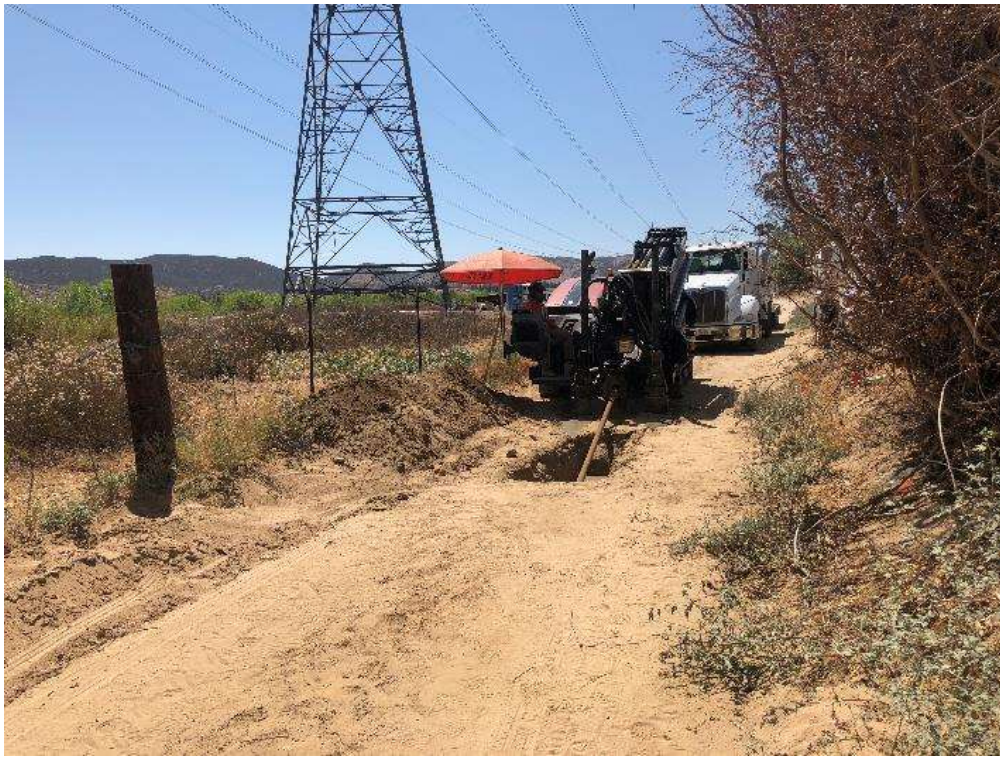
5. Work associated with the Banning Connection included excavation of boring pits and completion of horizontal directional drilling (HDD) along Smith Creek (see Photo 3).

Photo 3 – HDD operations occurring along Smith Creek for the Banning Connection (August 14, 2018).

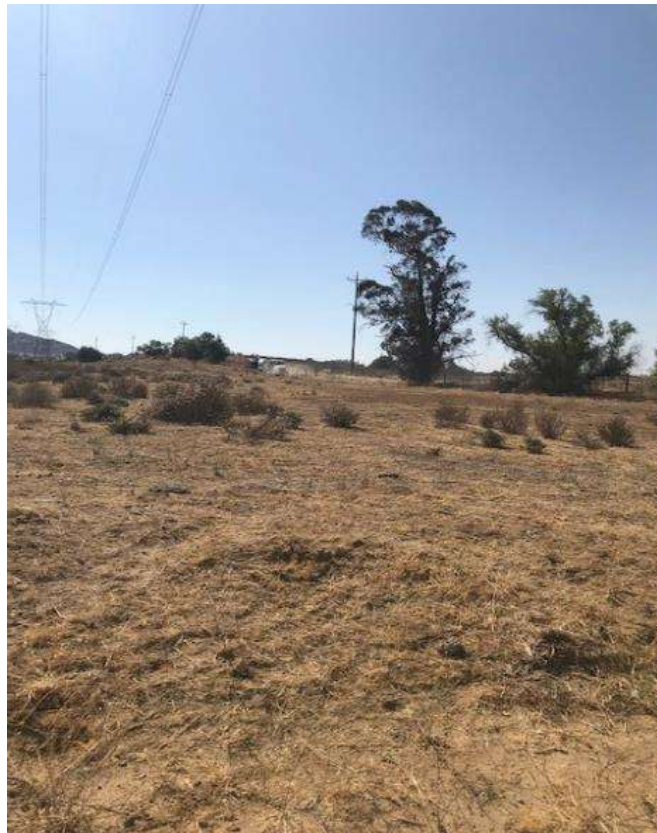
1. Four Level 1 Incidents were reported by the CPUC EMs for work associated with the HDD work at Smith Creek during the subject period as described below. A summary of the CPUC Incidents, PMs, and NCRs issued to date is presented in Table 3.
 - On August 14, the CPUC EM observed crews associated with the Smith Creek Telecom HDD operations use an unapproved access road west of the Smith Creek work area (see Photo 4). The SCE Biological Monitor had previously notified the crews that the road was not approved for Project use; however, the crews continued to utilize the road as access from the east was limited due to poor road conditions. Subsequently, SCE postponed further construction activities in the area and

notified the CPUC that a Minor Project Refinement (MPR) is being prepared to request use of the road west of the Smith Creek work area.

Photo 4 – HDD crew utilizing unapproved access road west of Smith Creek work area (July 14, 2018).

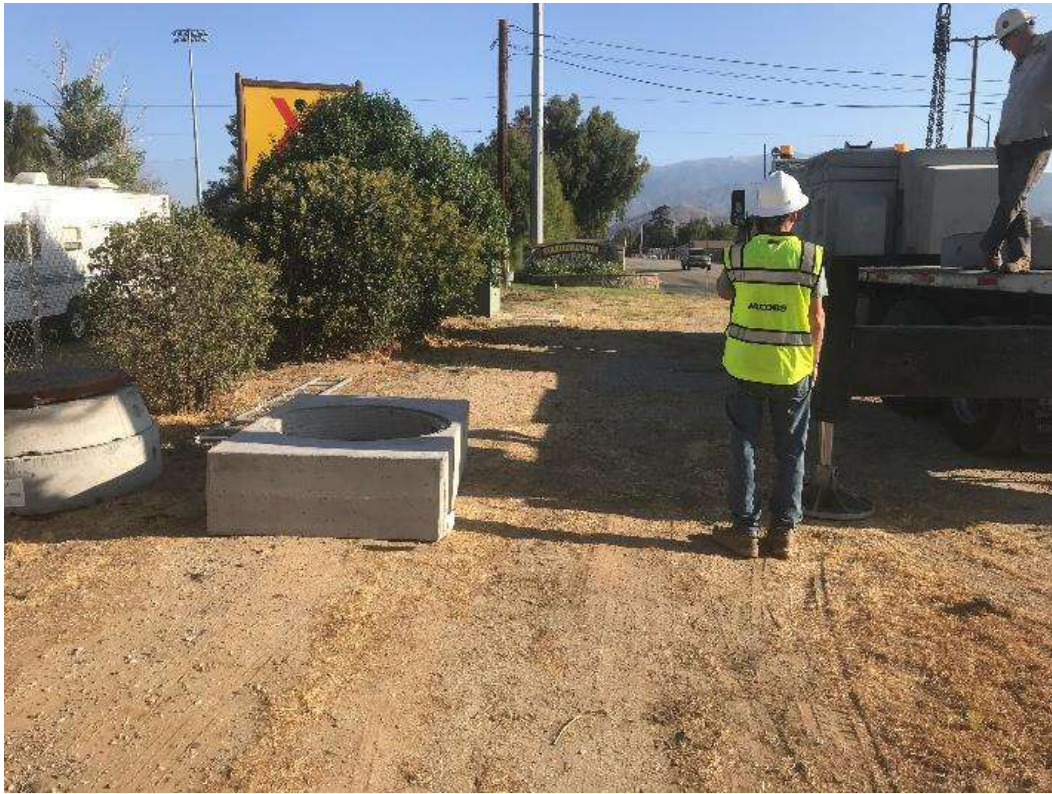
- On August 15, the CPUC EM observed crews associated with the Smith Creek Telecom operations unloading materials in an unapproved work area (see Photo 5). The incident occurred along the side of the road at the intersection of South San Geronio Avenue and Wesley Street. According to the SCE, no impacts to sensitive resources were identified.

Photo 5 – HDD crew unloading manhole cover in unapproved work area (August 14, 2018).

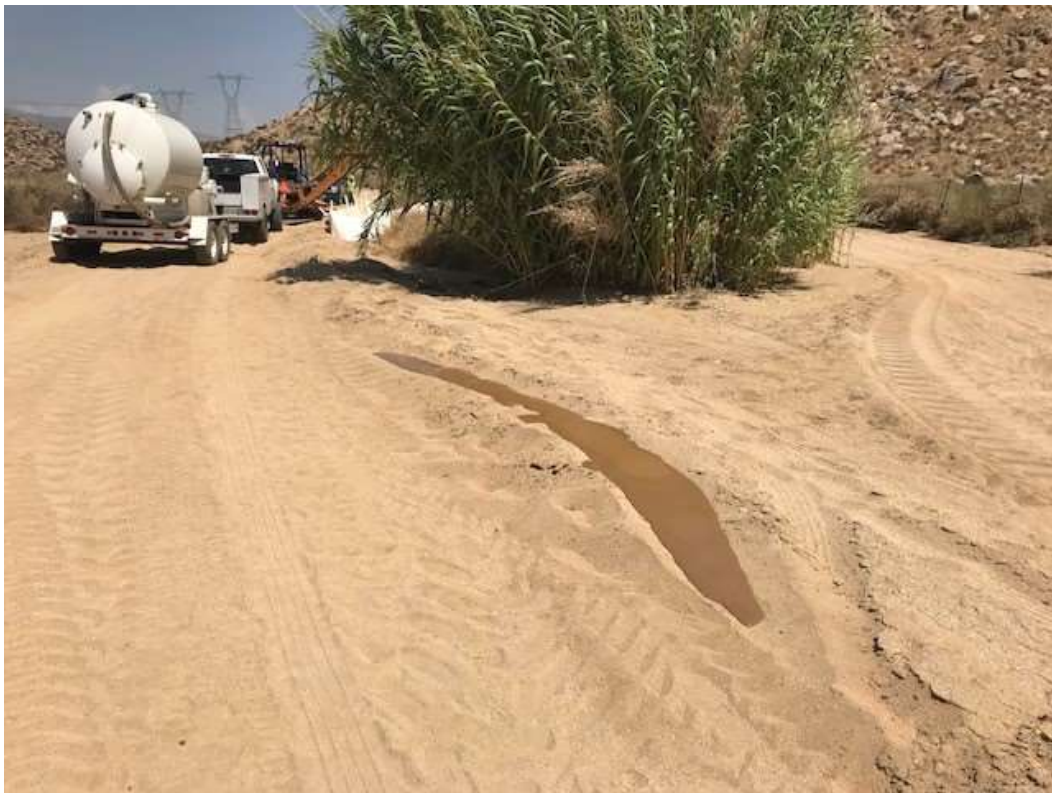
2. During HDD operations at the Smith Creek location, four frac-outs occurred within the jurisdictional drainage (ID #4099 Smith Creek) during conduit pullback. No flowing water was present at the time. The first frac-out was observed by the CPUC EM along the access road just before 2:00 pm and was immediately reported to the HDD crew. HDD activities continued for approximately 30 minutes and three other frac-outs occurred during that time. The total volume of drilling mud that surfaced for all four frac-outs combined was estimated to be approximately 20 gallons. The construction crew used a vacuum truck to remove the drilling mud that surfaced. The CPUC has requested documentation that resource agencies were notified of the frac-outs. To date, this has not been provided. According to SCE's HDD Frac-out Prevention Response Plan, "If there is a frac-out in the water feature, all work must be halted until authorization to proceed under an emergency permit is obtained". As stated above, work continued after the first frac-out was observed. SCE has indicated that the incident is still under investigation and that an environmental stand-down for the contractor is in place.

Photo 6 – Initial frac-out identified by CPUC EMs along Smith Creek during HDD operations (August 14, 2018).

5. One spill was reported associated with NTP #3 during the monitoring period. SCE provided a spill report on August 20 for the frac-outs that occurred on August 14. The spill report indicated that resource agencies were notified. The CPUC has requested documentation of these notifications.

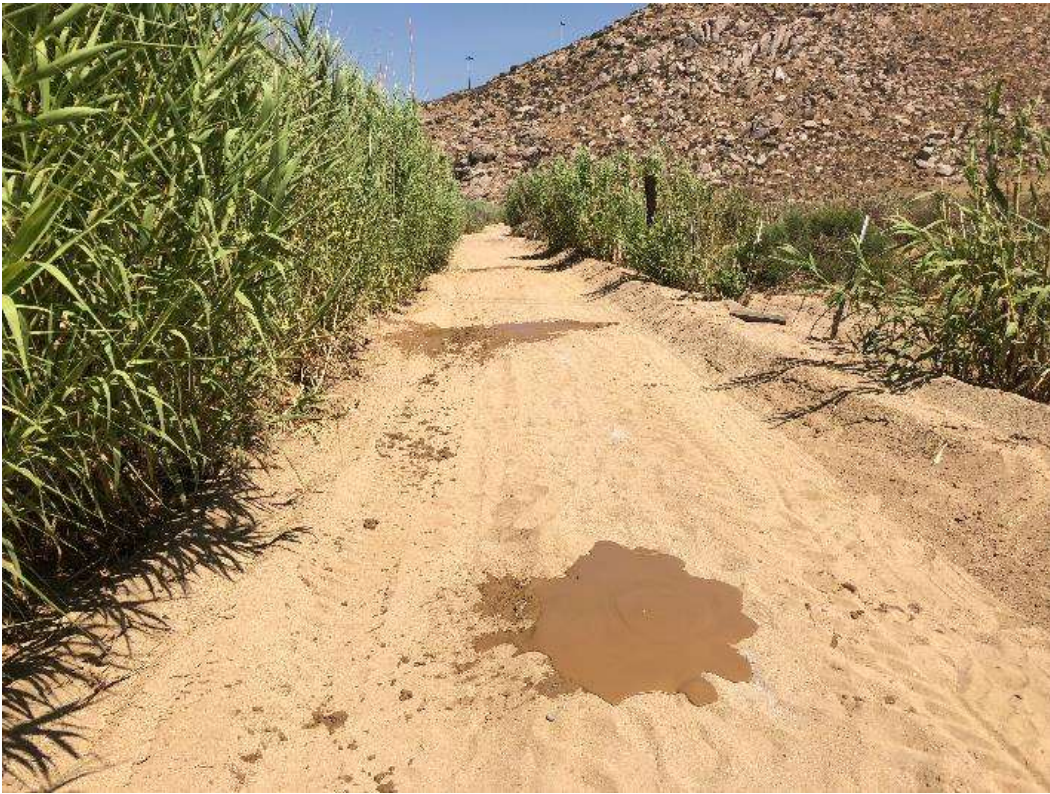
Photo 7 – Three additional frac-outs identified along Smith Creek during HDD operations (August 14, 2018).

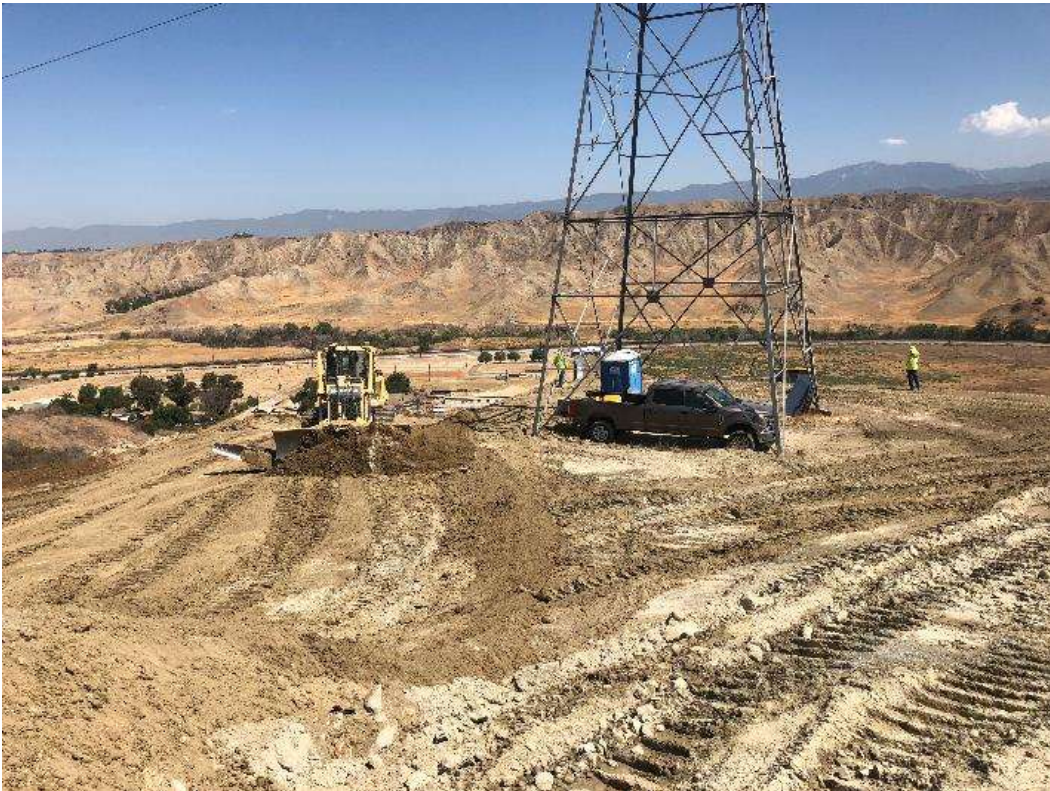
4. Work associated with Segment 3 included access road maintenance and installing BMPs at Sites 3N01, 3N02, 3X21, 3X23, 3X50, 3X51, 3X56, 3X57, 3X62, 3X63, 3X64, and 3X65. Vegetation removal occurred at Sites 3N01 and 3N02. Grading activities were conducted at Sites 3X14, 3X15, 3X16, 3X19, and 3X21 (see Photo 8).

Photo 8 – Grading activities occurring at Site 3X19 (August 14, 2018).
