**PROJECT MEMORANDUM**  
**SCE WEST OF DEVERS UPGRADE PROJECT**

**Date:** October 16, 2018  
**To:** Billie Blanchard, Project Manager, CPUC  
**From:** Vida Strong, Aspen Project Manager  
**Subject:** Monitoring Report #35: October 1 to 7, 2018

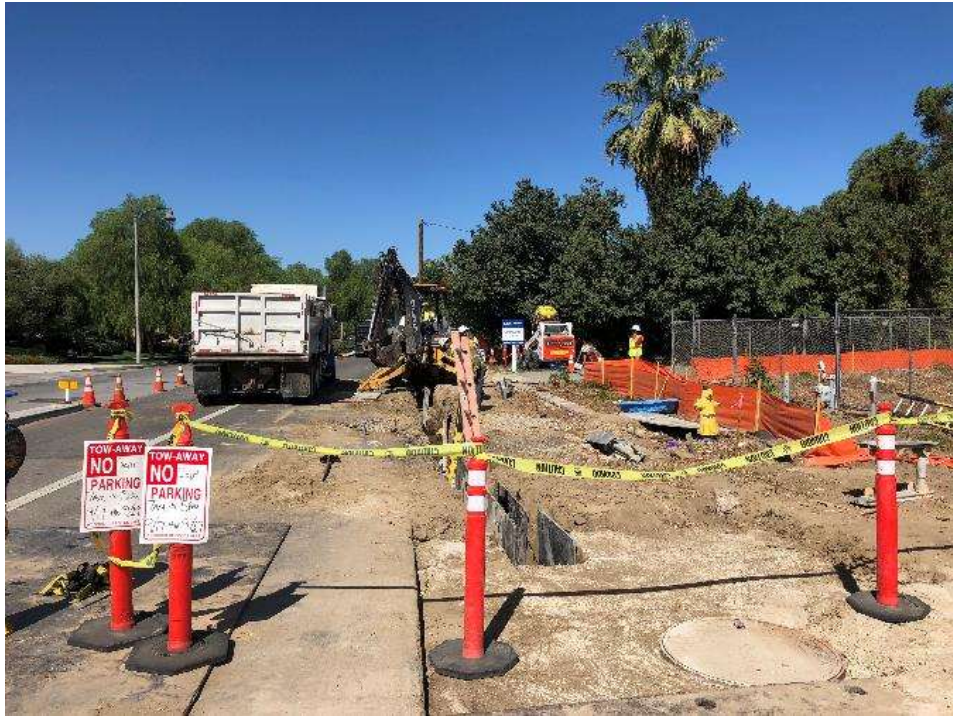
2. Distribution work associated with the Dental and Intern Circuits included trenching for underground alignment, installation of underground conduit, and concrete restoration (see Photo 1).

Photo 1 – Trenching and conduit installation along Mission Avenue for the Dental/Intern Circuits (October 1, 2018).

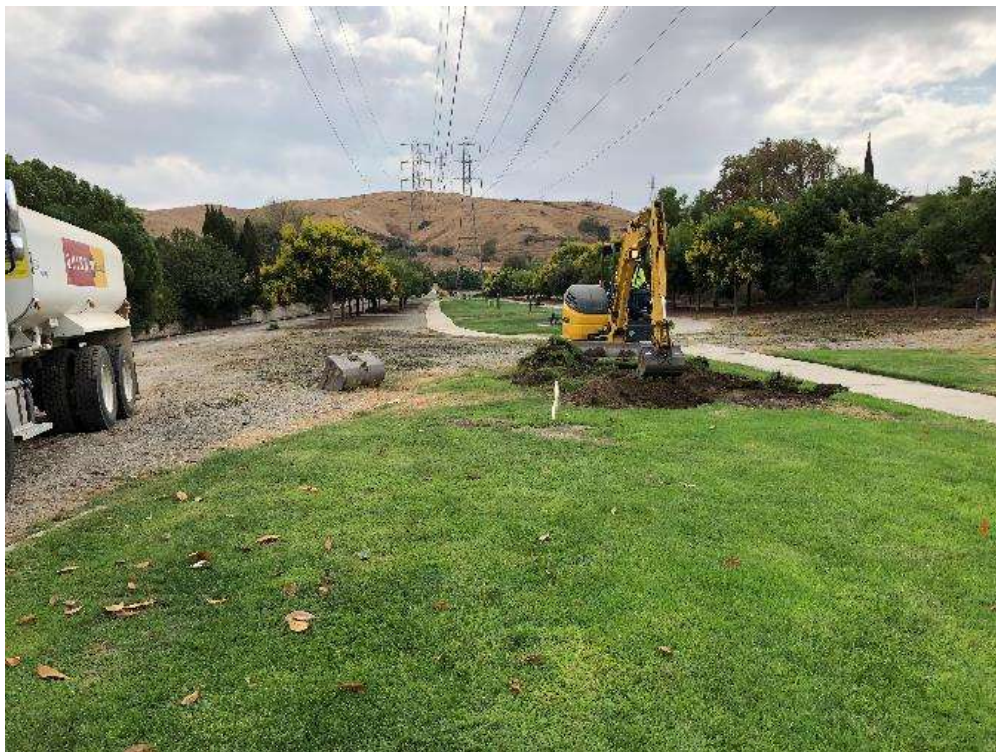
2. Work associated with Segment 1 included BMP installation at Site 1X11. Vegetation removal and grading activities were conducted at Site 1X04-1X05 (see Photo 2).

Photo 2 – Power Grade crew removing vegetation at Site 1X04-1X05, Segment 1 (October 2, 2018).

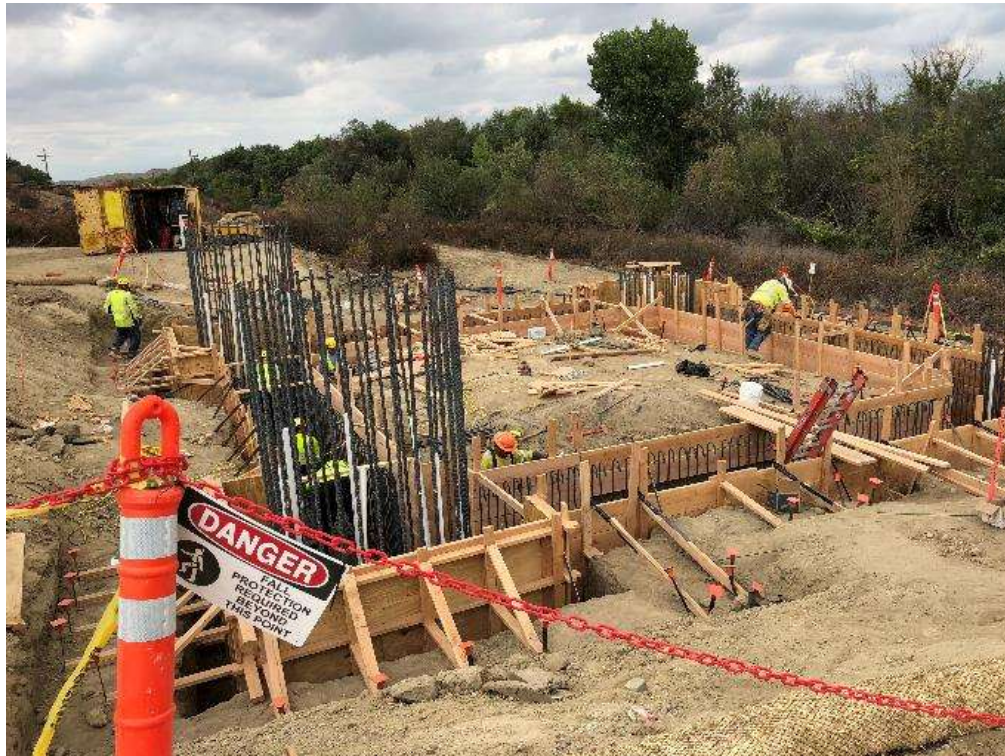
5. Work associated with Segment 4 included access road maintenance between San Timoteo Canyon Road and Site 4N60. Foundation drilling was conducted at Site 4S60. Construction of a grade beam occurred at Site 4N64 (see Photo 3). Concrete foundation pouring occurred at Sites 4S60 and 4N64. Tower assembly and/or erection was performed at Site 4N63. Wire wreck-out and wire stringing activities occurred between Sites 4X55 and 4N64 (see Photos 4 and 5). No access road improvements were conducted.

Photo 3 – Installing forms for grade beam at Site 4N64, Segment 4 (October 2, 2018).

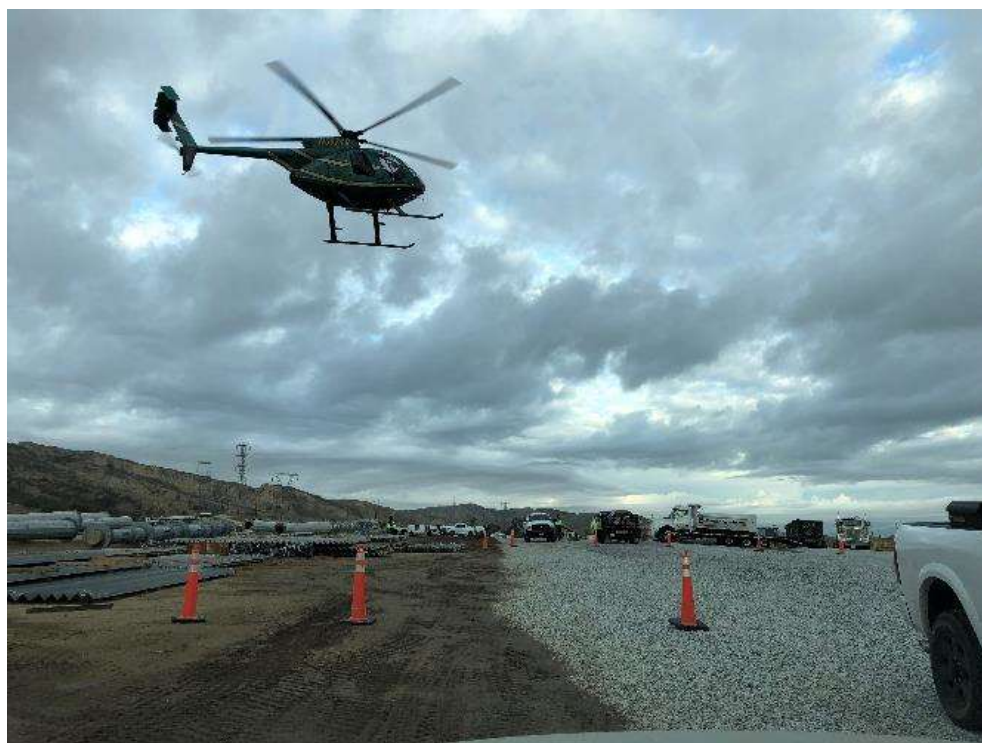
Photo 4 – Summit Helicopter vessel landing at Poultry MY in preparation of wire stringing activities along Segment 4 (October 3, 2018).

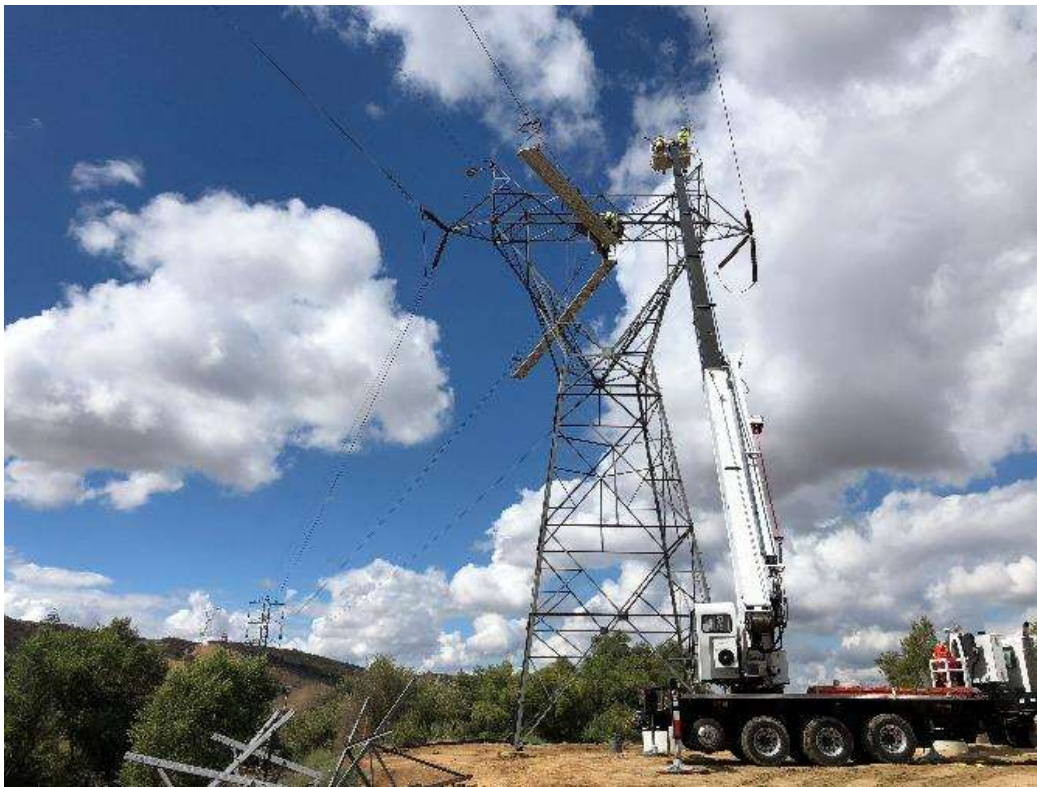
Photo 5 – Abercrombie crew wrecking out wire from existing tower at Site 4N62, Segment 4 (October 4, 2018).

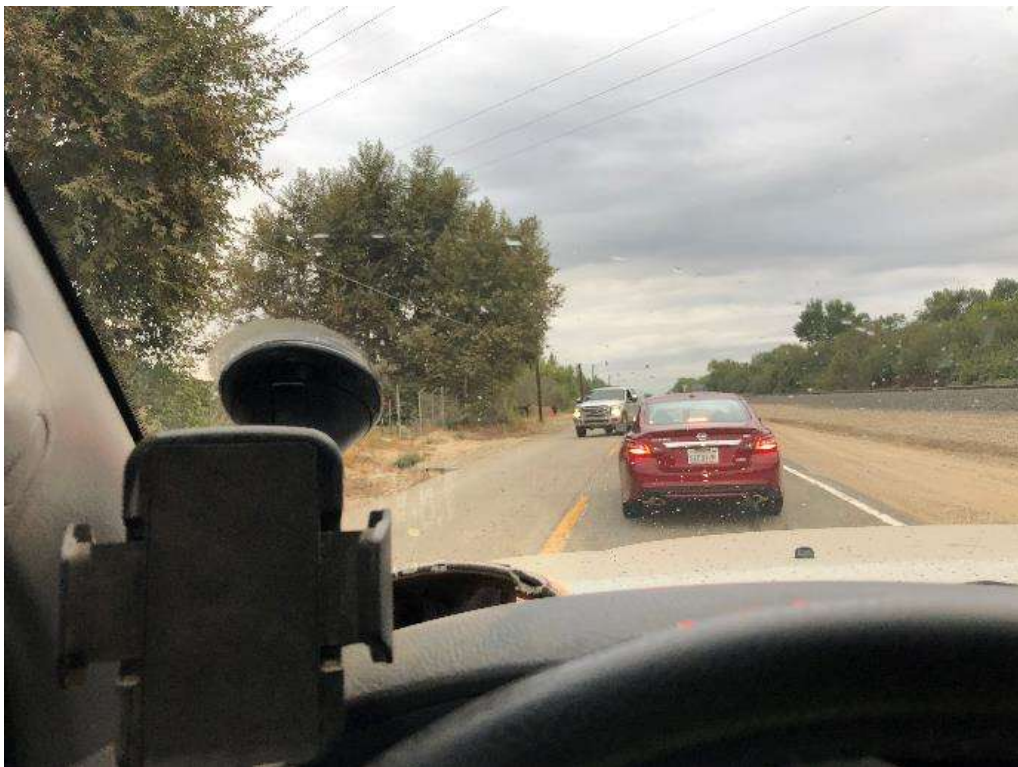
1. There were no SCE self-reported or CPUC incidents documented for construction activities associated with NTP #4 throughout the monitoring period.
2. On October 2, the CPUC EM observed traffic stopped at the access road entrance along San Timoteo Canyon Road as foundation cages were being delivered via flatbed truck to sites associated with Segment 4. Approximately 3-5 vehicles in each opposing lane were halted by CJ/Aldridge Drilling pickup trucks with flashing hazard and construction lighting (see Photo 6). No orange safety cones or flaggers were present at the location. The CPUC EM notified SCE environmental management, who provided email concurrence for this approach from the City of Calimesa.

Photo 6 – Traffic stopped by CJ/Aldridge pickup truck along San Timoteo Canyon Road (October 2, 2018).

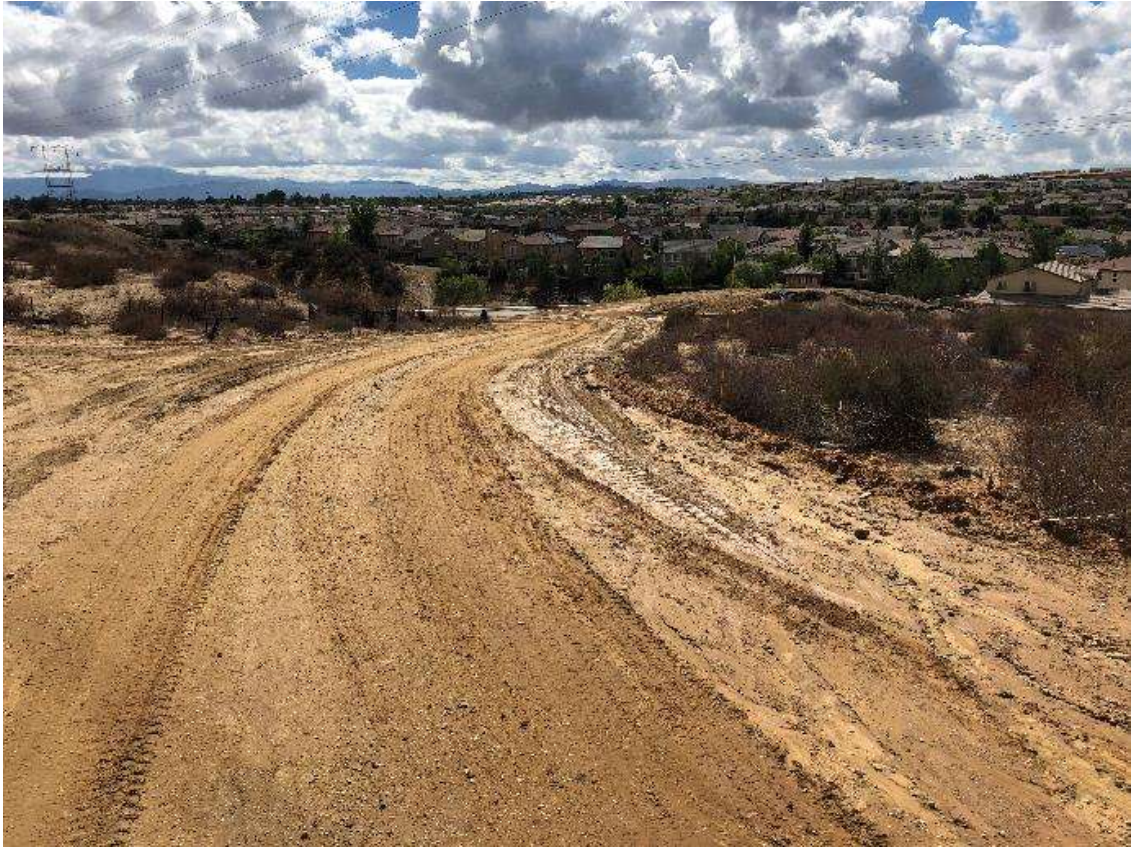
4. There were three SWPPP maintenance items and no corrective actions associated with NTP #4 recorded during the monitoring period. The maintenance items were all identified on October 4 and consisted of the addition of sandbags to minimize minor erosional features at Sites 4X47 and 4X51 and repairs to damaged silt fencing at Site 4N60 (see Photo 7). The CPUC EM confirmed that each of

Photo 7 – Minor erosional rills along access road near Site 4X51, Segment 4. CPUC EM confirmed that additional sandbags had since been installed (October 4, 2018).

these items was resolved with the 72 hour deadline defined in the project SWPPP. To date, there are no open SWPPP maintenance items or corrective actions associated with NTP #4.
