PROJECT MEMORANDUM
SCE WEST OF DEVERS UPGRADE PROJECT

Date: November 14, 2018
To: Billie Blanchard, Project Manager, CPUC
From: Vida Strong, Aspen Project Manager
Subject: Monitoring Report #39: October 29 to November 4, 2018

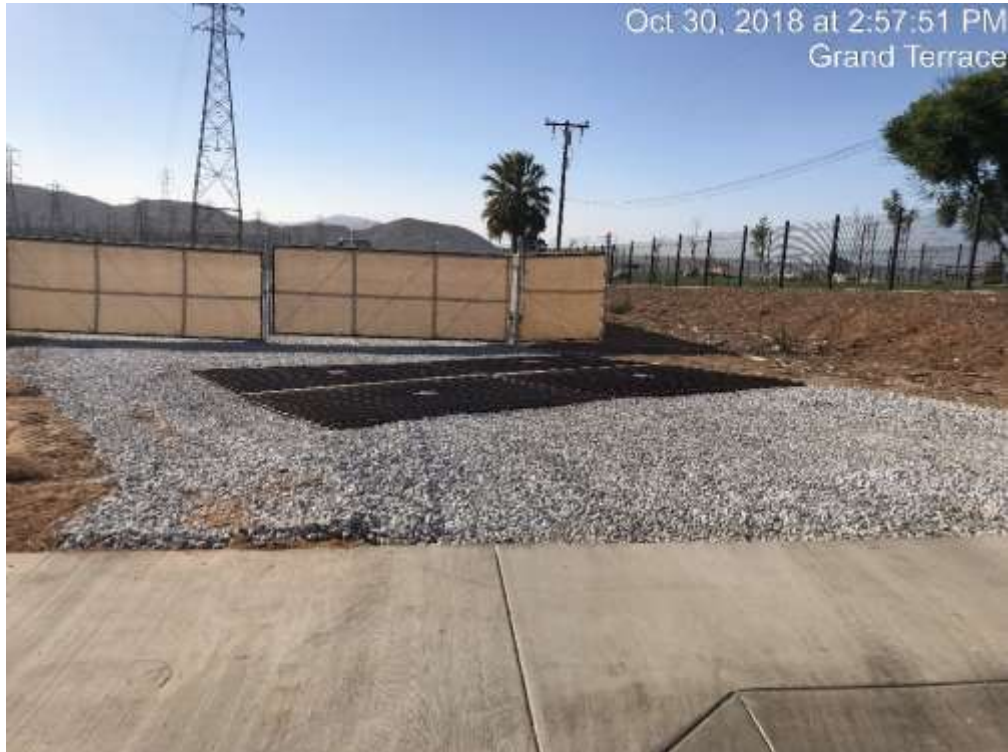
Photo 1 – Grand Terrace Yard had a stabilized entrance installed to prevent track-out and dust. (October 30, 2018).

6. The Grand Terrace MY will be used primarily as a show-up location for project construction crews. Power Grade installed a stabilized entrance and rocked the interior of the yard during the monitoring period (see Photo 1).

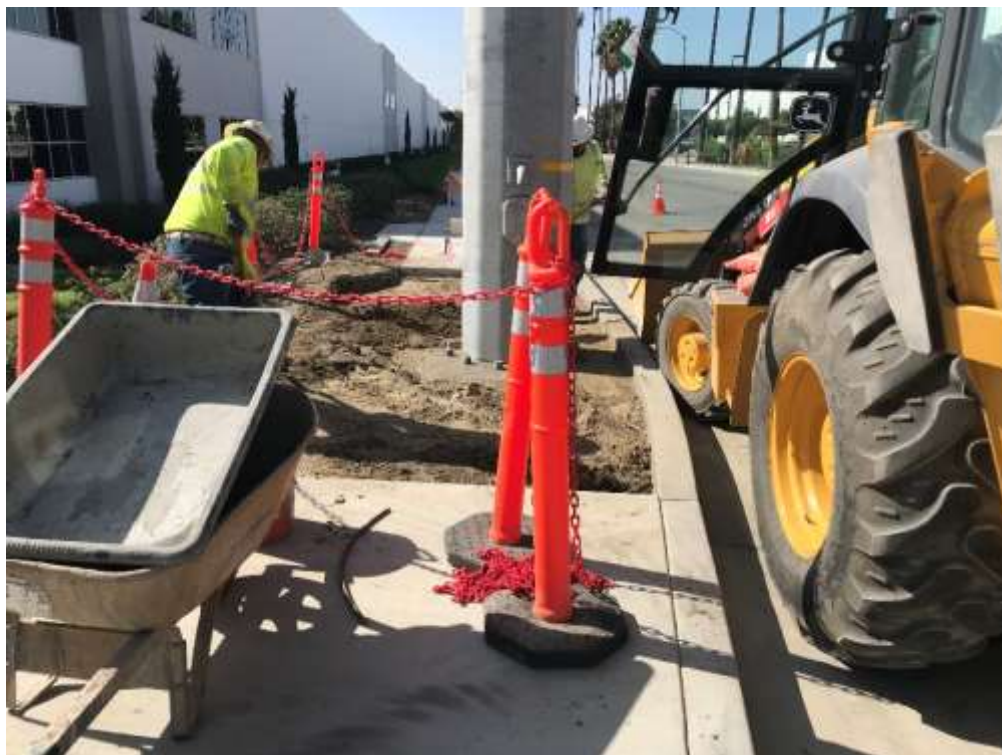
Photo 2 – Sidewalk restoration following pole placement along Nevada Street for the subtransmission work performed by Hotline Construction (October 30, 2018).

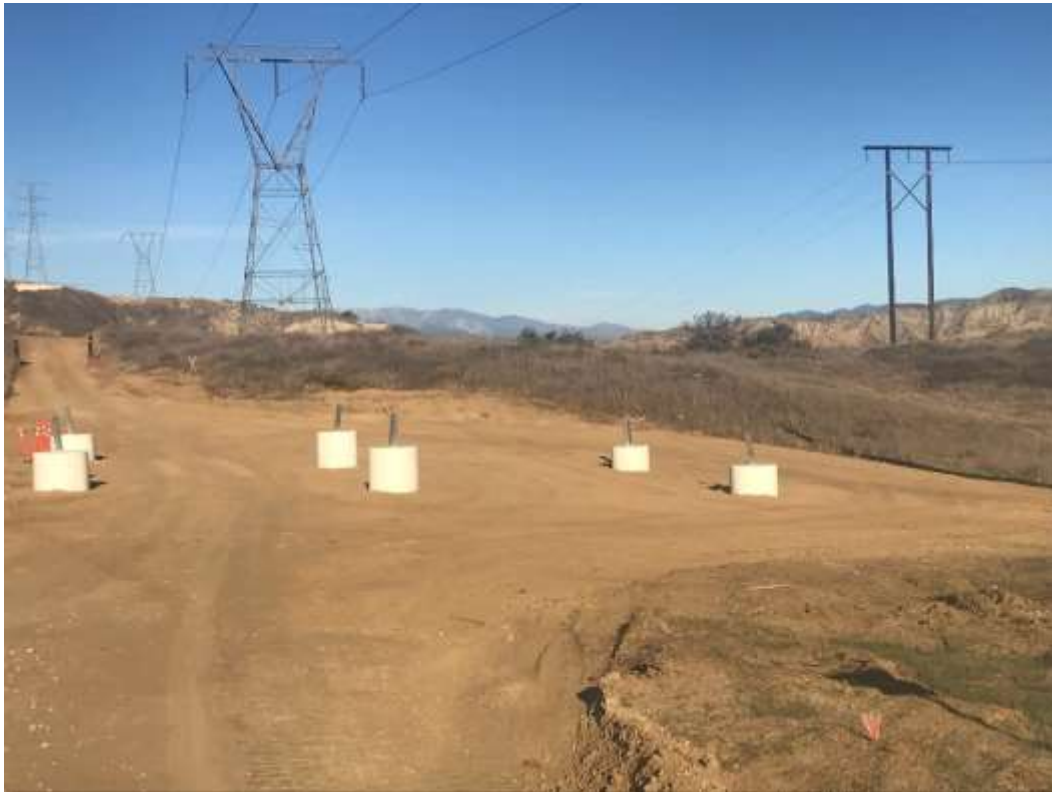
Photo 3 – Completed foundations at Segment 3 Tower 3X14 (October 31, 2018).

4. Work associated with Segment 3 included retaining wall construction at Site 3X37. Foundation drilling and pouring was performed at Sites 3X13, 3X14, and 3X15 (see Photo 3). Soil export was conducted at Sites 3X61 and 3X65.

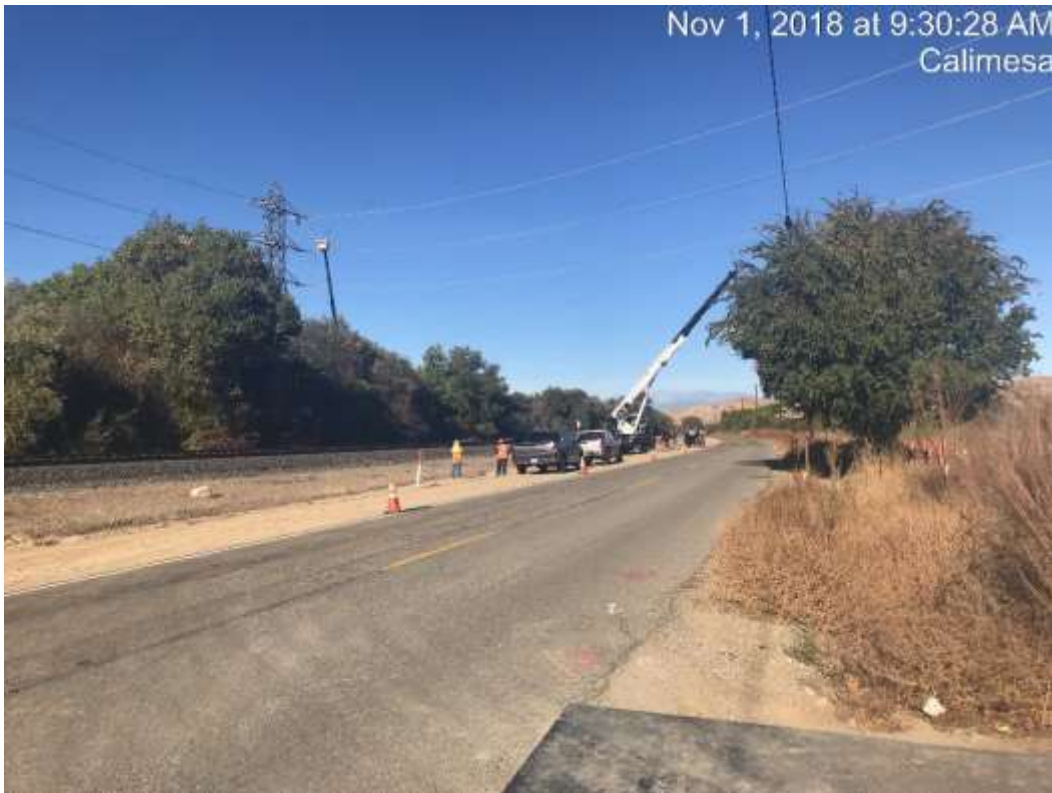
Photo 4 – Wire stringing across San Timoteo Road, Segment 4 (November 1, 2018).

5. Work associated with Segment 4 included tower and foundation removal along with tower construction. Tower assembly and/or erection was performed at Sites 4N58, 4N54, and 4N53. Wire stringing activities occurred between Sites 4X55 and El Casco Substation via helicopter (see Photo 4).

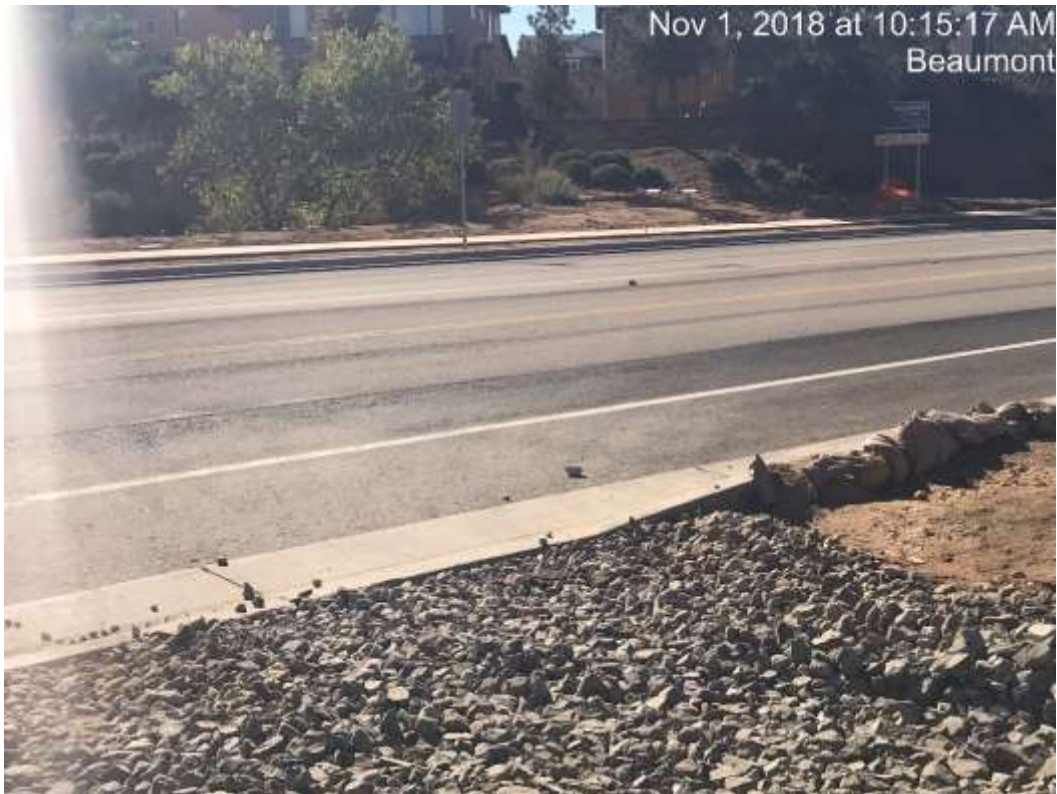
2. The CPUC EM noted track out of 4-inch rock onto Palmer Avenue by project related traffic (see Photo 5). The observation was relayed to Jacobs environmental staff.

Photo 5 – Track out of rock onto Palmer Ave was reported by the CPUC EM (November 1, 2018).
