PROJECT MEMORANDUM
SCE WEST OF DEVERS UPGRADE PROJECT

Date: February 11, 2019
To: John Forsythe, Project Manager, CPUC
From: Vida Strong, Aspen Project Manager
Subject: Monitoring Report #49: January 27 to February 2, 2019

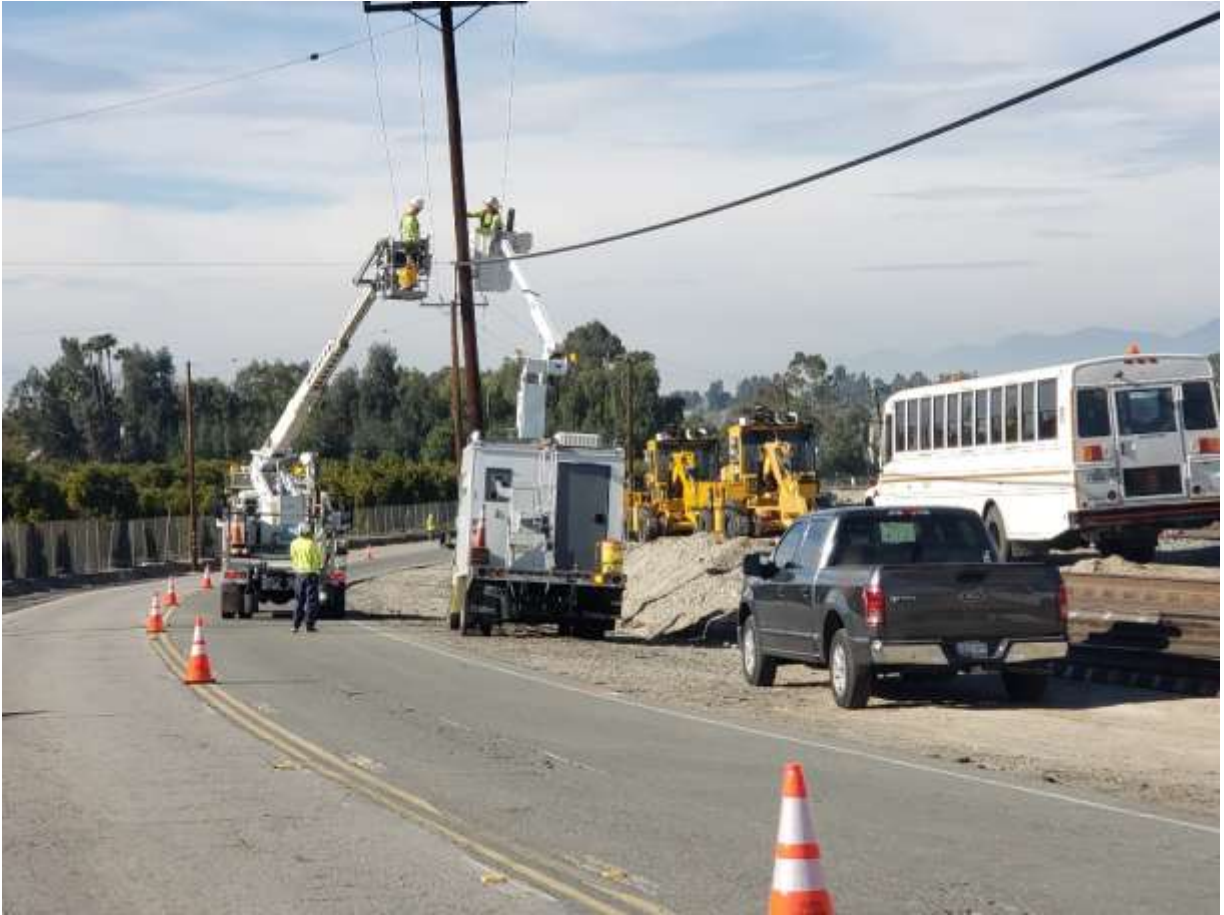
Photo 1 – SCE Telecom work along San Timoteo Canyon Road.

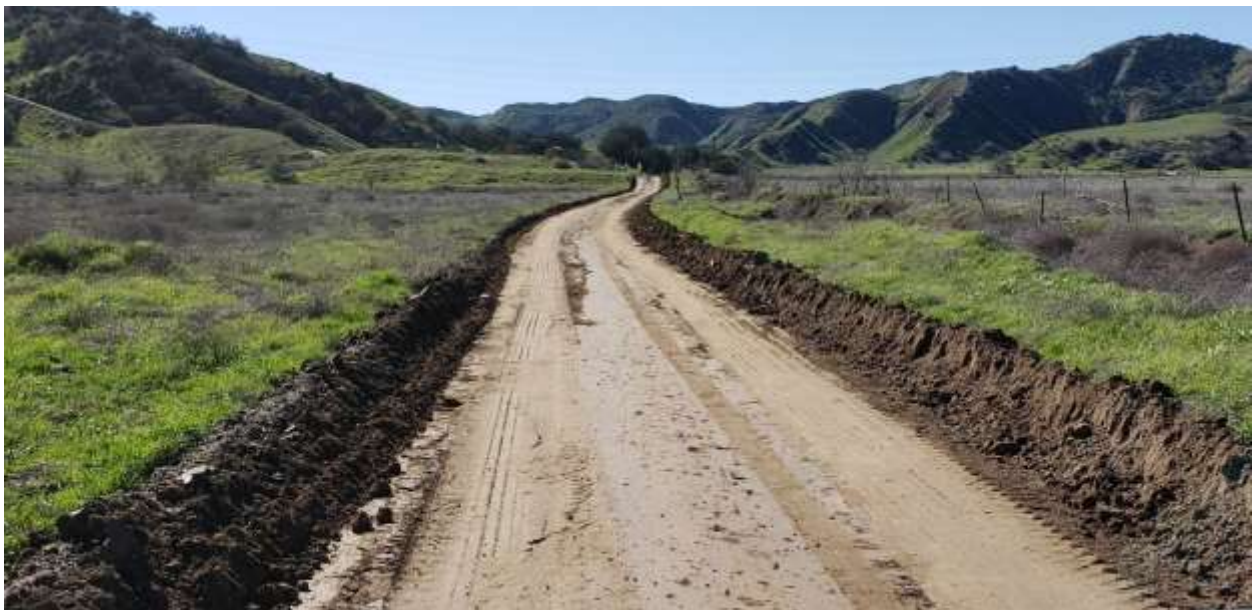
2. The CPUC EM noted that access road grading following recent rain events was occurring in various locations in Segment 3 and raised a concern that the new grading and associated berms could be modifying the natural drainage patterns (see Photos 2 and 3). This concern was communicated to Project environmental staff.

Photo 2 – Crews conducted access road grading in areas of Segment 3 to allow of equipment access to tower sites during and following rain events.

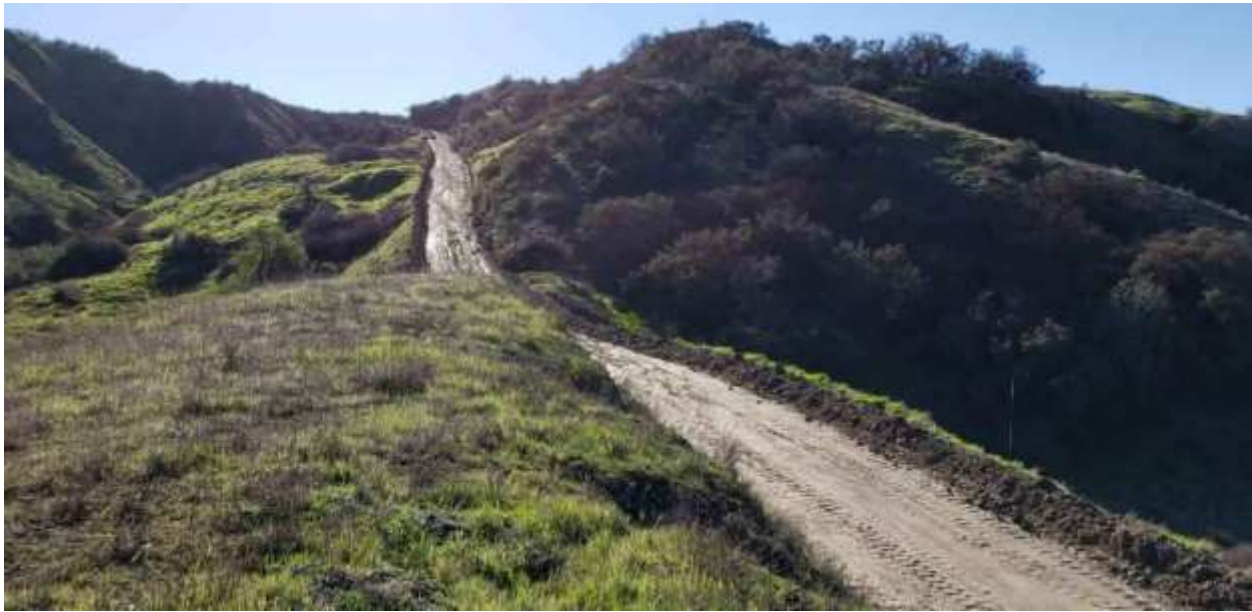
Photo 3 – Access road grading to facilitate project equipment accessing work sites in Segment 3.

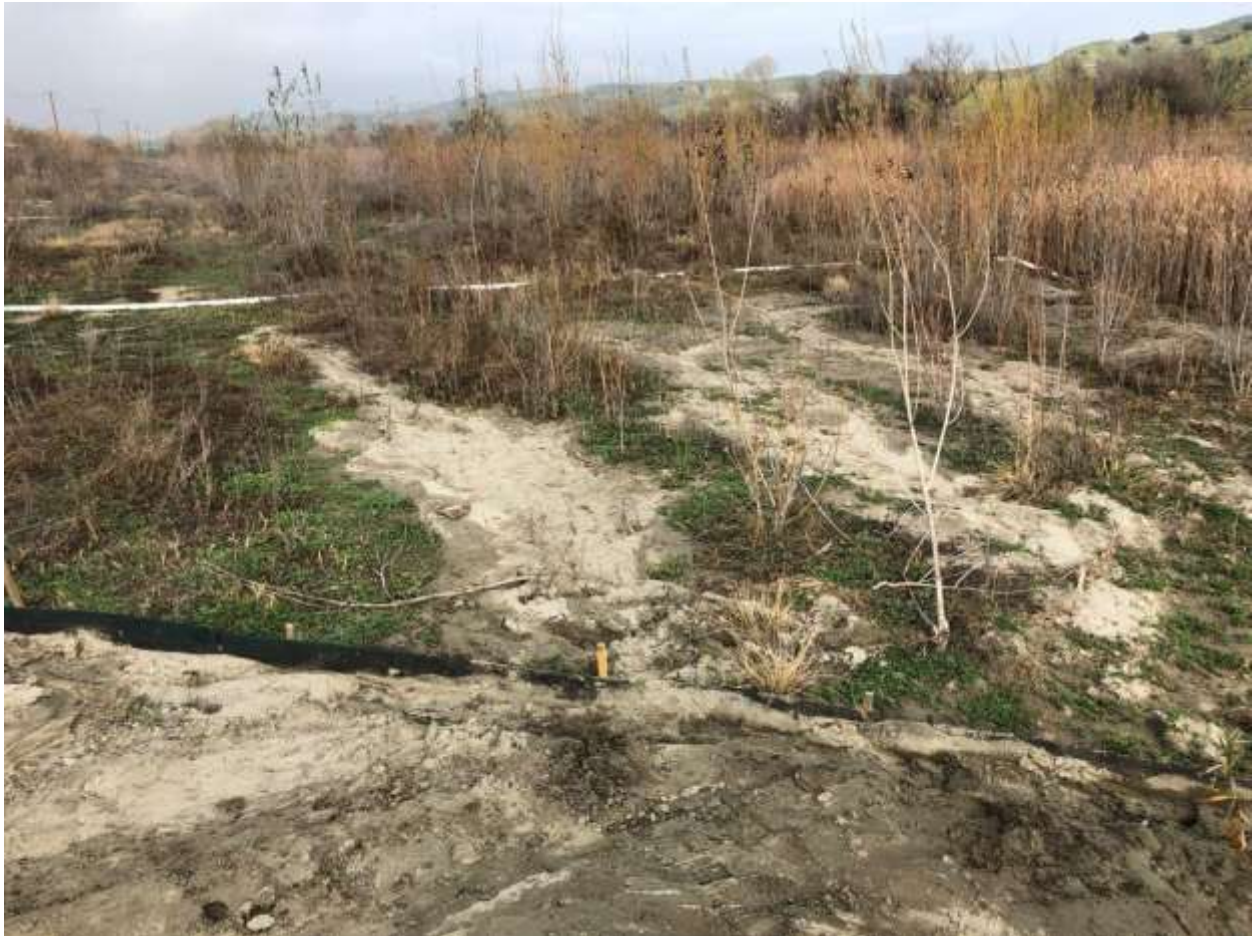
1. One SCE self-reported compliance incidents and no CPUC compliance incident were documented for construction activities associated with NTP #4 throughout the monitoring period. On February 01, evidence of sediment washing over perimeter controls into a wetland water feature occurred at Segment 4 Tower 4N63 (see Photo 4). SCE self-reported this as a Level 1 Incident (“Offsite migration of sediment [no impacts to ESAs]”) and notification was provided to CDFW, USACE, SWRCB, and the CPUC.

Photo 4 – Offsite sedimentation after recent rain events at Tower 4N63, Segment 4. Sediment from the graded tower side overlook BMPs and discharged sediment into the adjacent jurisdictional drainage. USACE, CDFW, and SWRCB were notified by SCE. Photo courtesy of SCE.

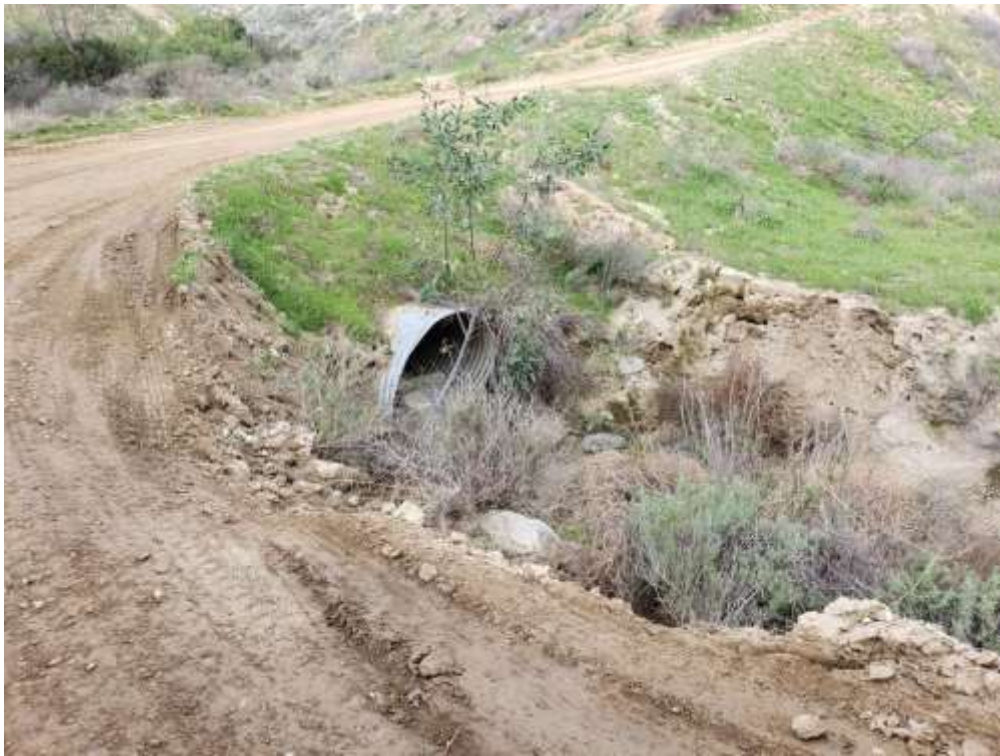
Photo 5 – Vehicle tracks outside of the road bed and encroaching on ESA for jurisdictional feature along access road to Site 3X63, Segment 3. Additional ESA delineators to facilitate ESA flagging visibility for project vehicles was discussed with Project environmental staff.

3. The CPUC EM noted vehicle tracks encroaching on an ESA for a jurisdictional drainage along the access road to Site 3X63. The CPUC EM discussed with Project environmental staff the installation of additional ESA delineators that would be easier to see from large vehicles so that large trucks can more easily avoid encroaching on the resource (see Photo 5).

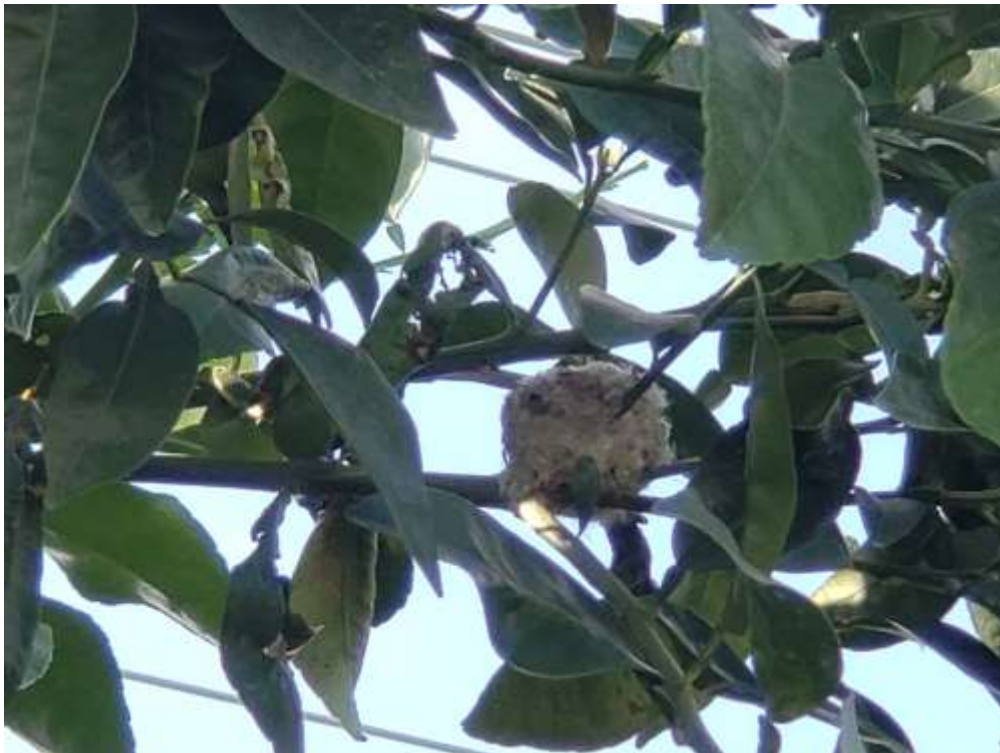
Photo 6 – Newley discovered Anna’s hummingbird nest in Segment 1. Per the Nesting Bird Management Plan, an avoidance buffer was established.

6. There were no reportable (> 1 gallon) spills associated with NTP #4 identified during the monitoring period.
7. One new nest was identified during the reporting period associated with NTP #4 work areas (see Photo 6) and the required buffer was established in accordance with the Project NBMP. No removal of inactive non-special-status bird species’ nests occurred during the subject period.
