PROJECT MEMORANDUM
SCE WEST OF DEVERS UPGRADE PROJECT

To: John Forsythe, Project Manager, CPUC
From: Vida Strong, Aspen Project Manager
Date: June 20, 2019
Subject: Monitoring Report #68: June 9 to June 15, 2019

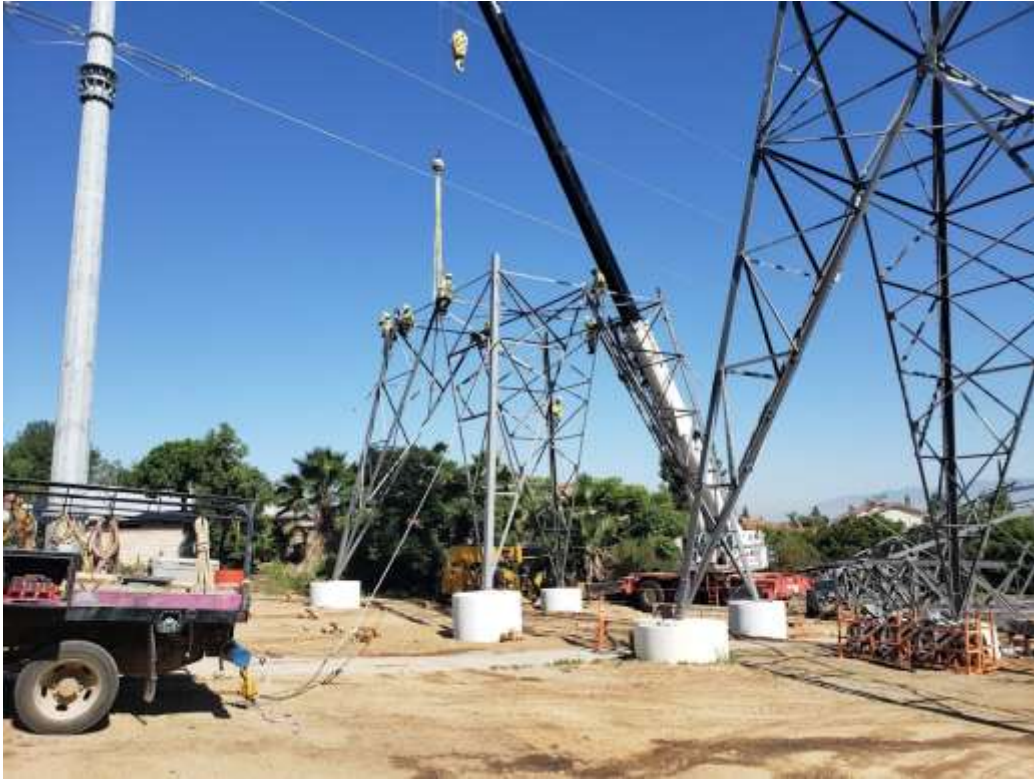
2. Work associated with Segment 1 during the monitoring period included: Tower assembly at Construction Areas 1X04, 1X10, 1X13, 1X15, 1X17, 1X18, and 1X19 (see Photo 1); tower wreck-out at Construction Areas 1X21 through 1X24; irrigation repair at Construction Area 1X13 (see Photo 2); and punch-list verification at Construction Areas 1X11, 1X12, 1X16, and 1X26.

Photo 1 – Tower assembly activities on Segment 1 (June 12, 2019).

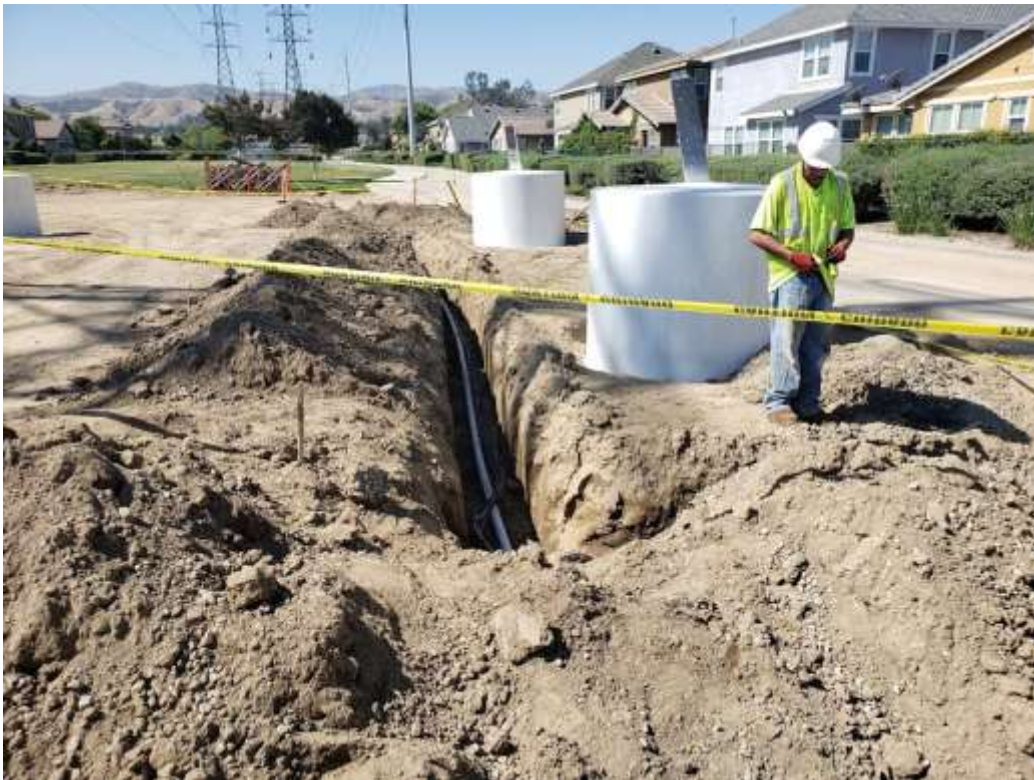
Photo 2 – irrigation repair on Segment 1 (June 12, 2019).

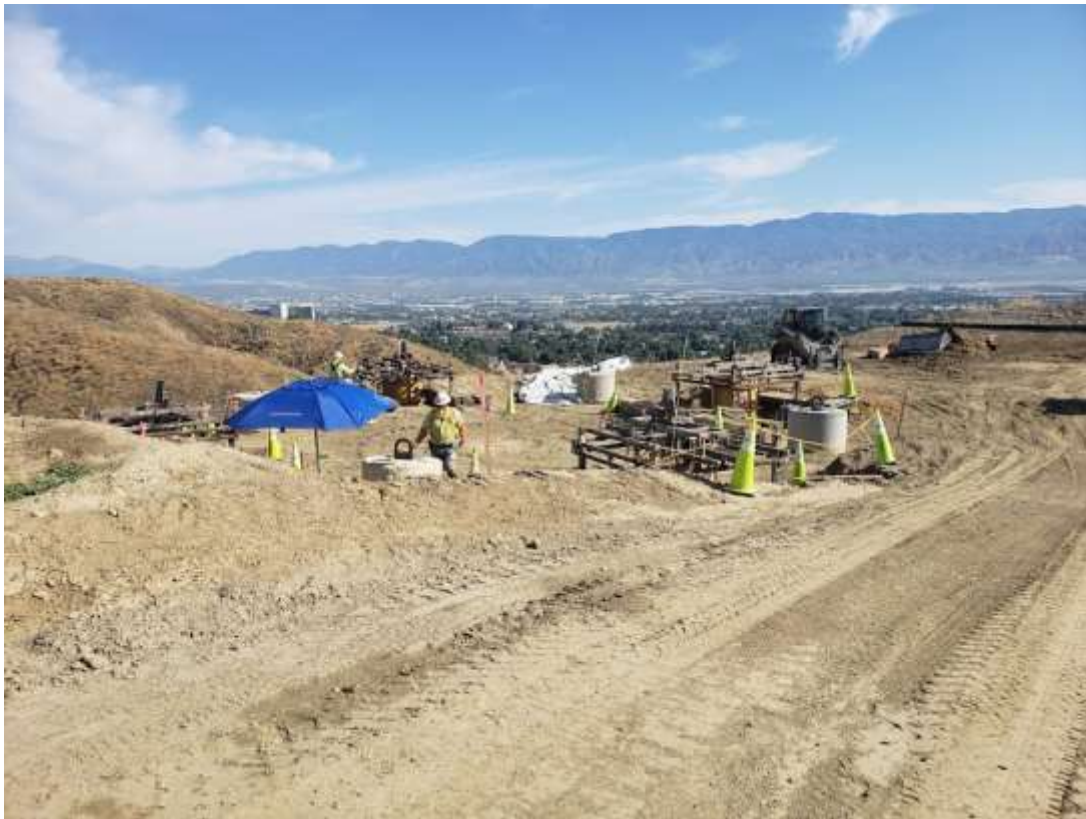
3. Work associated with Segment 2 included: Clearing, grubbing, grading, and soil export at Construction Areas 2X18, 2X25 and 2X26; grading, soil import, and soldier pile wall installation at Construction Area 2X32; foundation work at Construction Areas 2X07, 2X10, 2X11, and 2X15 (see Photo 3); BMP installation and maintenance at Construction Areas 2X22, 2X25, 2X26, 2X28, 2X29, and 2N30; and access road maintenance from Construction Areas 2X10 to 2X32.

Photo 3 – Foundation activities on Segment 2 (June 11, 2019).

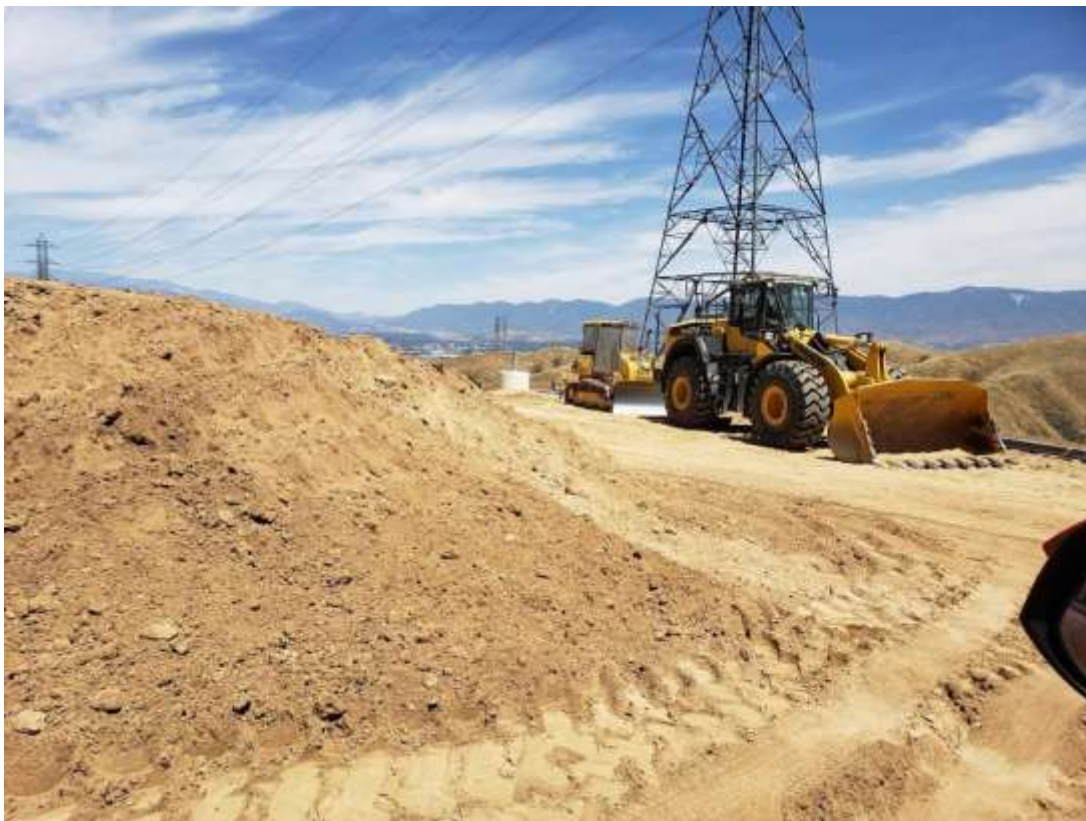
4. Work associated with Segment 3 included: Clearing, grubbing and Hilfiker wall installation at Construction Area 3X37; soil cement installation at Construction Area 3X33; grading and soil exporting at Construction Area 3X64 (see Photo 4); soil export at Construction Area 3X31; and berm repair at Construction Area 3X48.

Photo 4 – Soil export preparation on Segment 3 (June 11, 2019).

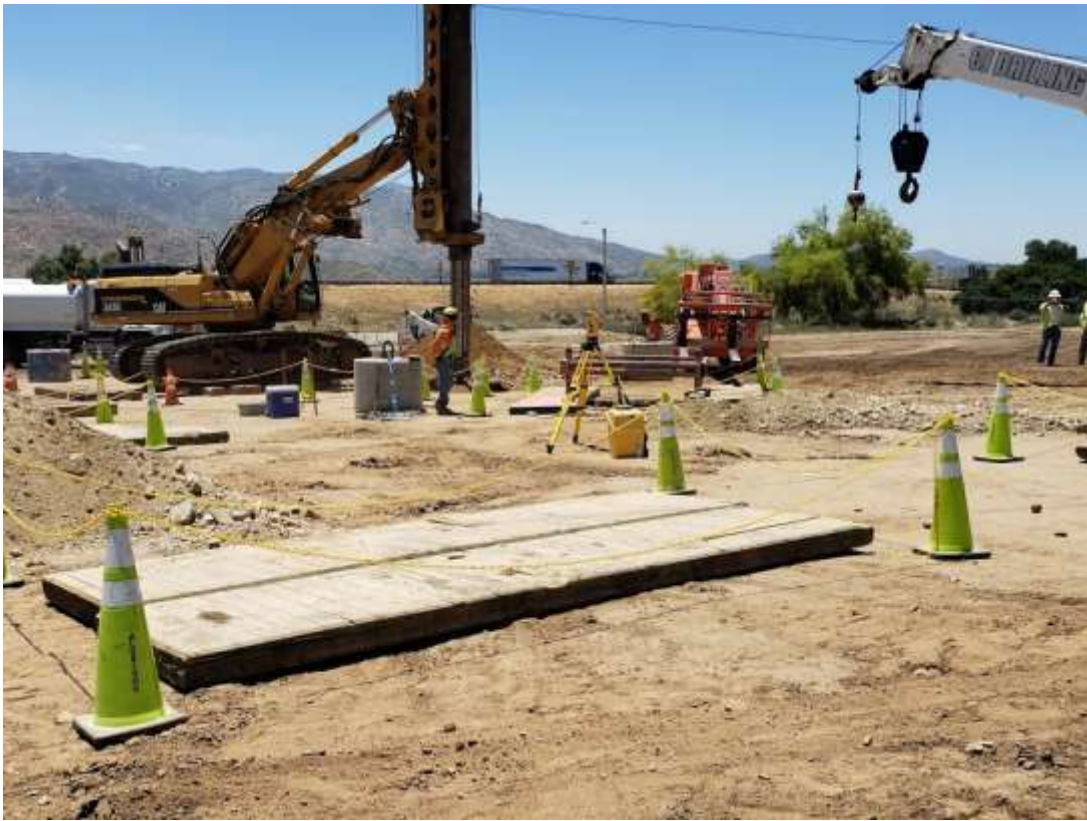
6. Work associated with Segment 5 (which includes sites within Morongo lands along Segment 5 as reported by SCE) included: Foundation work at Construction Areas 5X28, 5X29, 5X52 and 5X54 (see Photo 5); and BMP maintenance at Construction Area 5X28.

Photo 5 – Foundation activities on Segment 5 (June 12, 2019).

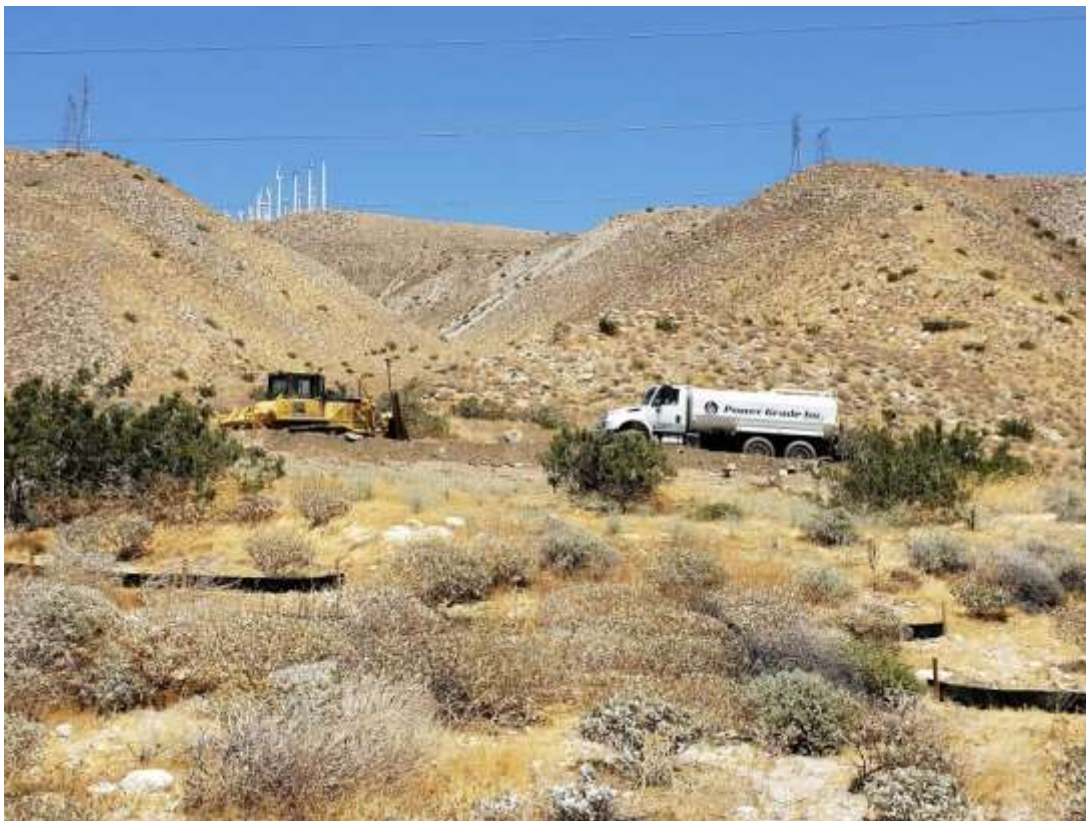
7. Work associated with Segment 6 (non-BLM lands) included: Grading and rock export at Construction Areas 6S28A, 6S30, and 6S30A (see Photo 6); foundation work at Construction Areas 6N15, 6S15, 6N16, 6N17, 6S17, 6N18, 6S18, 6X19, 6N20, 6N21, 6N22, and 6N23; BMP installation at Construction Areas 6N38, 6N39, 6S39, 6N40, 6S40, 6S41, 6X42, 6X46, 6X47, and 6X48; access road maintenance from Construction Areas 6S28 to 6N30; and guard structure installation at Construction Area T259.

Photo 6 – Grading activities on Segment 6 (June 12, 2019).

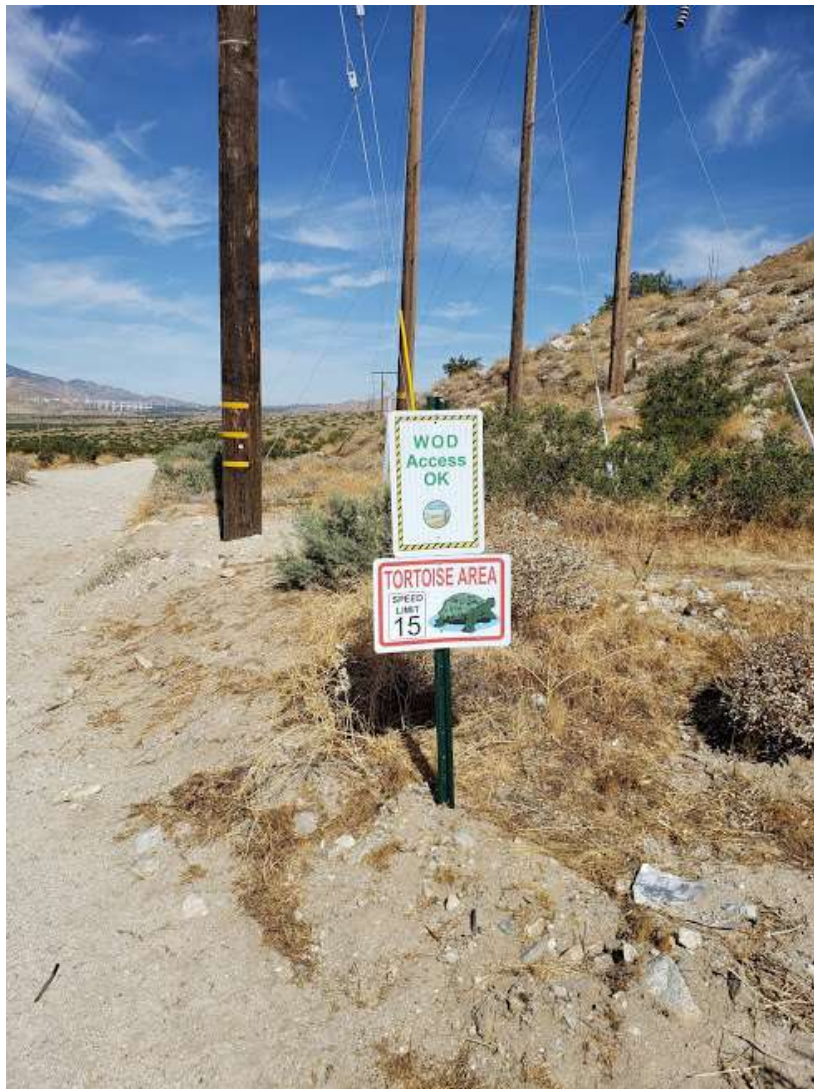
5. SCE installed new desert tortoise access road speed limit signs at entrances to the right-of-way in Segment 6 reminding Project personnel of the 15 MPH speed limit (see Photo 7).

Photo 7 – New Desert Tortoise speed limit signs on Segment 6 (June 10, 2019).
