**PROJECT MEMORANDUM**  
**SCE WEST OF DEVERS UPGRADE PROJECT**

**To:** John Forsythe, Project Manager, CPUC  
**From:** Vida Strong, Aspen Project Manager  
**Date:** January 30, 2020  
**Subject:** Monitoring Report #96: January 20 to January 26, 2020

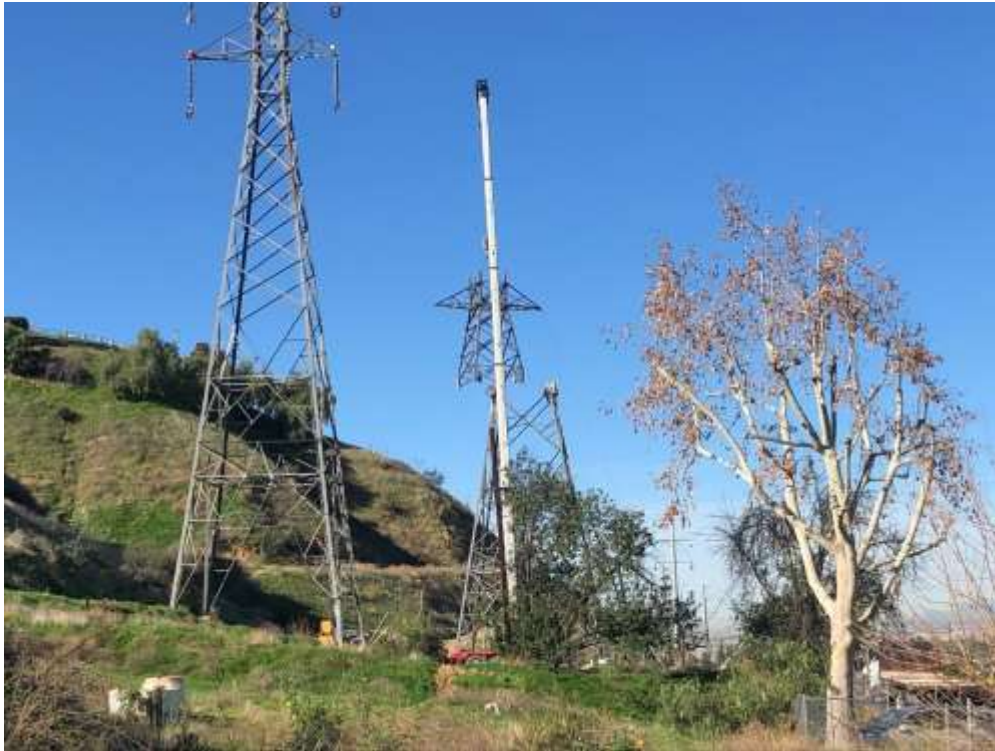
Photo 1 – Tower assembly at Construction Area 2N29, Segment 2 (January 24, 2020).

2. No construction activities associated with Segment 1 occurred during the subject monitoring period.
3. Work associated with Segment 2 included: Tower assembly at Construction Areas 2X04, 2N15, 2N21, 2N23, 2N28 through 2N30, 2N33, and 2N34 (see Photo 1); tower wreck-out activities at Construction Areas 2N25, 2N28 through 2N30, and 2N32 through 2N35; wire stringing activities (helicopter and ground) at Construction Areas 2N01 through 2N26 and 2N31 (see Photo 2); and BMP maintenance at Construction Area 2N16.

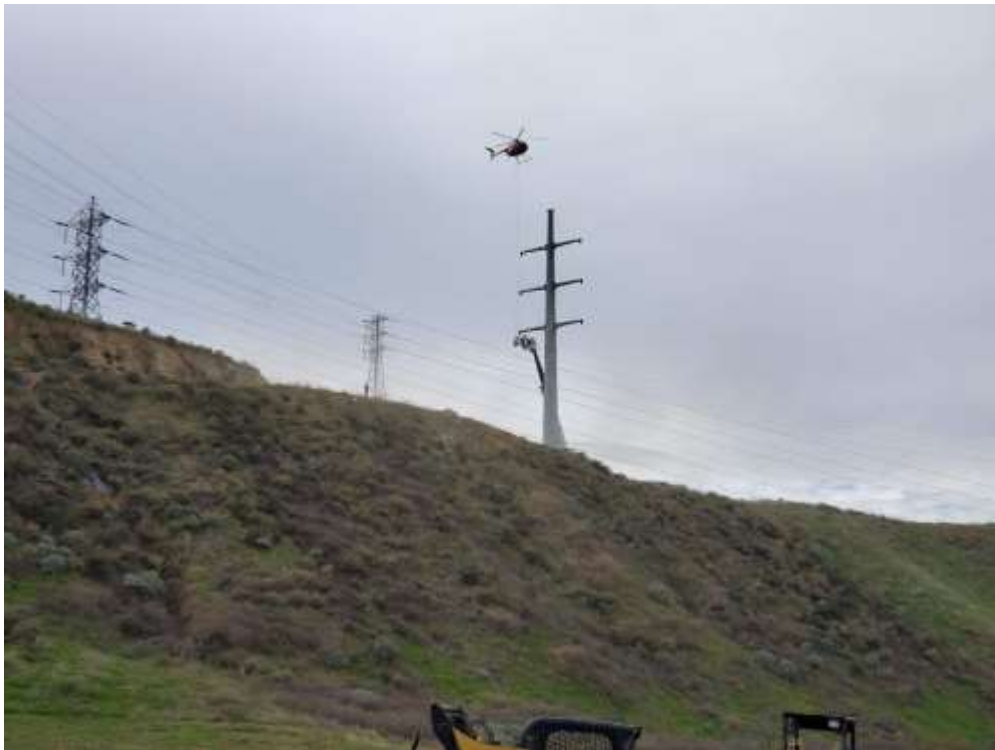
Photo 2 – Helicopter wire stringing activities at Construction Area 2N17, Segment 2 (January 20, 2020).

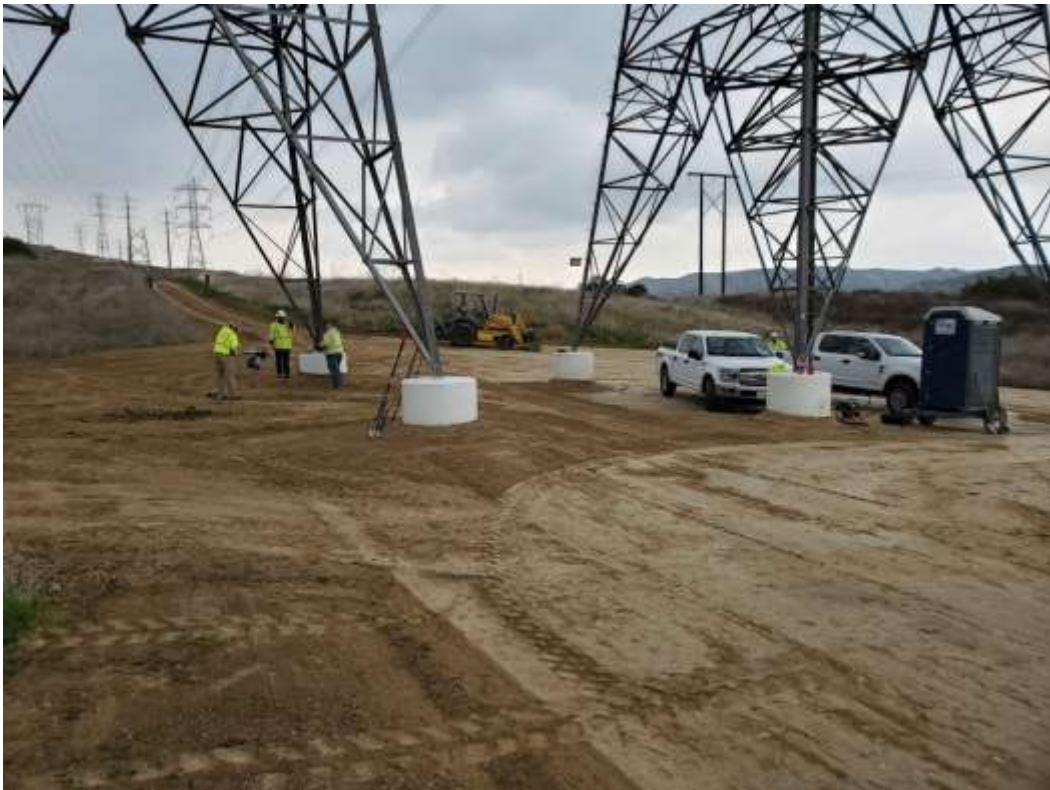
Photo 3 – Tower pad recontouring at Construction Area 3X14, Segment 3 (January 21, 2020).

4. Work activities associated with Segment 3 included: MAC drain installation at Construction Areas 3N03, 3X12, and 3X20; dissipator installation at Construction Area 3X20; tower pad restoration at Construction Areas 3X14, 3X17, and 3X20 through 3X26 (see Photo 3); BMP maintenance at Construction Areas 3N03, 3N04, 3X08, 3X10, 3X12, 3X14, and 3X17; and roadway and spur road maintenance from Construction Areas 3X20 through 3X23.

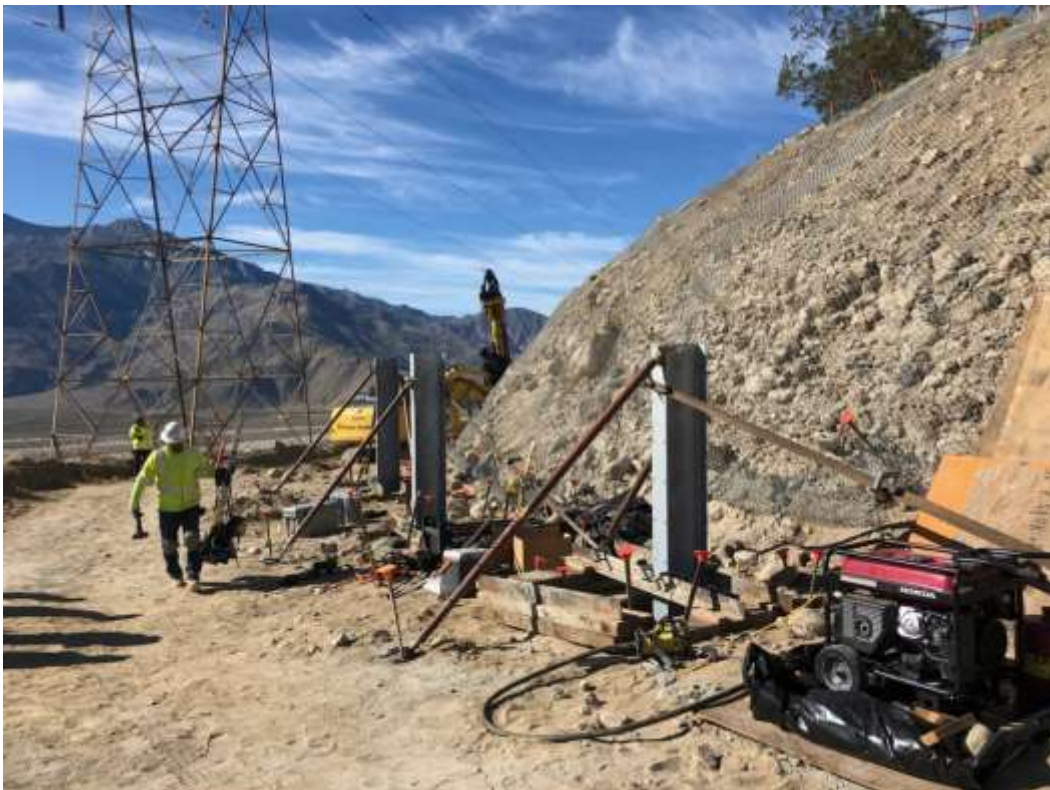
Photo 4 – Soldier pile wall construction at Construction Area 6N30, Segment 6 (January 23, 2020).

7. Work associated with Segment 6 (non-BLM lands) included: Grading, drilling, soldier pile wall construction, and material export at Construction Area 6N30 (see Photo 4); rock and stockpile removal at Construction Area 6S28-S; and BMP maintenance at Construction Areas 6N27, WSS-6-6N26-6N27, 6S27, WSS-6-6S26-1-MPR-29, 6N26, 6S26, WSS-6-6S26-2-MPR-29, 6N25, 6S25, and 6X24.

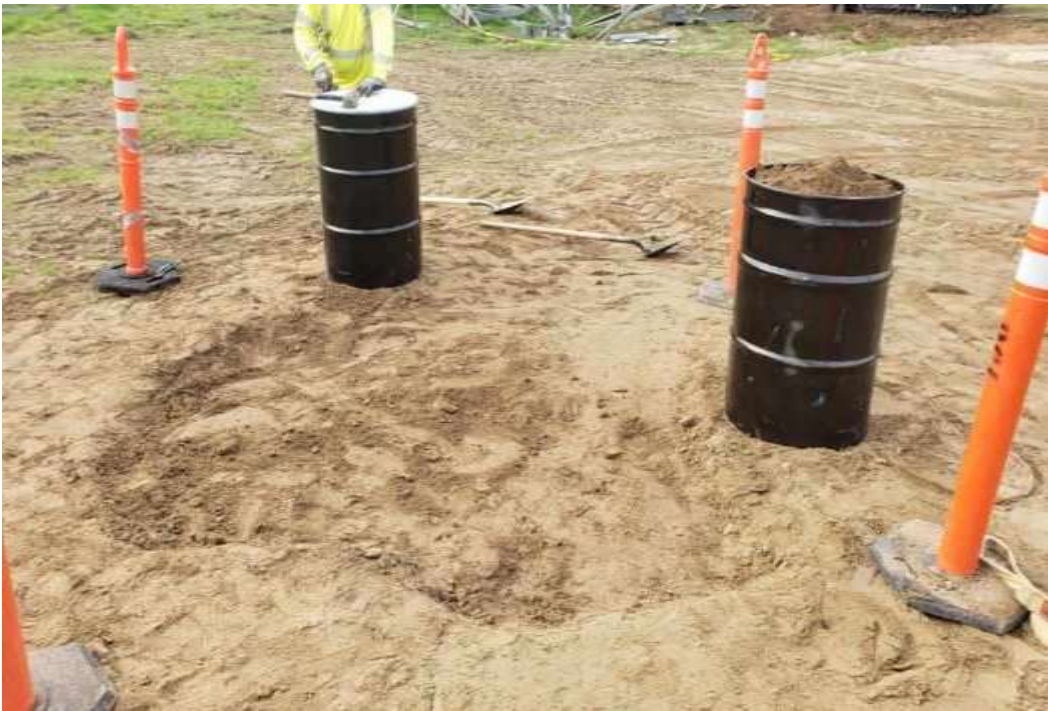
4. There was one reportable (>1 gallon) and no non-reportable (<1 gallon) spills associated with NTP #4 identified during the monitoring period. On January 21, during the morning sweep of Construction Area 2N35, the Biological monitor observed diesel fuel spilled on the ground adjacent to a backhoe staged onsite. Approximately 1-2 gallons of diesel fuel was spilled on the ground as the result of vandals siphoning gas from the equipment. The crew immediately cleaned up the spill placing impacted soil in two 55-gallon drums to be disposed of at an SCE approved facility (see Photo 5).

Photo 5 – Diesel fuel clean-up at Construction Area 2N35, Segment 2 (January 21, 2020)  
(Photo courtesy of SCE).
