PROJECT MEMORANDUM
SCE WEST OF DEVERS UPGRADE PROJECT

To: John Forsythe, Project Manager, CPUC
From: Vida Strong, Aspen Project Manager
Date: March 19, 2020
Subject: Monitoring Report #103: March 9 to March 15, 2020

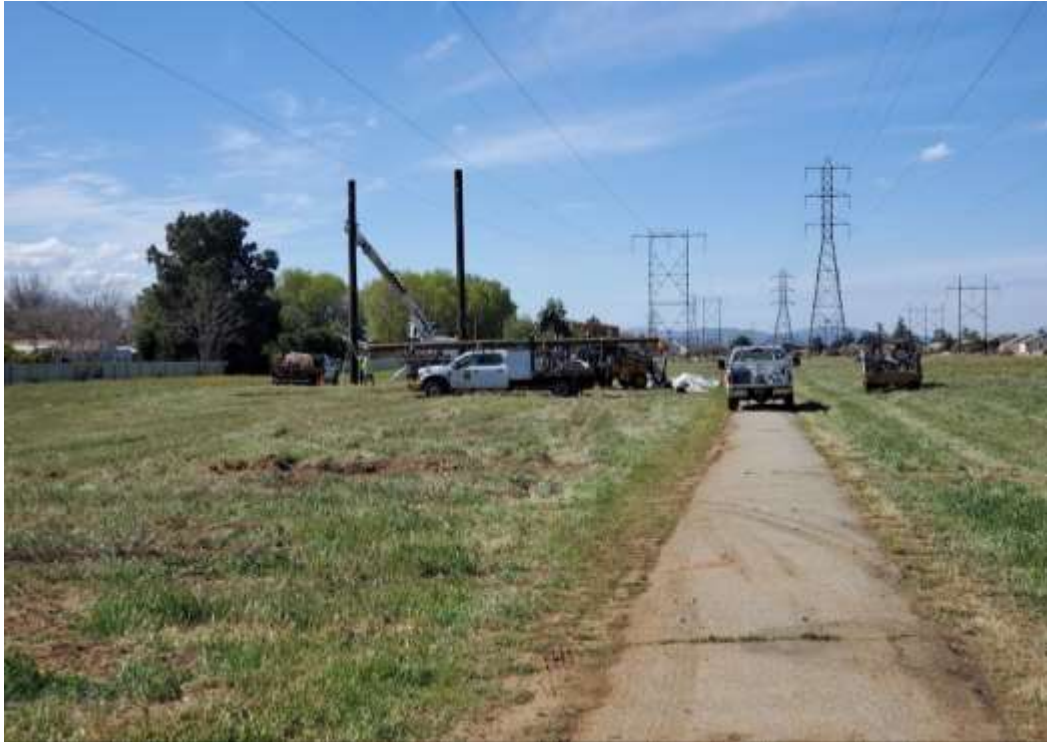
Photo 1 – Snub pole installation at Construction Area WSS4X27-4X29, Segment 4 (March 9, 2020).

5. Work associated with Segment 4 included: Foundation activities at Construction Areas 4X06 and 4X08 through 4X10; tower assembly at Construction Areas 4X30 through 4X32; stripping forms and grading on the access road to Construction Area 4X04; and setting snub poles and anchors at Construction Area WSS-4X27-4X29 (see Photo 1).

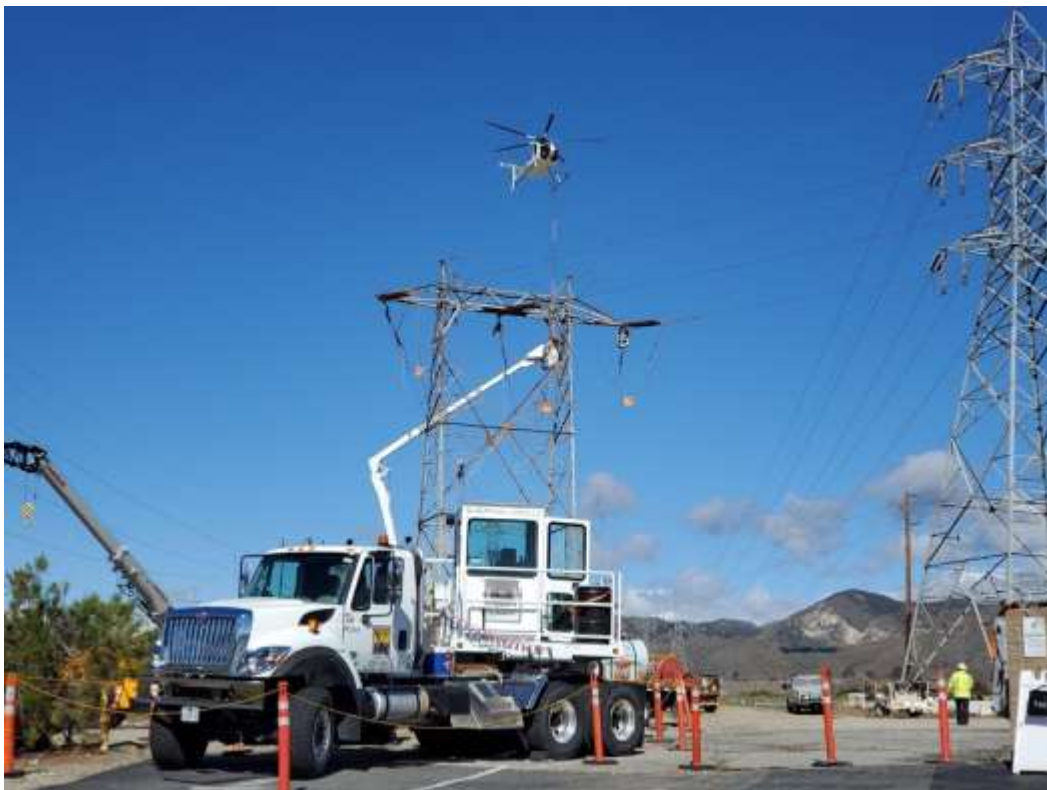
Photo 2 – Wire wreck-out activities at Construction Area 5X29, Segment 5 (March 11, 2020).

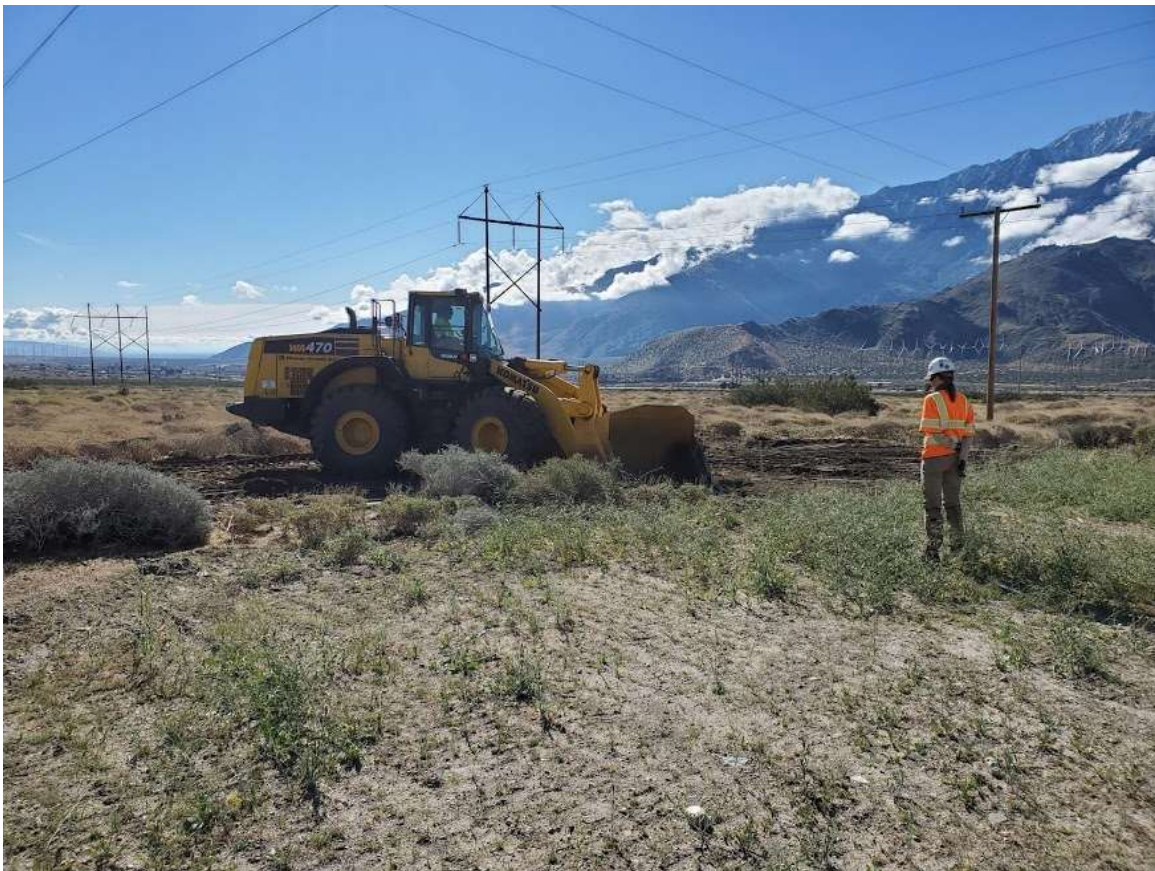
Photo 3 – Vegetation clearing at Construction Area 6X46, Segment 6 (March 11, 2020).

7. Work associated with Segment 6 (non-BLM lands) included: Vegetation clearing at Construction Areas 6X42 and 6X46 (see Photo 3); backdrain installation, backfilling, and grading at Construction Area 6N30; foundation activities at Construction Areas 6X08, 6N32, and 6N34; guard pole installation at Construction Areas 6X46 and M7-T3; fiber optic splicing at Construction Area 6S26; and BMP maintenance at Construction Areas 6X09-6X10 and 6X46.

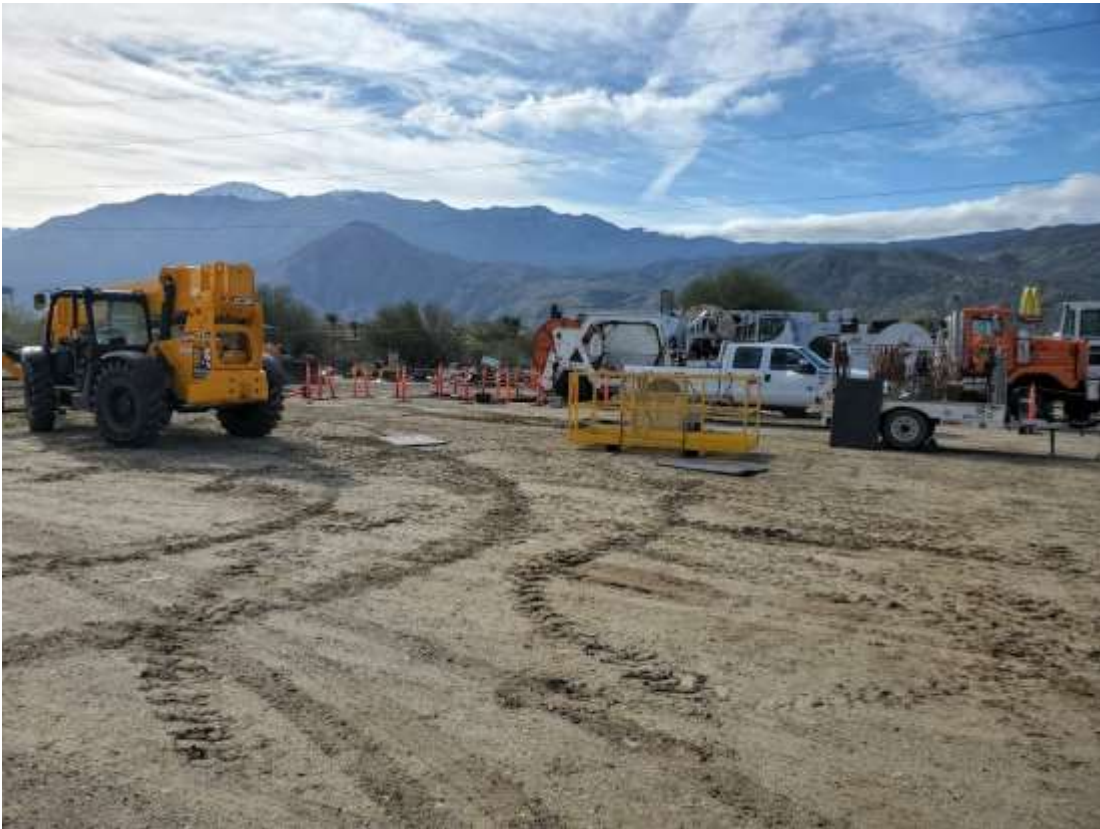
2. On March 16, the CPUC EM observed construction vehicles, equipment, and materials staged outside of any approved disturbance areas between Construction Areas 5X28 and 5X29 (see Photo 5). The Project Field Contract Representative was immediately notified of the observation. The equipment was being used for wire wreck-out activities and could not be safely moved. SCE requested a TEWS to continue to use the area for wire wreck-out activities. The CPUC EM issued a Level 1 incident Report for equipment staged outside of approved disturbance areas.

Photo 5 – Equipment and materials staged outside of approved disturbance areas between Construction Areas 5X28 and 5X29, Segment 5 (March 16, 2020).
